2035012 Final Report for
**Sunshine Coast
Regional District**

**Feasibility Studies - Replacement/Upgrade
of Three Wastewater Systems**

Onsite Wastewater Treatment and Dispersal System Assessment – Greaves Wastewater Treatment Facility

PROJECT No: 2021.02

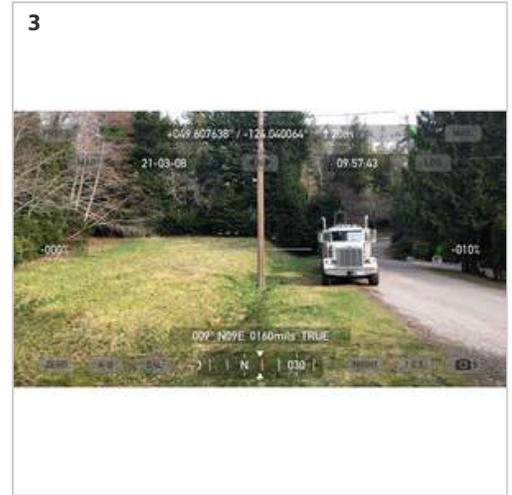
#16 - GENERAL SITE OBSERVATIONS

- Vegetation encroachment, primarily Western Red Cedar and Alder trees, is significant. All trees within 3m-5m of the dispersal area should be felled and the stumps removed. Ongoing vegetation management is recommended.

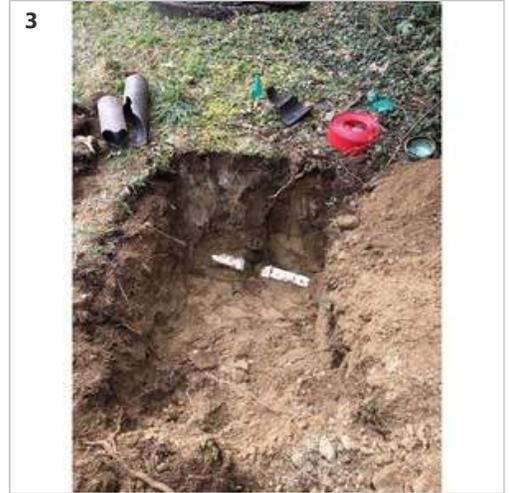
#21 - MANIFOLD AND VALVES
 Completed | Bradley Fossen | 01. OBSERVATION
 Plan: Greaves Construction Drawing

- The settling tank has a cracked lid which should be replaced for integrity and to prevent rainwater infiltration.
- The effluent manifold, providing flow to two distribution boxes, is uneven. As a result, flow to each distribution box, and its respective dispersal field, is uneven.

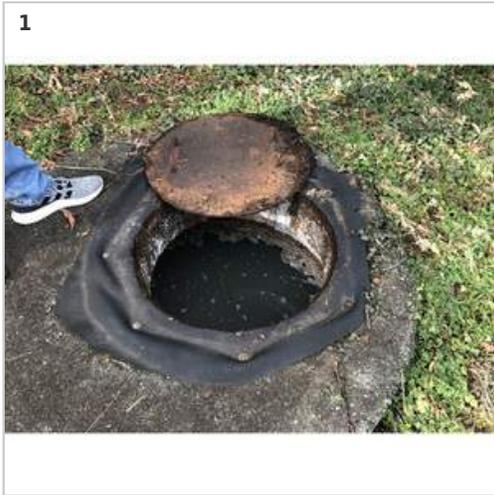
#17 - SIPHON CHAMBER

- The syphon chamber has a performance malfunction and is currently operating via overflow. The syphon mechanism should be replaced. A replacement floating outlet configuration may offer additional usable life for the existing dispersal field.

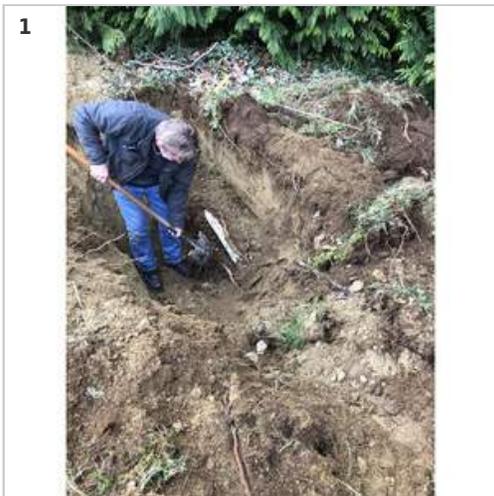
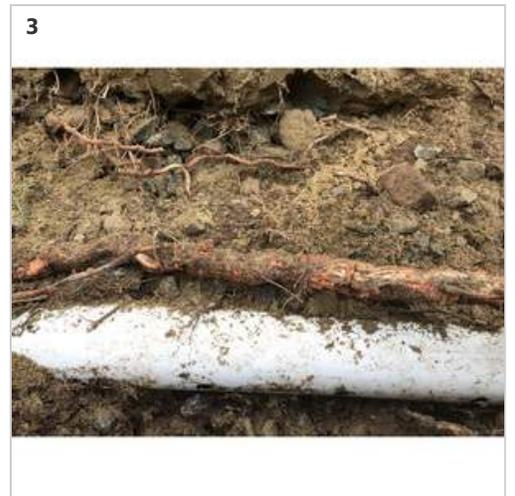
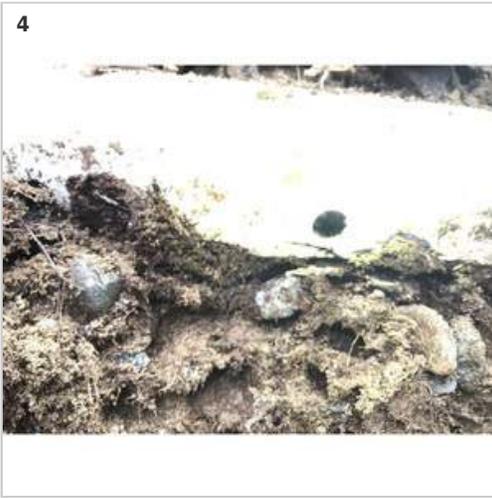
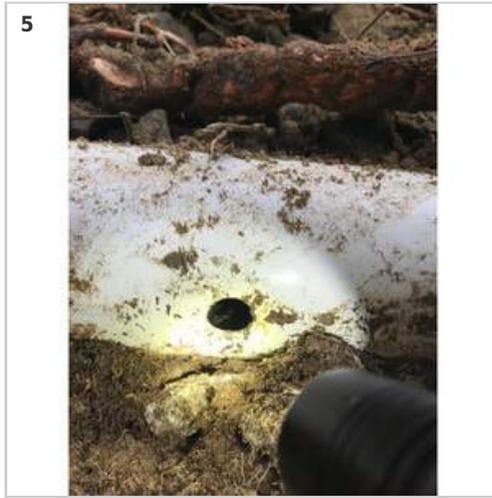
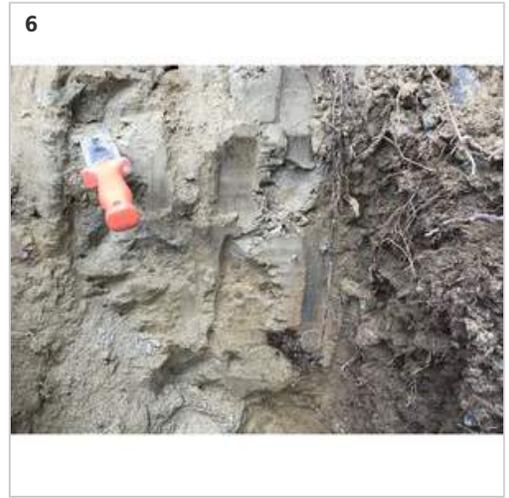
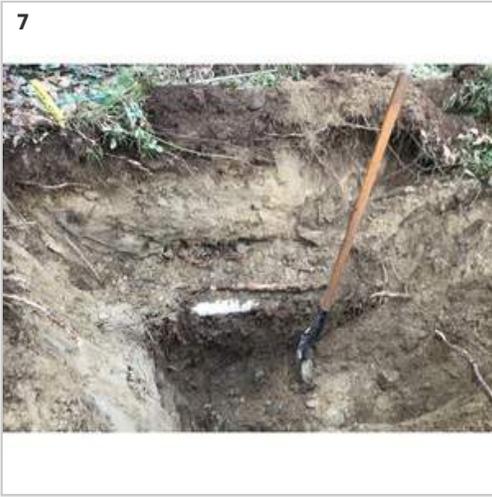
#22 - TEST PIT 1 AND LATERAL EXPOSURE

- Test pits and soils assessments indicated approximately 130 cm of soil depth, with a most restrictive layer of favourable loamy sand of single grain / loose consistency, with no indication of a seasonal high water table.
