Keats Landing Ports Load Limit Safety Assessment

February 15, 2019

Herold Project #: 4551-002

STRUCTURE CONDITION INSPECTION AND REPORT

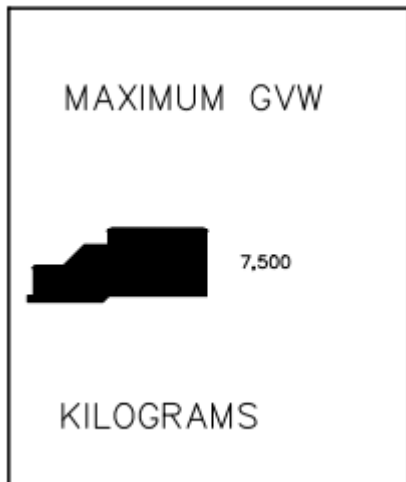
Figure 5.2.1 Load Limit Signage

The following is a detailed diagram of the load limit sign currently posted at the facility. The signage is in conformance with loading analysis results.

The load rating was achieved by applying a maximum speed of 10 km/hr to the design vehicles. As such, speed limit signage stating this maximum is also required at the facility.

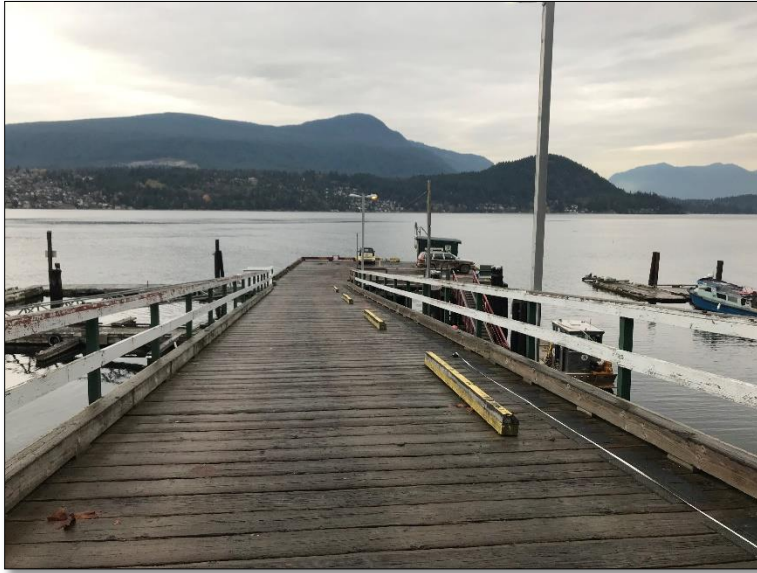
Photograph 1: Keats Landing Port Facility, note: general arrangement looking south

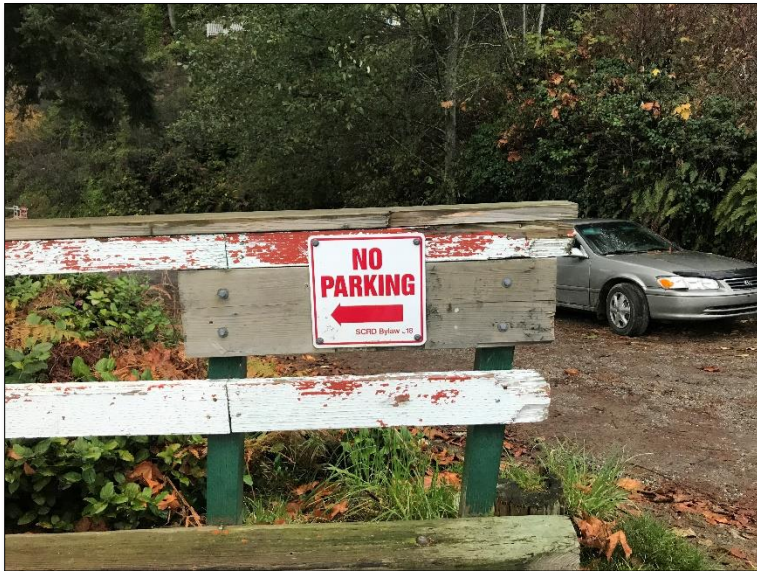
Photograph 2: Approach handrails and guard, note: deterioration due to weathering and biological damage

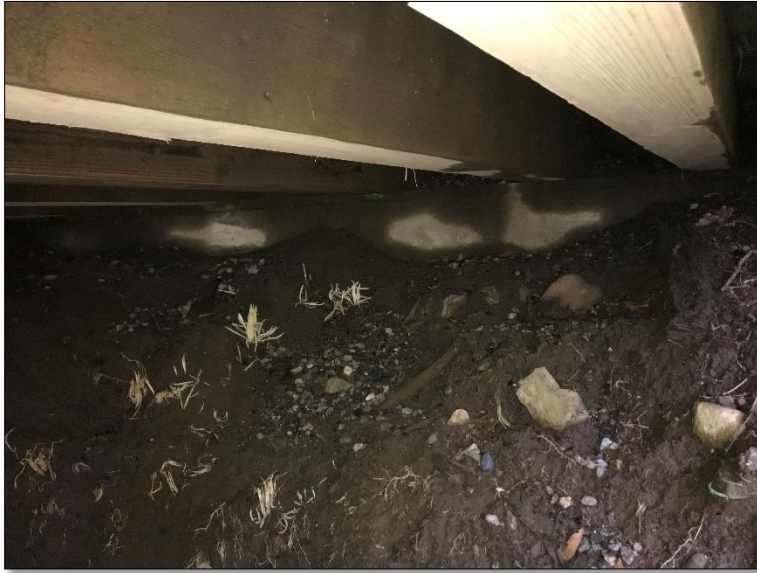
The abutment is in overall good condition. The stringers are resting directly on the concrete and there is evidence of water seepage along the face of the abutment. The stringers may

deteriorate at a more rapid rate due to moisture ingress. Ongoing monitoring is recommended.

Photograph 3: Concrete abutment, note: water seepage

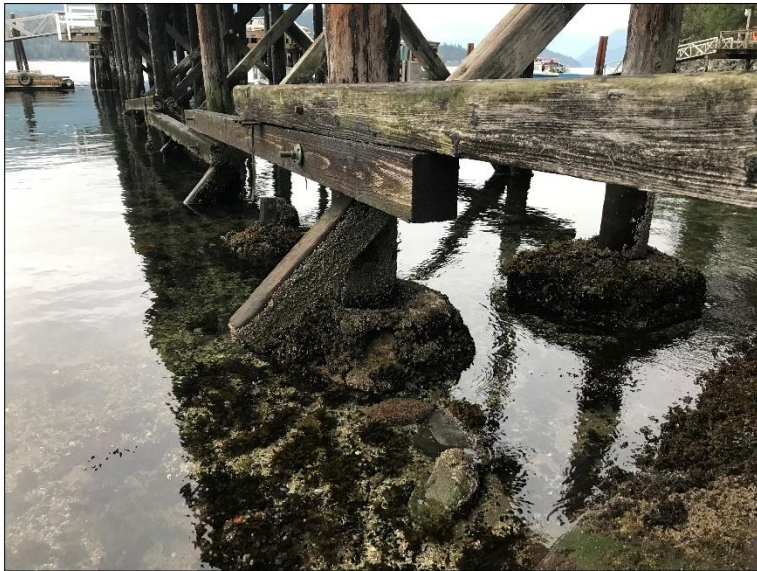
Photograph 4: Bearing pile 5A, note: spalling of the concrete footing

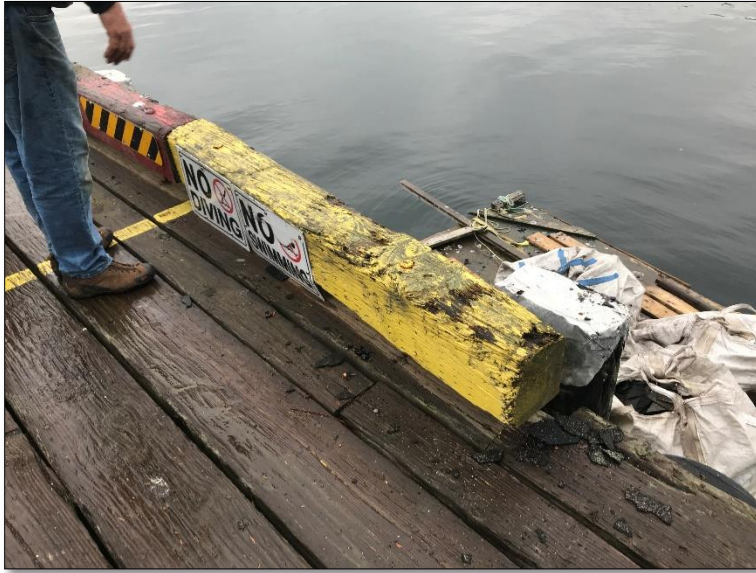
Photograph 5: Guard on wharfhead, note: to be replaced

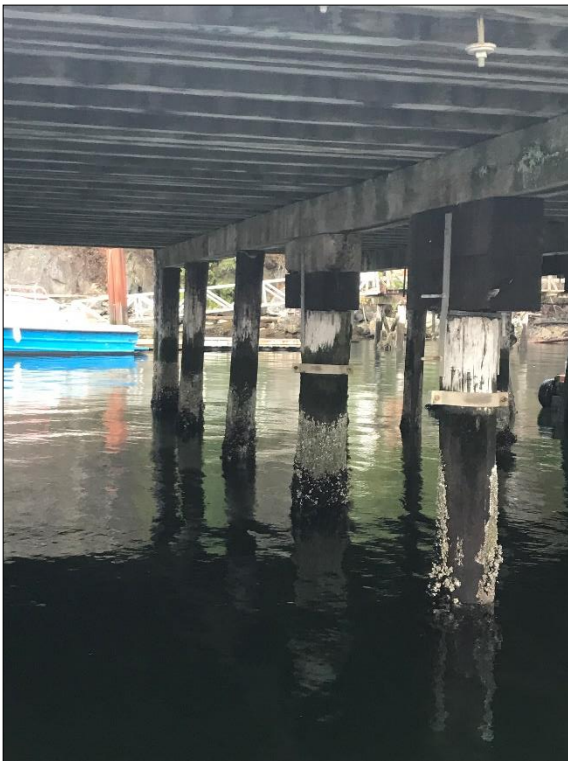
Photograph 6: Bearing pile repairs, note: strap does not extend to pilecap

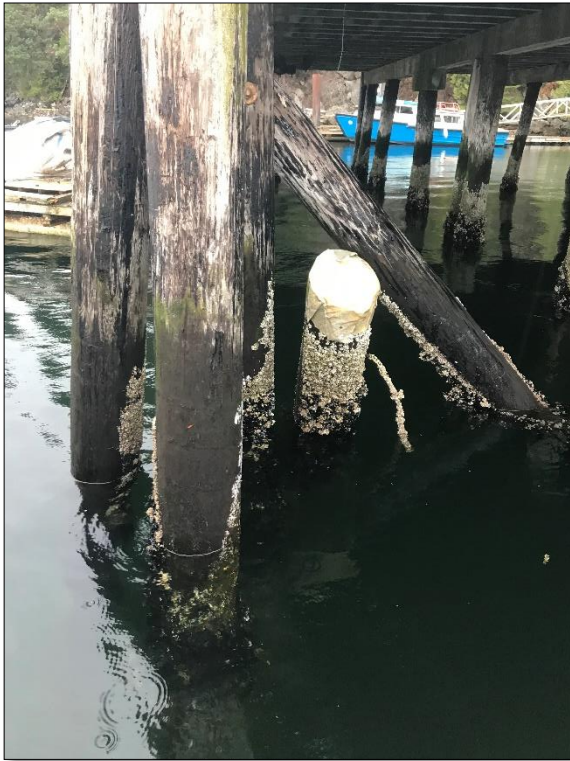
There is one connection that has failed at the top of the bearing pile, which is recommended for re-instatement. One other repair to the batter piles is also recommended.

Photograph 7: Batter pile 20A east to west, note: no longer connected to bearing pile

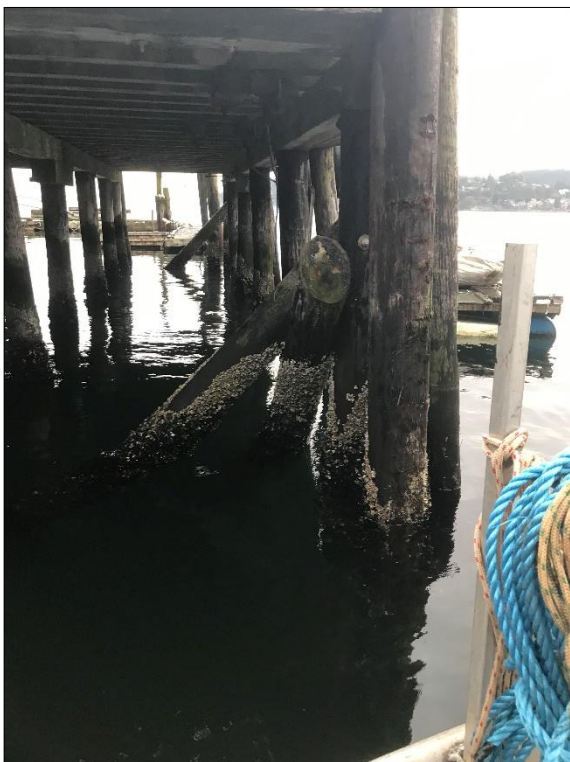
Photograph 8: Batter pile 20F, note: no aluminum flashing at cut end

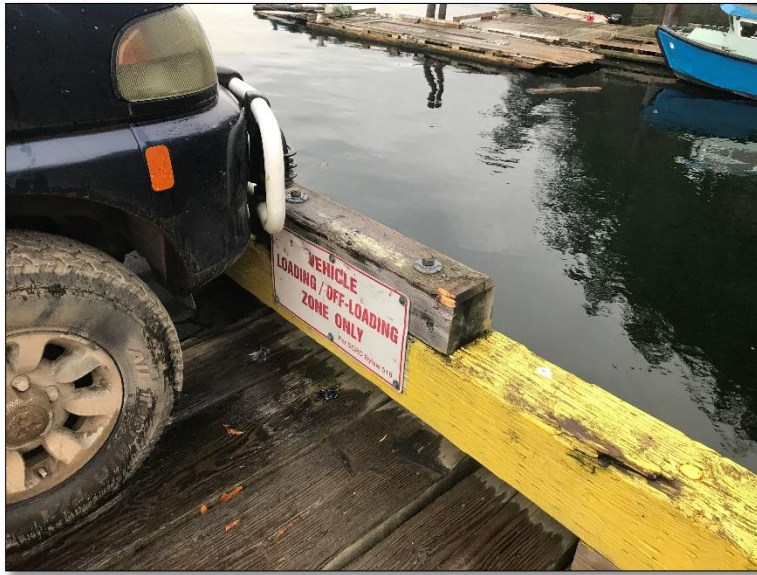
Photograph 9: Vehicles remaining parked on the structure for extended periods of time

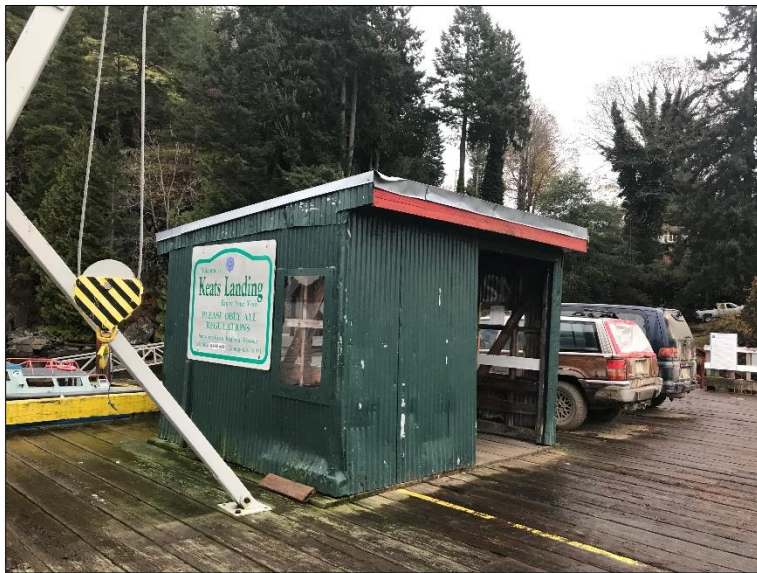
Photograph 10: Service shed, note: mechanical damage to siding

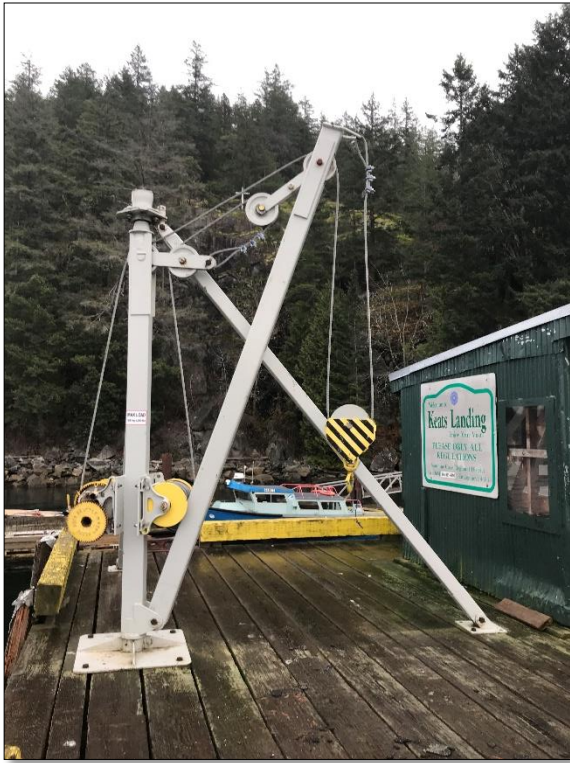
Photograph 11: Derrick crane, note: general arrangement

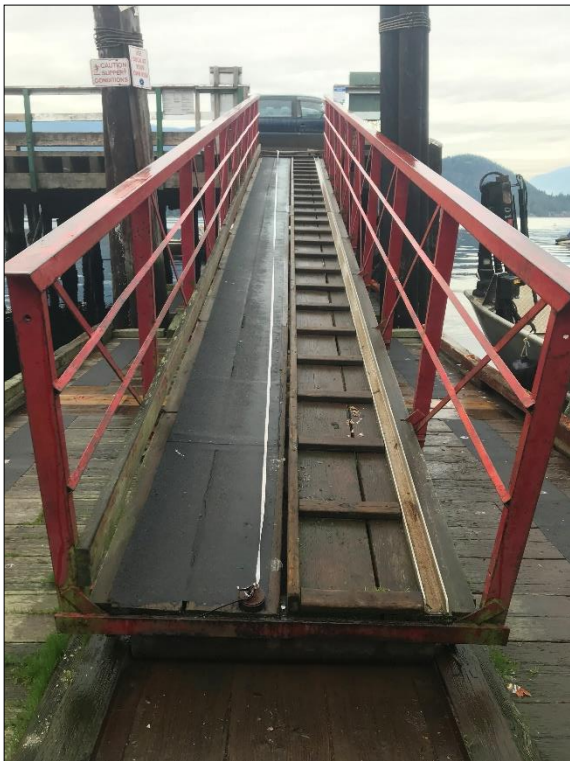
The steel elements are recommended to have the coating reinstated at several locations. The steel gangway and roller assembly has added a significant weight to the float at the seaward end, and is likely contributing to the freeboard differential along the float edges.

Photograph 12: Gangway, note: minor coating losses and surface corrosion of the steel

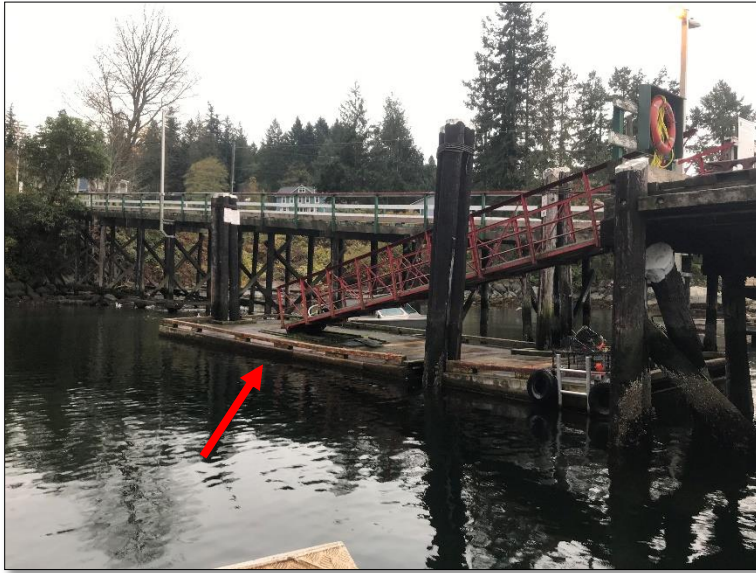
The float is listing significantly at the gangway roller on the east side. It is recommended that a dive inspection be conducted to determine the condition of the timber elements of the substructure. If the timber substructure is not significantly damaged (mechanical and/or biological decay) additional floatation is recommended to be installed to correct the differential freeboard. Consideration may also be given to replacing the steel roller assembly at the seaward end of the gangway to reduce the dead load on the float.

Photograph 13: Float, note: low point at gangway roller

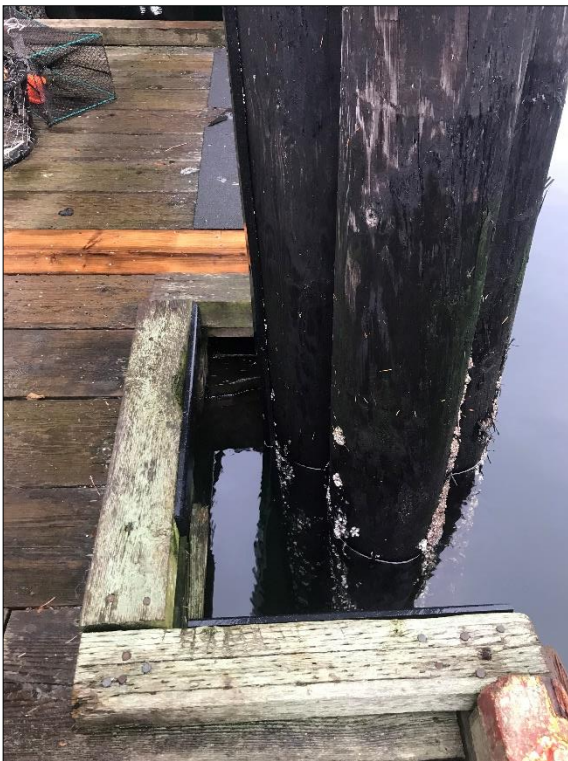
Photograph 14: Mooring pile well, note: not restraining mooring piles

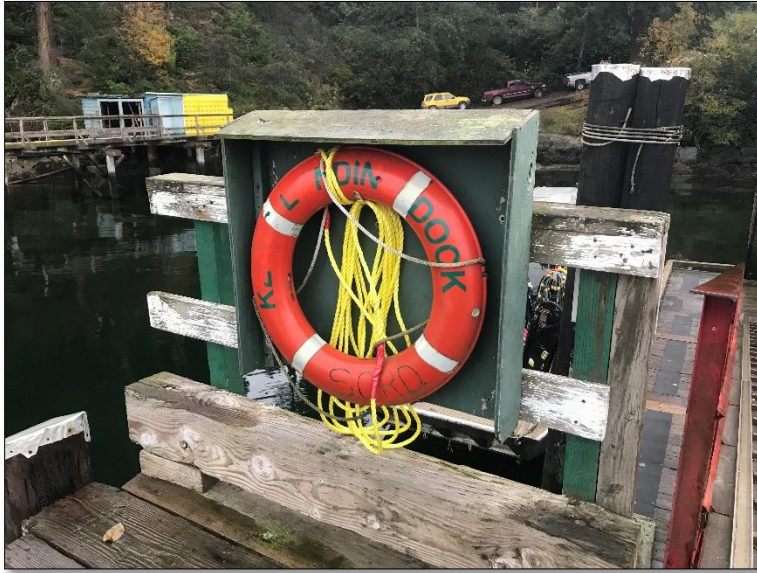
Photograph 15: Life ring

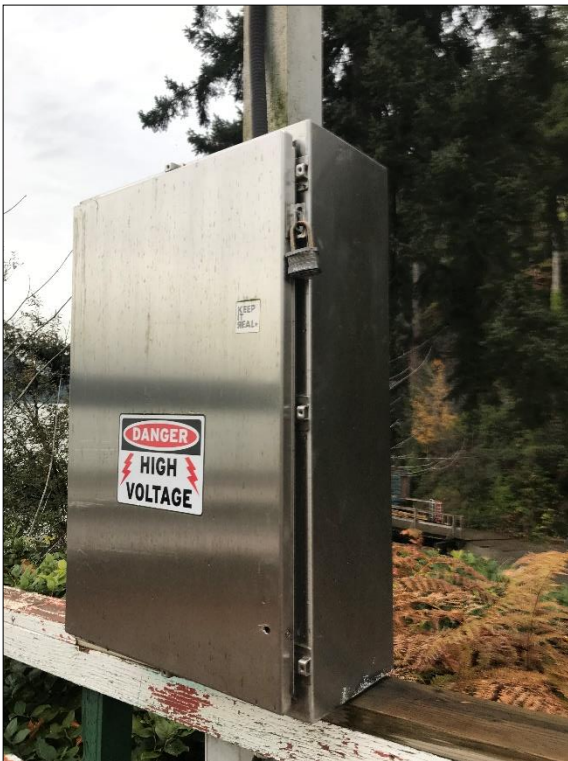
Photograph 16: Electrical service box, note: no lock at bottom connection

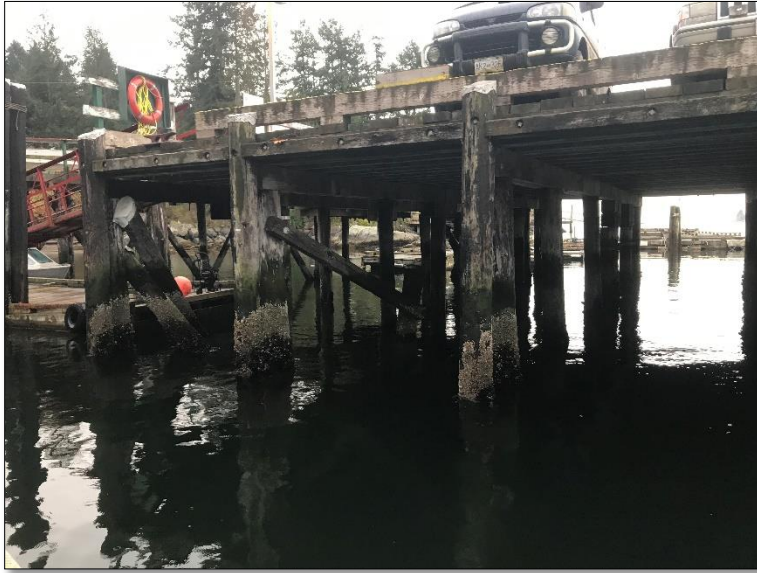
Photograph 17: Miscellaneous bracing connected to abandoned piling, note: potential navigation hazard

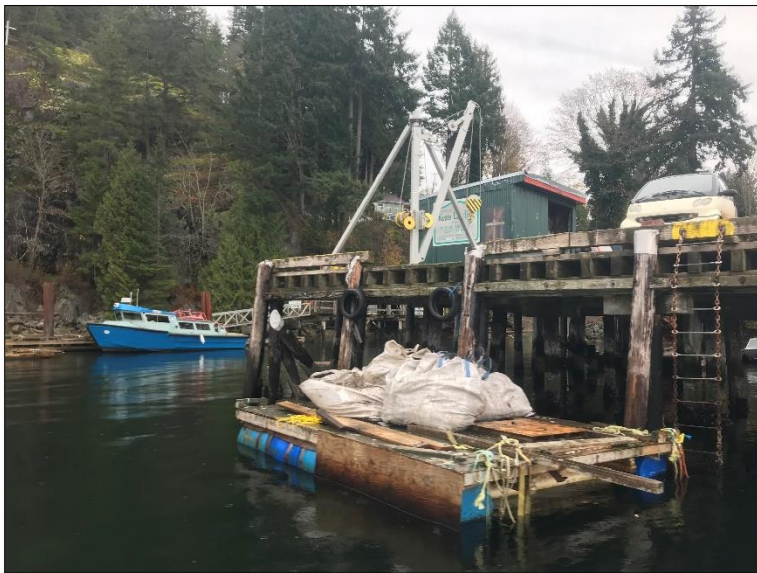
Photograph 18: Miscellaneous scow with debris secured to wharf, note: insufficient fendering for this application
