West Bay, Gambier Island Ports Condition Assessment

PORTS CONDITION ASSESSMENT

WEST BAY, GAMBIER ISLAND

Herold Project No.: 4551-012

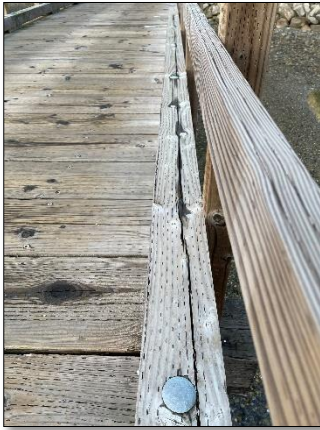
The handrails is in good condition and no remediation is required. The vehicle guard has significant cracking at the hardware locations due to overdriving of the thru bolts. Ongoing monitoring is recommended as the rate of deterioration will be accelerated. The decking is secured using screws, which is not considered best practices. Replace all screws with minimum 127mm spiral nails.

Photograph 3: Timber guard, note: cracking through hardware locations

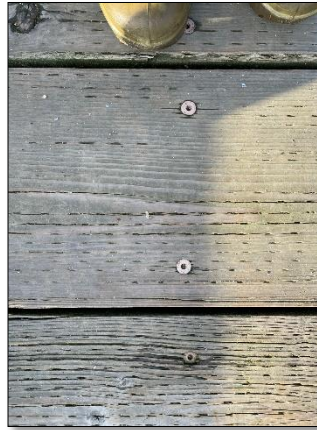
Photograph 4: Decking, note: secured with screws

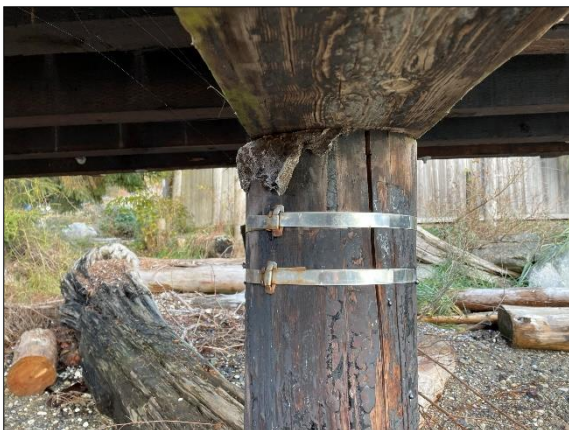
The bearing piles are in overall fair condition. Several bearing piles have been remediated using stainless steel strapping. The cracking in the affected piles is

considered to be moderate, and in some locations strapping is placed at intervals along the full exposed pile length. There are nine piles with steel strapping which are to be monitored with considerations given to replacement within the next three to five years. One of the strapped piles is recommended for replacement within the next year.

Photograph 5: Bearing pile 3A, note: strap repair

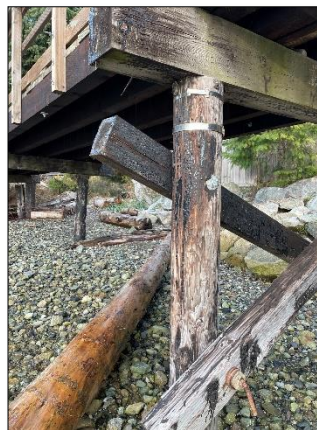
Photograph 6: Bearing pile 4B, note: strap repair

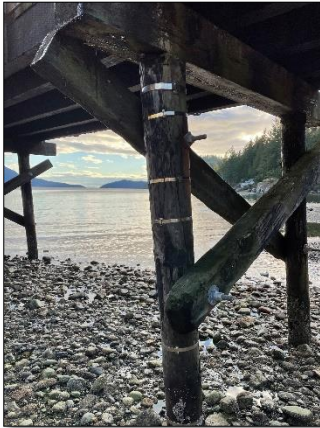
Photograph 7: Bearing Pile 6A, note: significant strapping

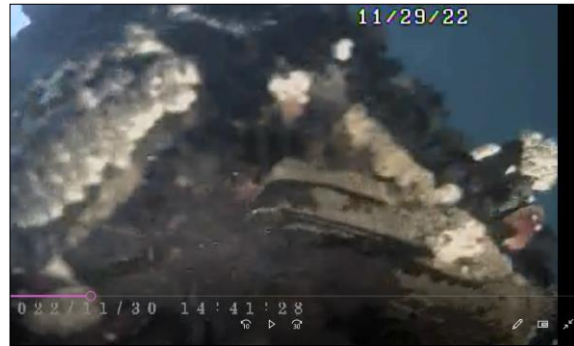
The cross bracing at the facility is in good to fair condition. There is one brace which requires replacement.

Photograph 8: Cross Brace 20B^{BOT}-20A^{TOP}, note: hollow at cut end

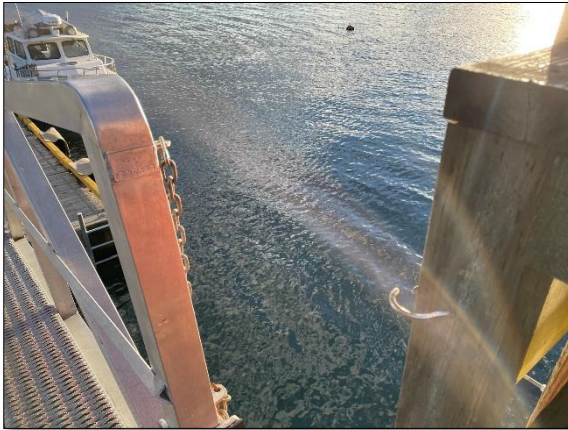
The gangway is in overall good condition. The chain guarding at the shoreward end has failed at the connections and requires re-instatement. This damage is likely due to significant movement of the float structure during large wind/wave events. The additional movement is likely due to the deteriorated condition of the float structure, and can affect the behavior of the gangway and associated structures. This is also evident in the condition of the landing pad timbers which show heavy damage and wear with loss of cross section.

Photograph 9: Chain Guard, note: failed connection

The chain guarding is recommended to be re-instated, and the landing pad timbers are recommended to be replaced. Replacement of the float in its entirety is recommended within the next year.

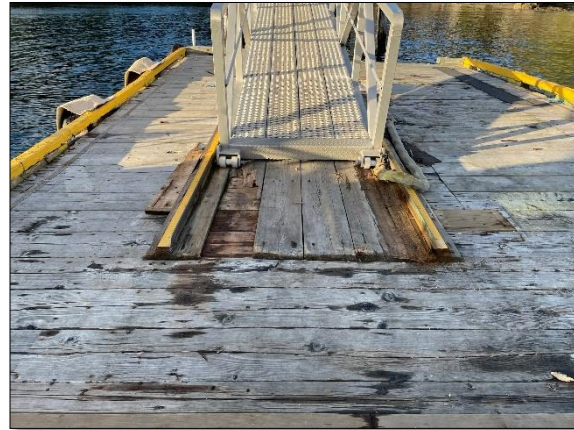
Photograph 10: Gangway Landing Pad, note: mechanical damage to timbers

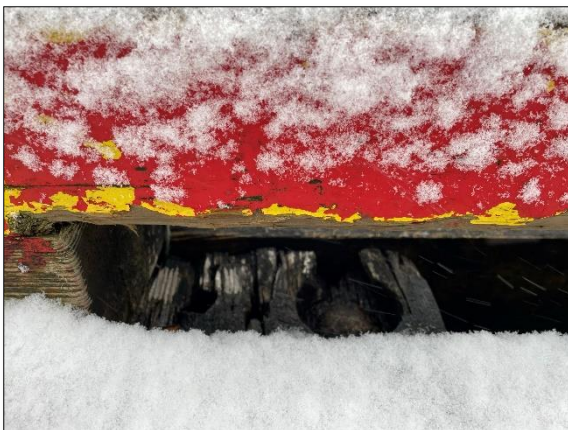
The substructure is in poor to very poor condition. The cross ties are significantly deteriorated at the connections, and there is a broken flange on the east edge of the float.

Photograph 11: Float Cross Ties, note: biological damage and deterioration

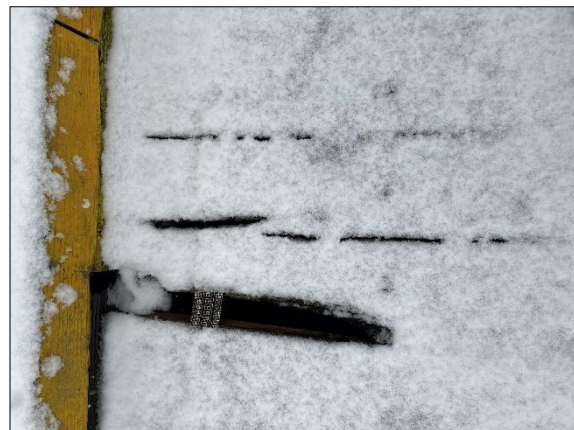
The float is in no longer considered to be in serviceable condition. The topsides are in fair to poor condition. There decking is weathered with areas of localized failure. The bull rails have minor to moderate cross sections loss, but appear to have been re-coated recently. The landing pad is significantly deteriorated due to mechanical damage from the gangway. Three boards are recommended to be replaced

Photograph 12: Float decking, note: failed sections and deterioration

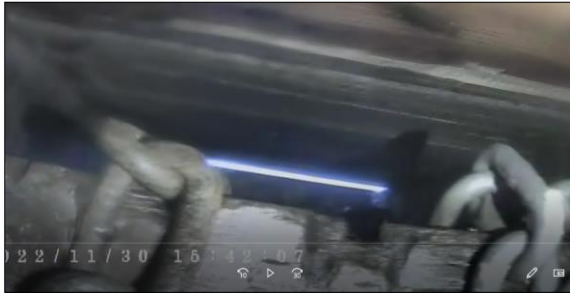
The mooring system is in overall good condition. It is to be noted that the chains are secured to the substructure of the float by looping around the cross tie members. Based on the condition observed on-site, the cross ties are not in acceptable condition to reliably resist mooring line loads. One mooring chain is showing signs of moderate corrosion and loss of section.

*Photograph 13: Mooring Chain Connection, note:
wrapped to cross tie*

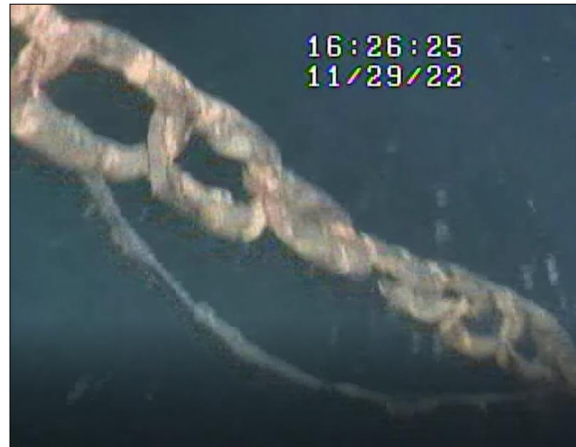
*Photograph 14: Southeast Chain, note: corrosion and
cross section loss*
