Halkett Bay, Gambier Island Ports Condition Assessment

PORTS CONDITION ASSESSMENT

HALKETT BAY, GAMBIER ISLAND

Herold Project No.: 4551-012

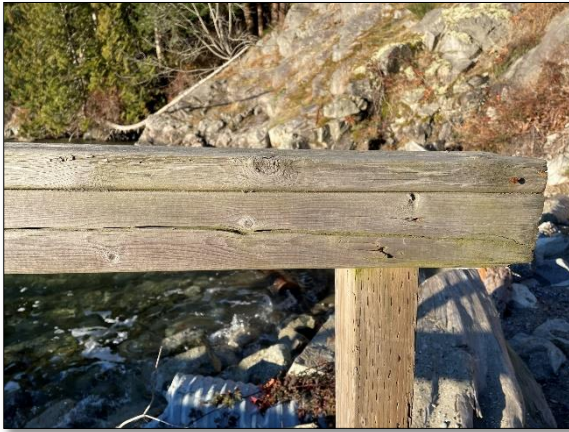
The handrails are in fair condition and there is one top rail and one mid rail recommended for replacement due to mechanical damage (splitting). There is one post which requires monitoring. The handrails have several coating failures and are not treated. It is recommended that the handrail system be re-coated to extend the service life.

Photograph 3: Top rail at 0m, note: splitting through rail

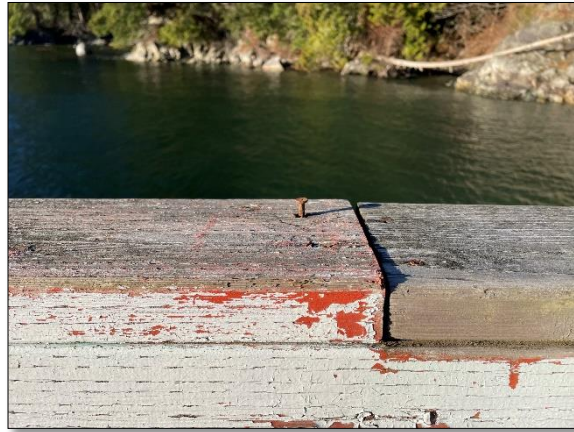
Photograph 4: Top rail at 14.9m, note: nails are raised

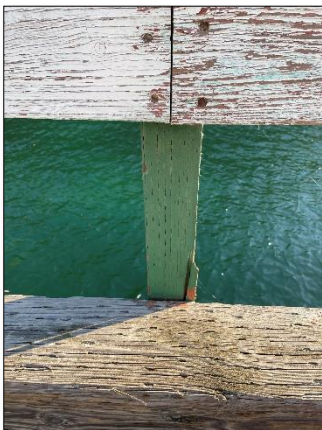
Photograph 5: Post at 29.8m, note: splitting

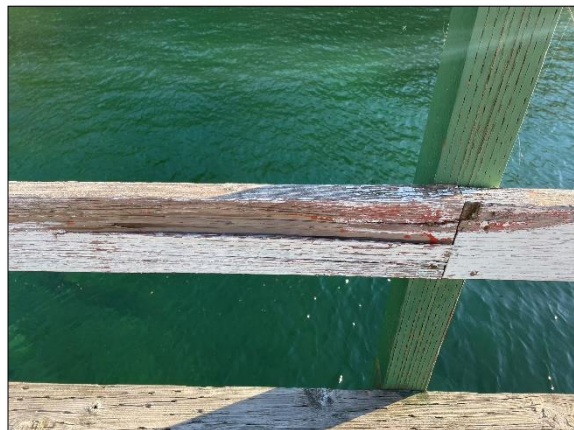
Photograph 6: Mid rail at 55.4m, note: loss of cross section

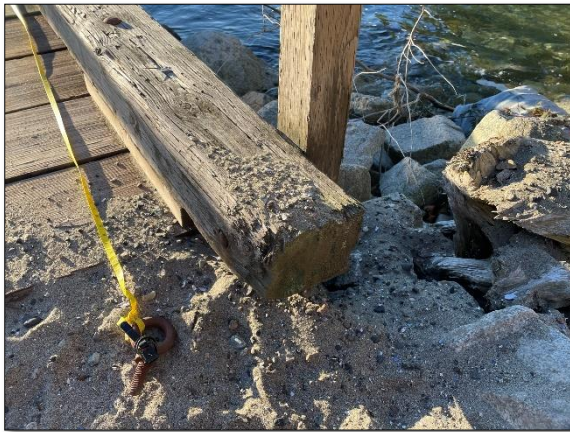
Photograph 7: Vehicle guard at 0m, note: loss of cross section at end of guard

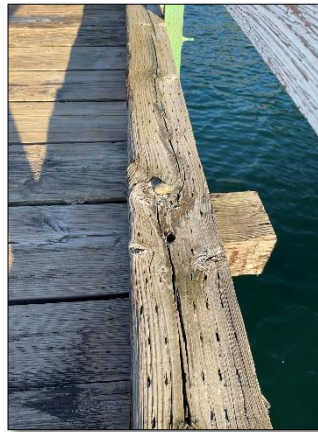
The vehicle guard is in overall good to fair condition. There is evidence of mechanical damage and weathering throughout. One section of guard recommended for replacement due to mechanical damage, likely due to vehicle impact.

Photograph 8: Vehicle guard at 57.6m, note: splitting and internal cross section loss

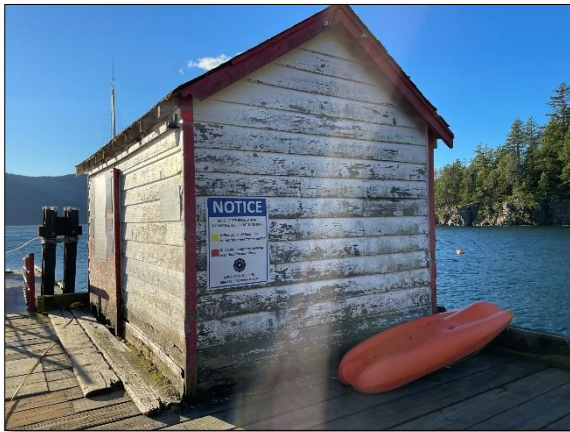
The service shed is in overall poor condition. The bottom of the shed walls and door are visibly decayed and have areas of localized failure. The coating on the exterior walls and door has several localized areas of failure, allowing additional water ingress and weathering. The area below the shed is double decked. Several deck sections are compromised, and the lower decking is visible. The shed is recommended to be replaced/remediated or removed.

Photograph 9: Service shed, general arrangement

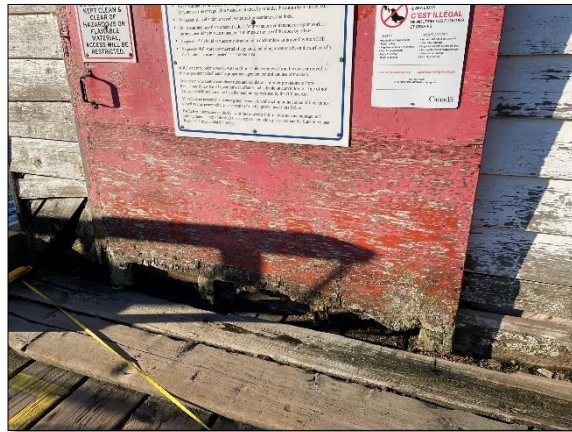
Photograph 10: Access door to shed, note: significant CSL and decay at base

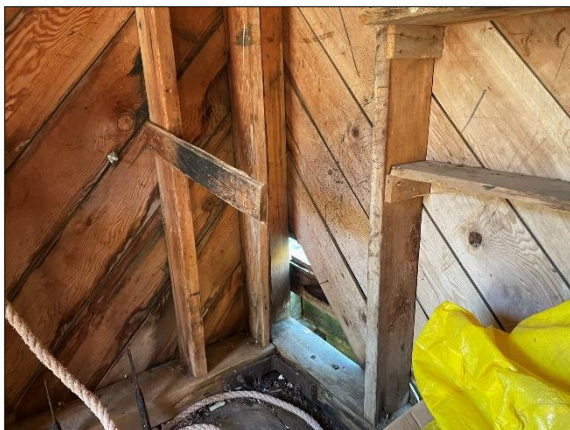
Photograph 11: Interior of service shed, note: failed wall panels

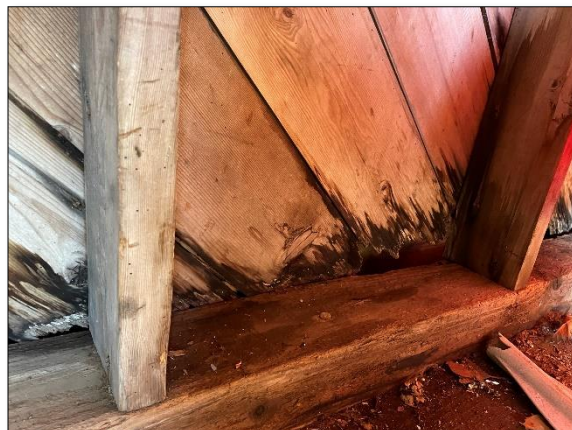
Photograph 12: Interior of service shed, note: base of wall is decayed and failing

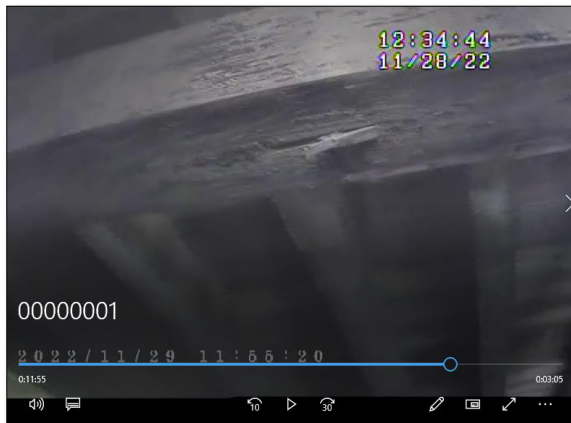
Generally, the pile caps are in overall satisfactory condition, with minor to moderate biological growth along the exterior surfaces of the members. Two pile caps were noted to have minor checking along the underside of the members at mid-span. Ongoing monitoring is recommended.

Photograph 13: Pile cap at Bent 5, note: check on underside at mid-span

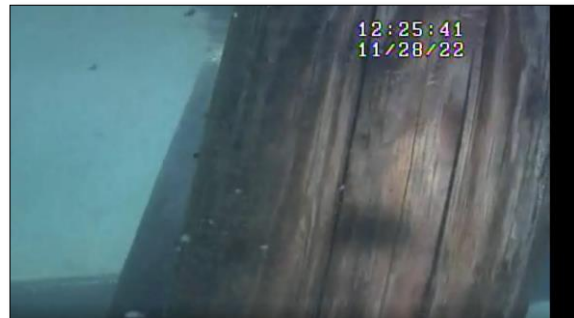
The bearing piles are in overall fair condition. As noted in the 2018 report, prepared by Herold Engineering, several bearing piles have moderate splitting within the top 1-3m due to weathering and/or conditions during pile driving. During the current assessment we were able to more closely assess the splitting. Four bearing piles have significant splitting with areas of moderate softness when probed. These piles are recommended to be banded with stainless steel banding with replacement of the piles considered within the next three years.

Photograph 14: Bearing pile 3C, note: splitting throughout pile length

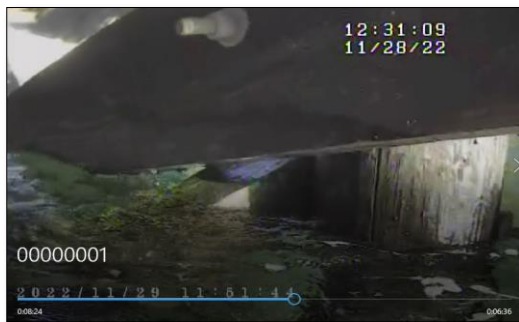
Photograph 15: Bearing pile 4B, note: cracking at cross brace connection

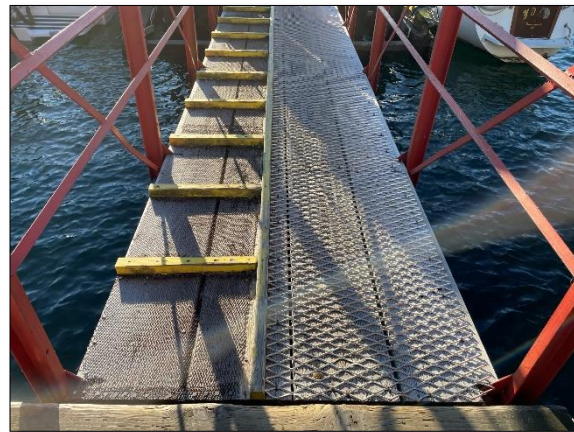
The gangway is in overall good condition. There are minor coating failures along the steel truss elements. There is no shoreward transition plate, however this does not appear to be a tripping hazard. Ongoing monitoring is recommended with field touch up of the coating to be completed as part of ongoing facility maintenance.

Photograph 16: Shoreward transition, note: missing

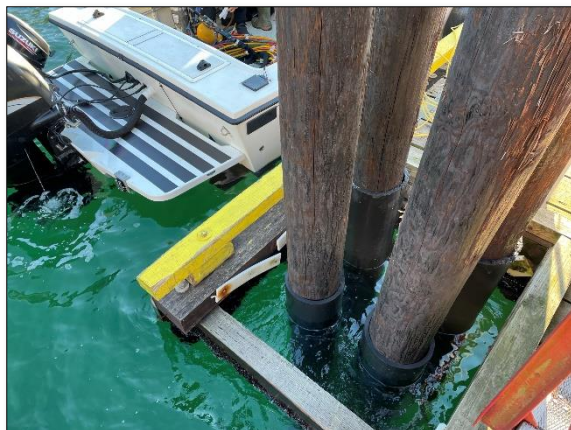
There is moderate amounts of damage within the mooring pile wells due to abrasion and impact. There is one UHMWPE rub strip which has failed at one connection point and is hanging within the pile well.

Photograph 17: Pile well, note: failed UHMWPE wear strip

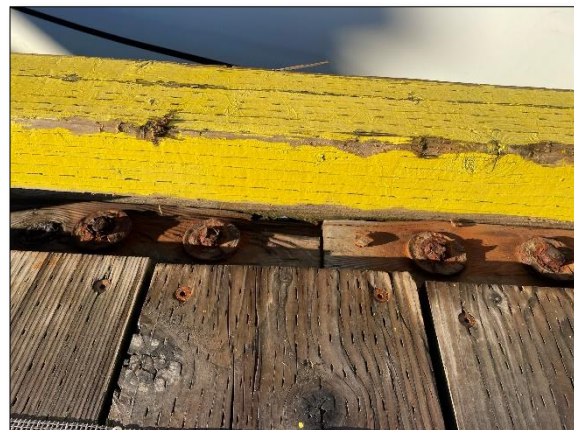
The substructure of the float is in overall poor condition. The north edge of the float has loose flange hardware. Corrosion is significant and evident from both topside and underneath the structure. There is significant movement through the connection during wave loading. The flange hardware and slice blocks are recommended to be replaced. Due to the nature of the repair, it is economical and preventative to replace all flange hardware throughout the float at the same time.

Photograph 18: Flange splice block hardware, note: significant corrosion

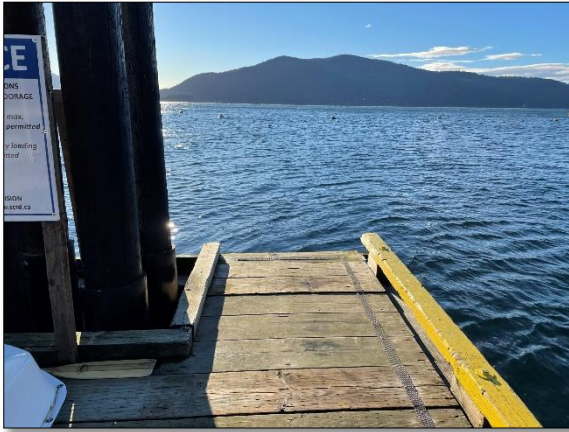
Photograph 19: East edge of float, note: no guarding

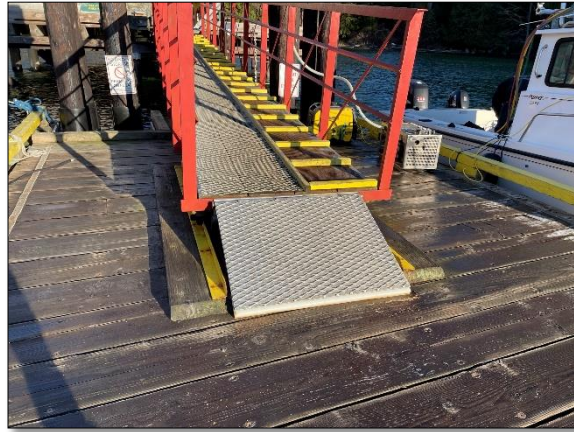
The transition plate from the gangway extends past the existing landing pad footprint at high tides and is beginning to abrade the float decking. Ongoing monitoring is recommended.

Photograph 20: Seaward transition, note: plate extends past landing pad

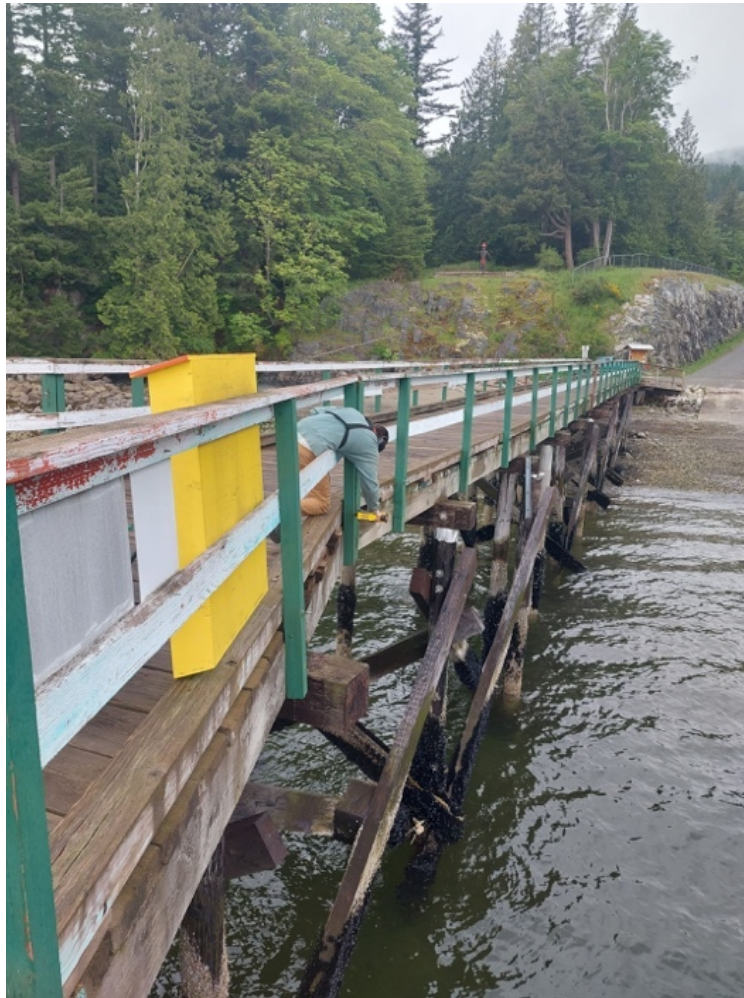
- (From Previous Inspection May 2021) 1 handrail post close to Bent 0 is significantly cracked. Recommended to monitor and expect to replace within the next year.
- Railings require pressure washing to ensure longevity (approved, deferred)
- Several handrails were tightened during inspection round 8

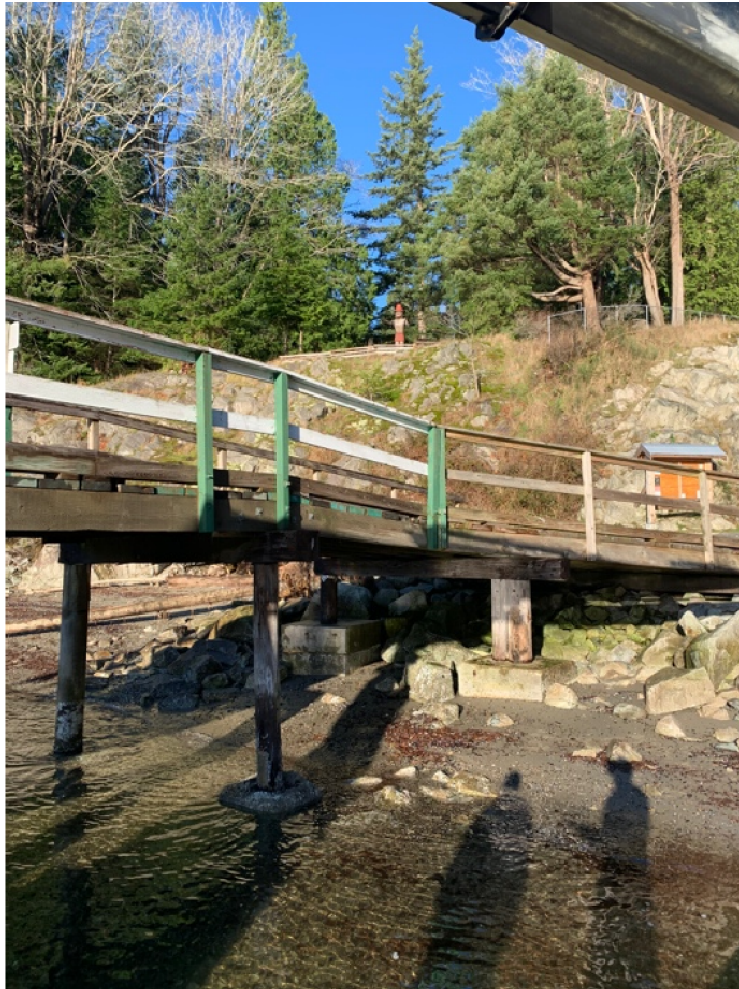
- **Bent 2** Footings appear to be undersized and worn out. Recommend that Herold Engineering review for possible upgrades

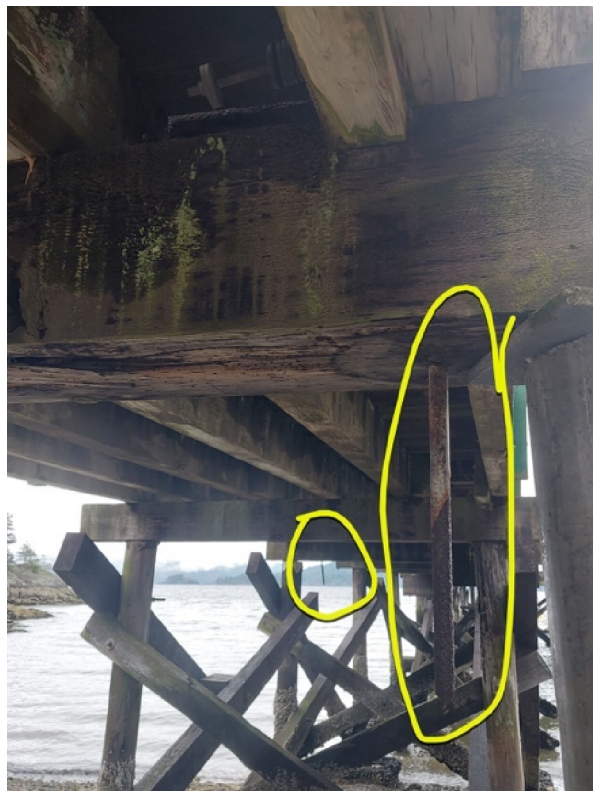
- Redundant stringer pins under pile caps at Bents 2 & 4, grinding off recommended.

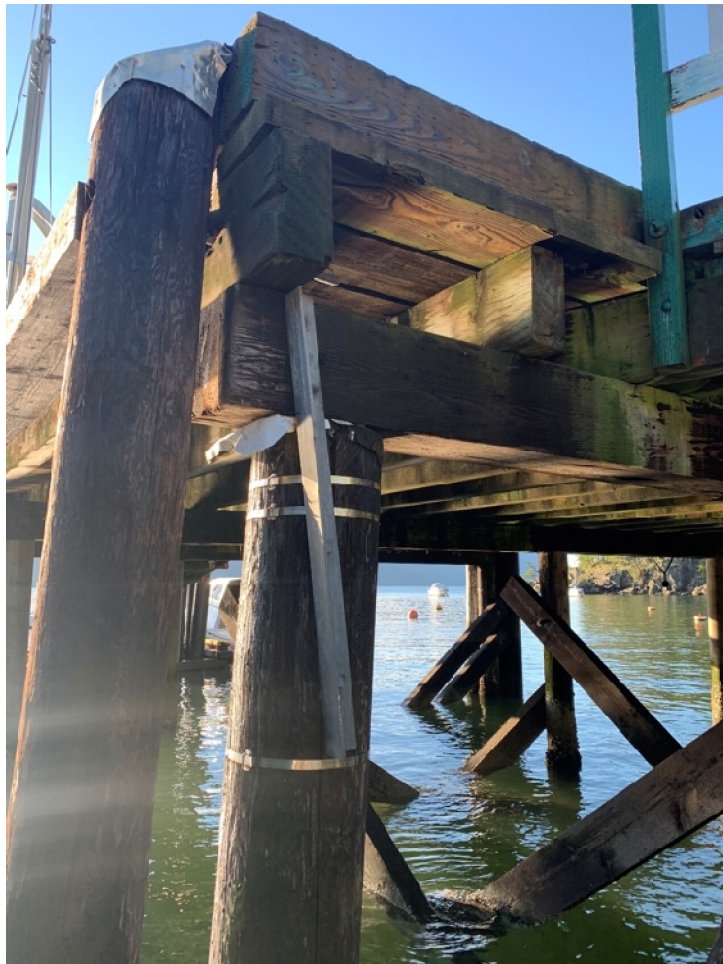
- **Bent 3** (From Previous Inspection January 2021) Loose bolt on cross brace attachment to pile 3b
- **Bent 4** (From Previous Inspection May 2021) Pile 4b slanted to the North 10 degrees (Monitor)
 - Cap Not fully bearing on 4B (Monitor)
- **Bent 5** (From Previous Inspection January 2021) Pile 5C showing cracking. Recommend adding strap at the top of the pile (deferred due to weather, attempt again on next round)
- **Bent 7** (From Previous Inspection January 2021) Slight Damage to Cap above 7b (monitor)
- **Bent 10** (From Previous Inspections) No cross brace on concrete Pile, and generally far fewer than other docks)
- **Bent 14** (From Previous Inspection May 2021) Pile 14a bolt too short, nut may come loose over time (monitor)
 - (From Previous Inspection) Pile 14A out of place – Possible Contact from barge? (Close inspection at low tide recommended)

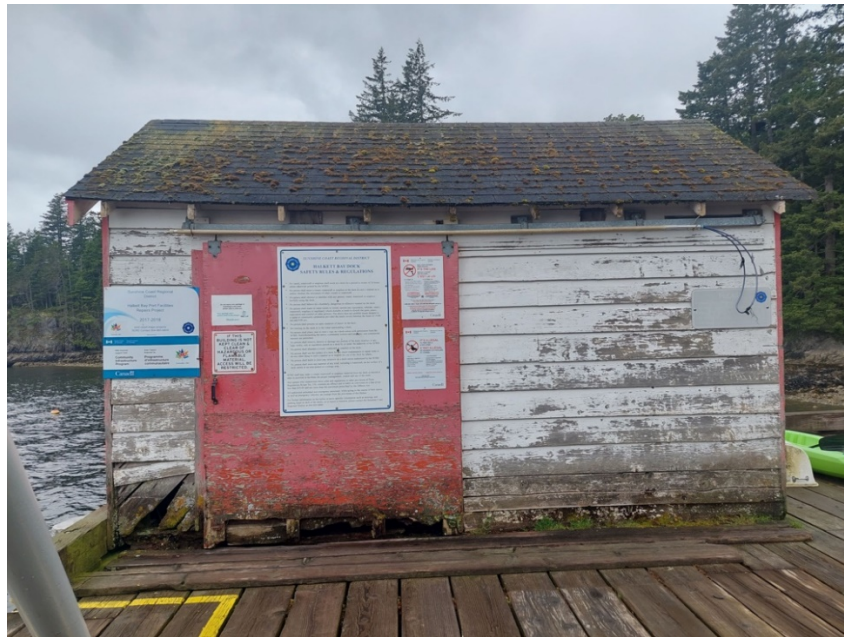
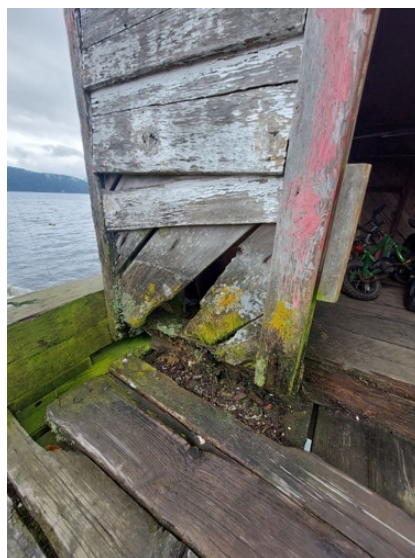
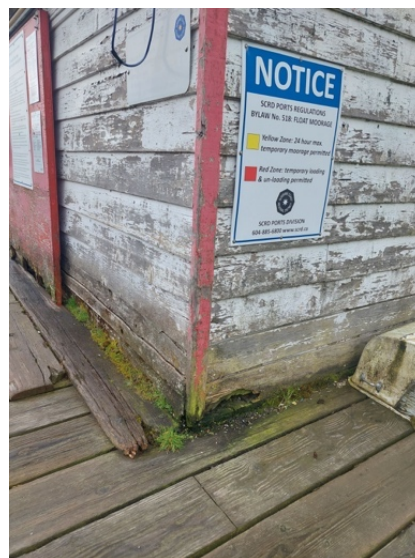
- (From Previous Report January 2021) Shed is deteriorating and needs structural upgrade, overhaul or removal. (Locals do not want removal, they reiterate it's importance to them)
- Renovation recommended, new siding boards, door rebuild.

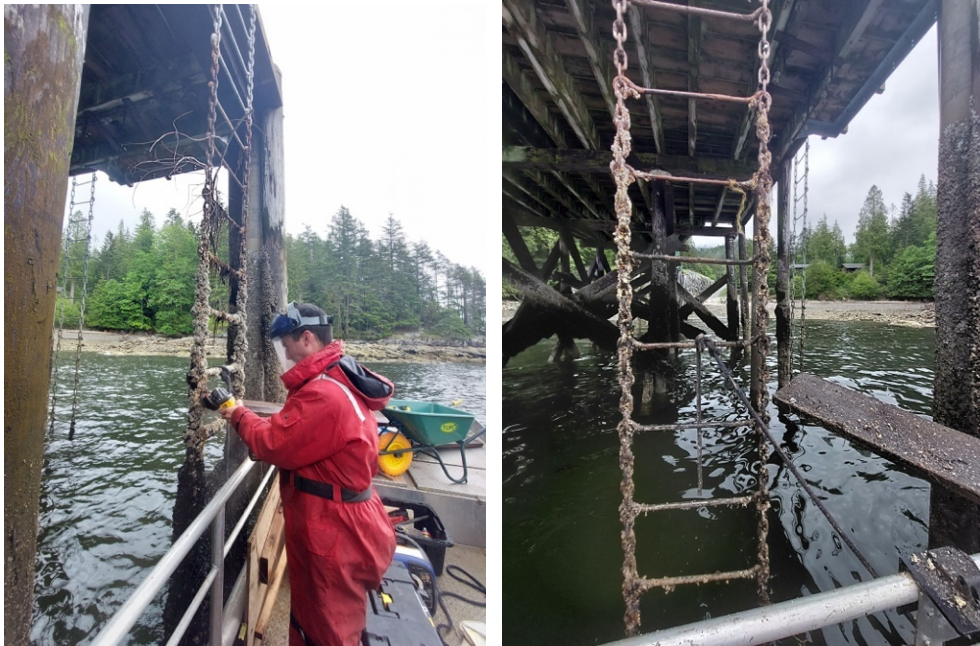
- (As noted from Previous Report January 2021) There are 2 ladders located on the Wharfhead. The one closest to the derrick crane is quite short and only extends ~6' below the Wharfhead. The one on the south side extends below low-low tide.
- Ladders were cleaned during this inspection round. (No ladder on float)

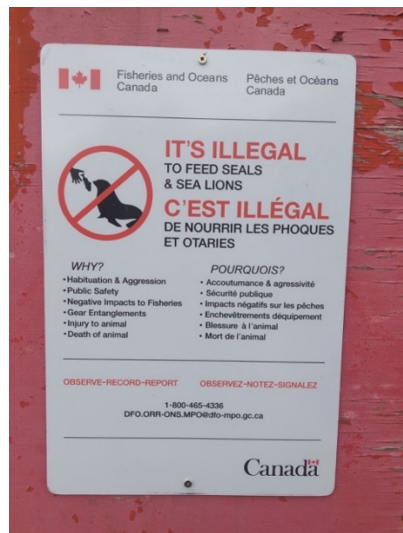
- A list of signage that should be present for each location from SCRD
- Halket Bay is the only location we've seen this sign. Should this be present at all locations?

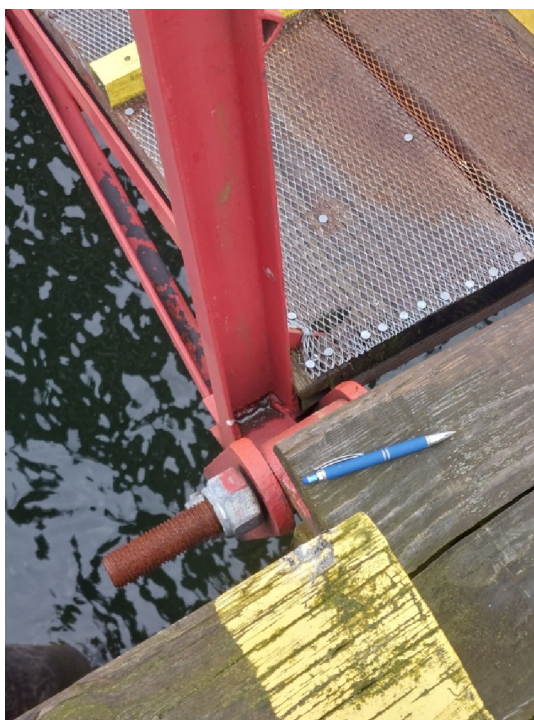
- Hinge at the top of gangway is 1 ¼" thick. Perhaps this should be the standard at all locations?

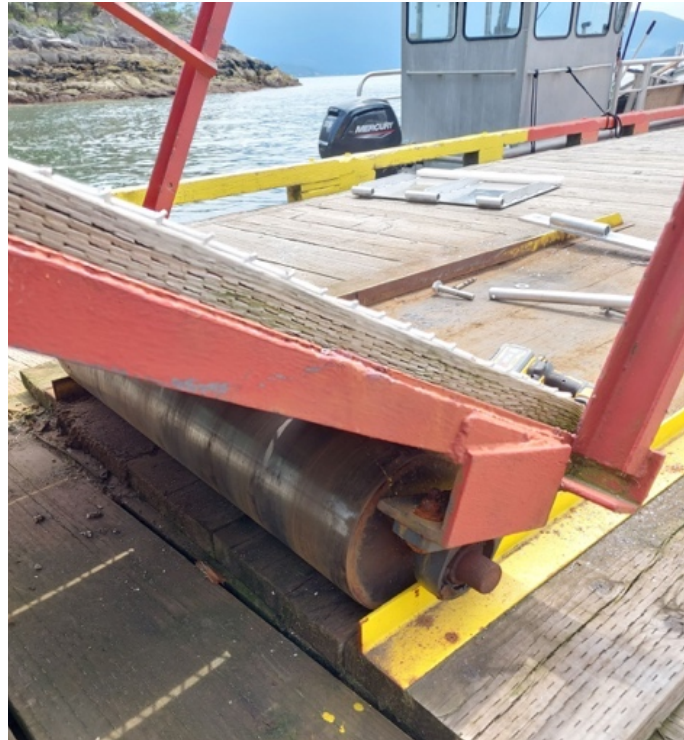
- Roller comes close to end of gangway landing pad at extreme low tides. Pictured at ~1' tide. It should be monitored at a 0' or a minus tide and if extension added only if necessary.

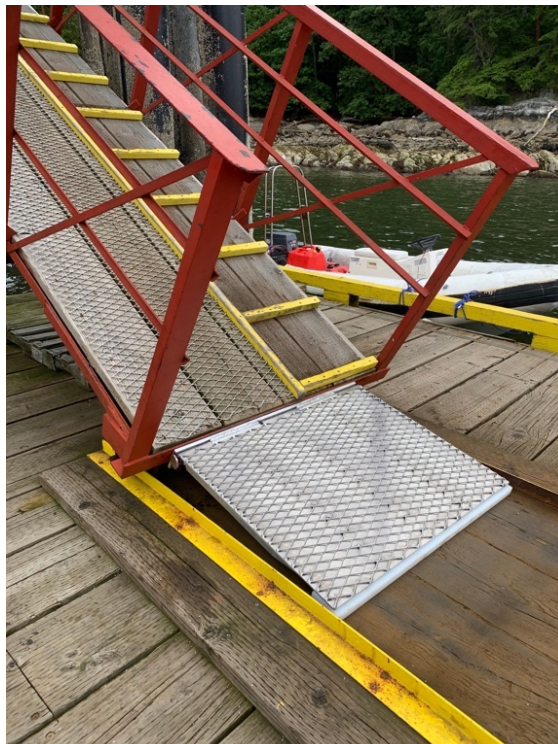
- (From Previous Inspection May 2021) No transition plate currently installed at the bottom of the gangway.
- Transition plate installed during this round.

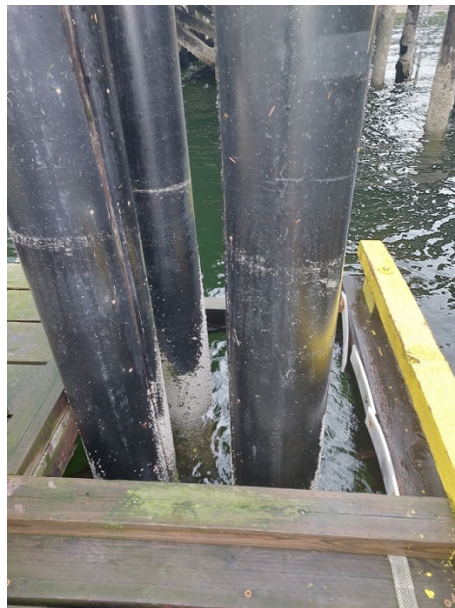
- (From previous inspection April 2019) Pile well plastic wear strips missing or loose in 2 of 4 pile wells. (Recommend replacing pile well wear strips at next inspection round)
