Gambier Harbour, Gambier Island Ports Condition Assessment

PORTS CONDITION ASSESSMENT

GAMBIER HARBOUR, GAMBIER ISLAND

Herold Project No.: 4551-012

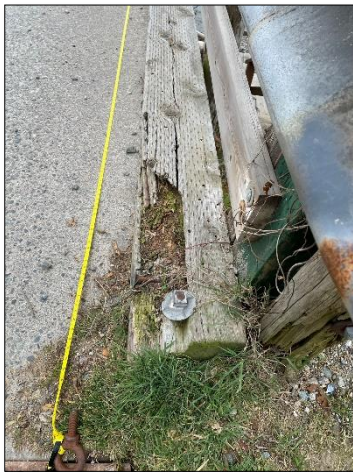
Photograph 3: Timber guard at Bent 0, note: mechanical damage and decay

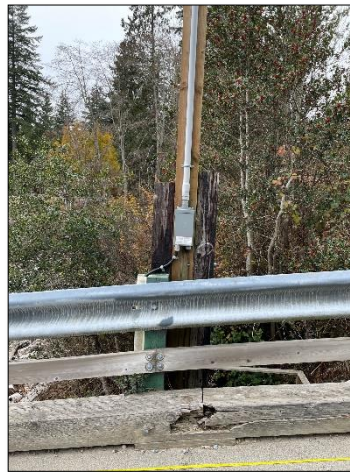
Photograph 4: Timber guard at Bent 1, note: significant decay and cross section loss

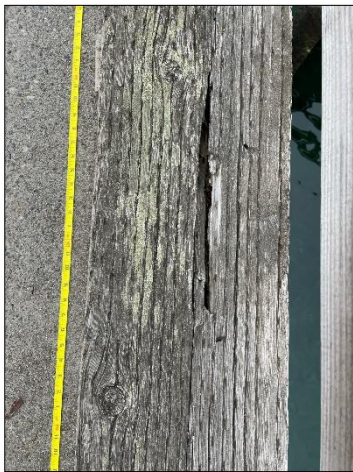
Photograph 5: Timber Guard, note: hole with internal deterioration

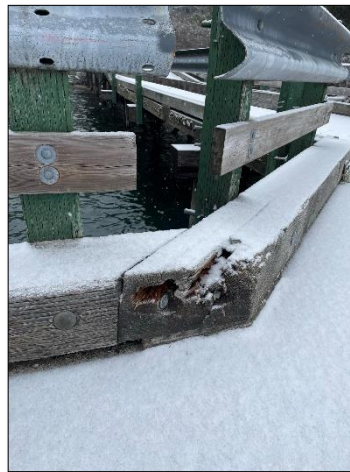
Photograph 6: Timber guard at gangway walkway, note: deteriorated end

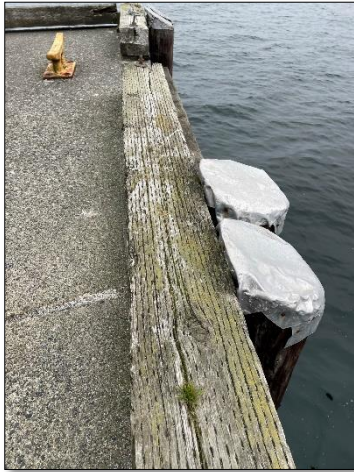
Photograph 7: Timber guard along gridline 21, note: vegetative growth and cracking

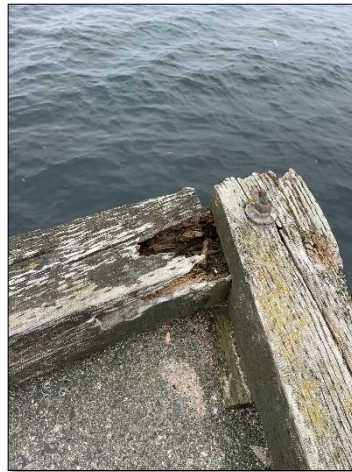
Photograph 8: Guard at 21A, note: cross section deterioration and decay

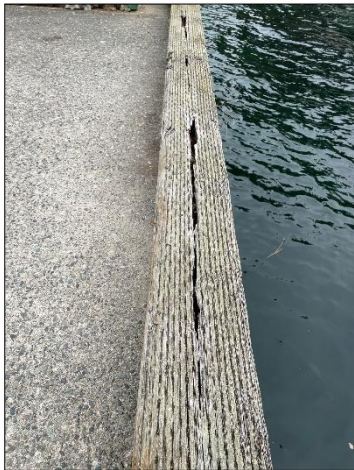
Photograph 9: Timber guard along gridline A, note: cracking and decay

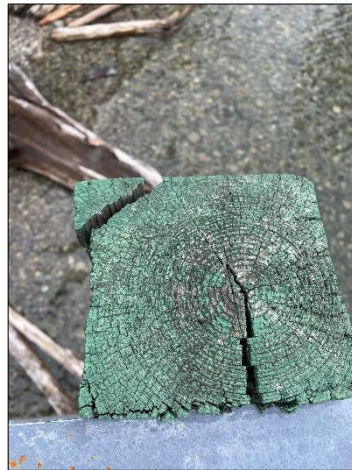
Photograph 10: Handrail post at 21.9m C', note: cracking

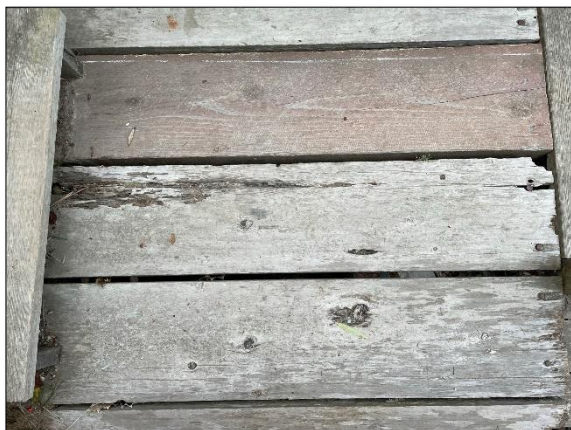
The timber stair set adjacent to the wharfhead is in fair condition. There are four sections of decking and two sections of handrail which are deteriorated and require replacement.

Photograph 11: Stairs, note: deteriorated decking

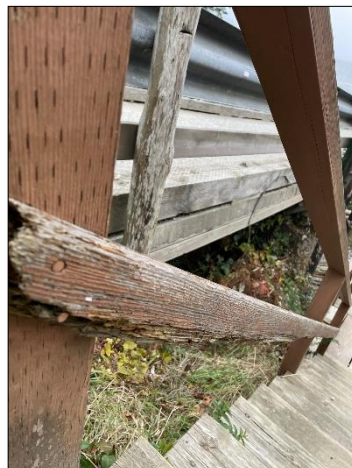
Photograph 12: Stairway, note: deteriorated mid rail

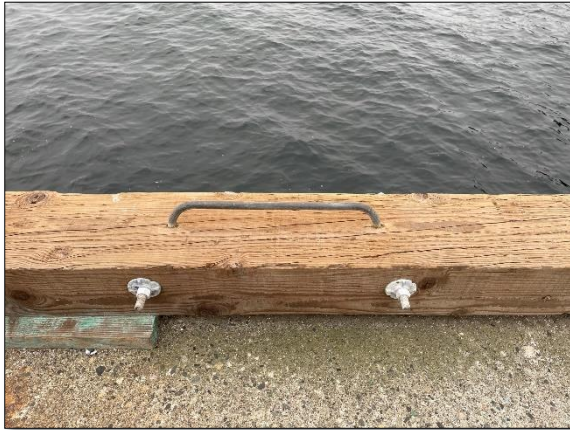
The signage is in fair condition with minor damage. The post supporting the sign at Bent 0 is significantly decayed and requires replacement. The safety ladder on the wharfhead does not have any signage. Signage is recommended visible from both water and land.

Photograph 13: Safety ladder, note: no signage

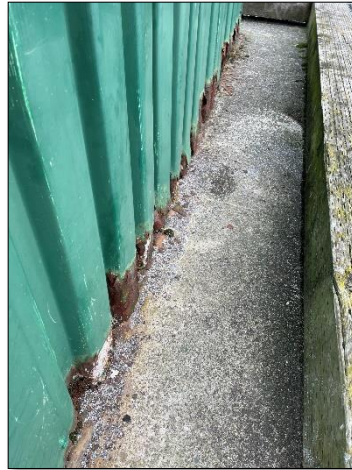
The service shed is in satisfactory condition. The bottom 100mm of the wall sheeting has areas of coating failure, with visible corrosion and reduction in the cross sectional area. Replacement of the lower sections of sheeting is recommended around the shed perimeter at the next major upgrade.

Photograph 14: Service shed, note: damage to sheeting

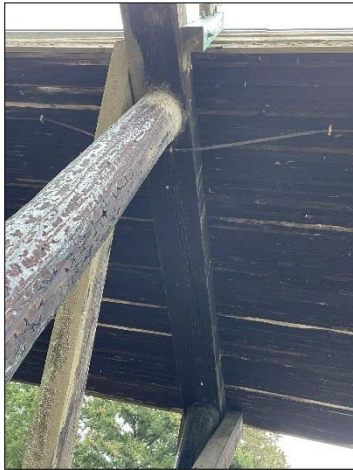
Generally, the pile caps are in overall good condition, with minor to moderate biological and mechanical damage. One pile cap was noted as having a minor check in the underside of the member. Ongoing monitoring is recommended.

Photograph 15: Pile Cap at Bent 2, note: check in underside

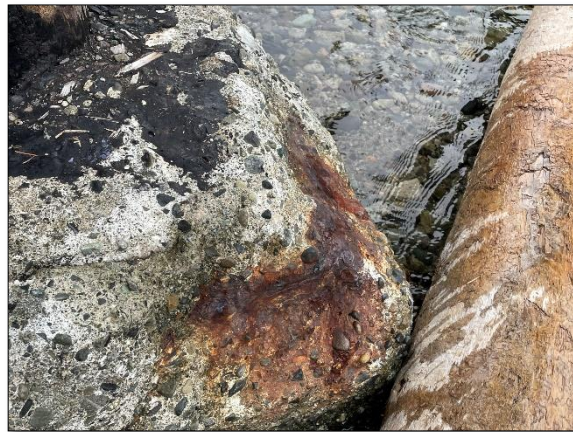
The bearing piles are in overall fair condition. There are nine concrete footings which are significantly spalled, with visible reinforcing. Re-casting of the footing is recommended.

Photograph 16: Footing at Bent 3, note: deteriorated footing

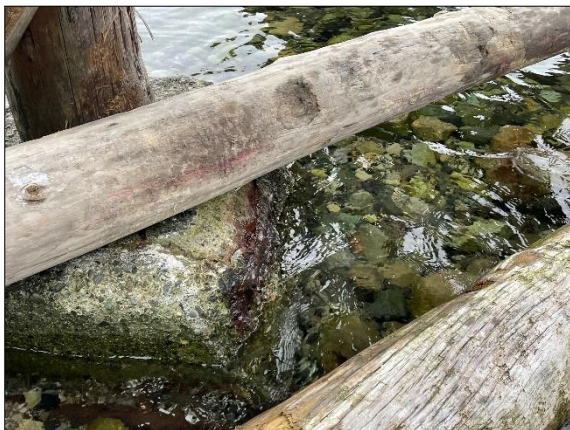
Photograph 17: Footing at Bent 4, note: deteriorated footing

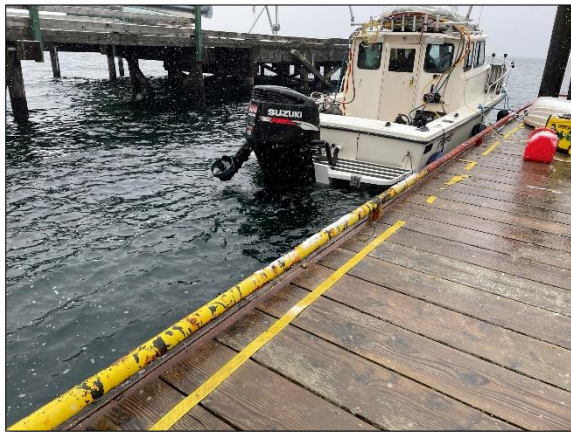
Photograph 21: Float bull rail, note: coating failures

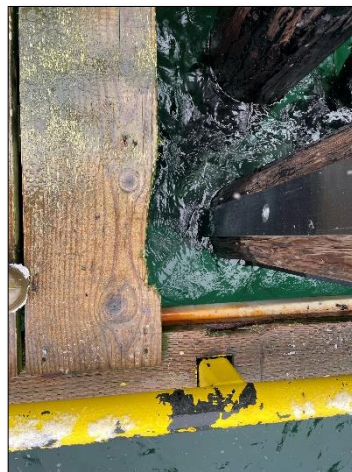
Photograph 22: Pile well, note: abrasion

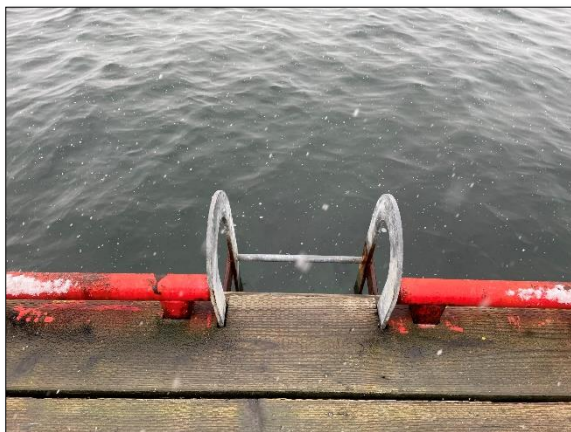
Photograph 23: Float ladder, note: no signage

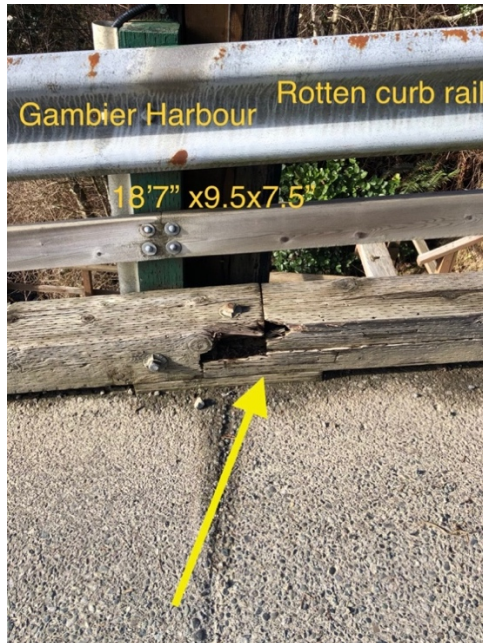
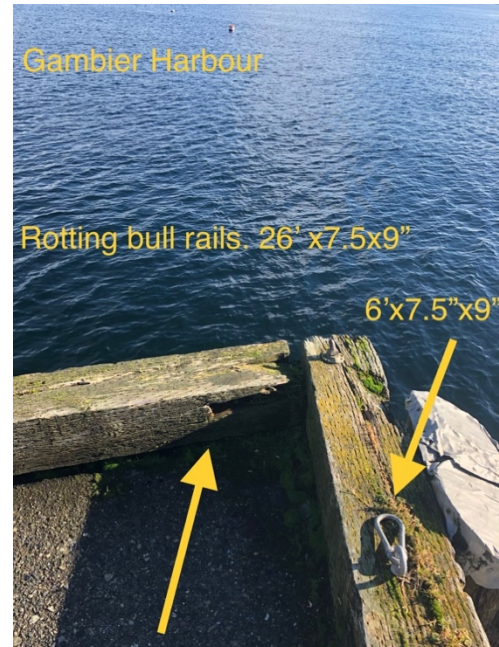
- (From previous inspection April 2019) Damage and rotting observed on the first curb rail on the approach along Row D. Replacement is recommended with 9 ½" x 7 ½" x 18' 7"

- (From Previous Inspection May 2021) East curb rail (shown above, left arrow) is no longer secured on the south side. Safety concern. Updated photo on the right. Replacement recommended.
- (As mentioned in January 2021 Report) Damage noted on horizontal member between fender piles on the end of the wharf head. Recommend considering replacement as part of future capital upgrades. **Continue to monitor**

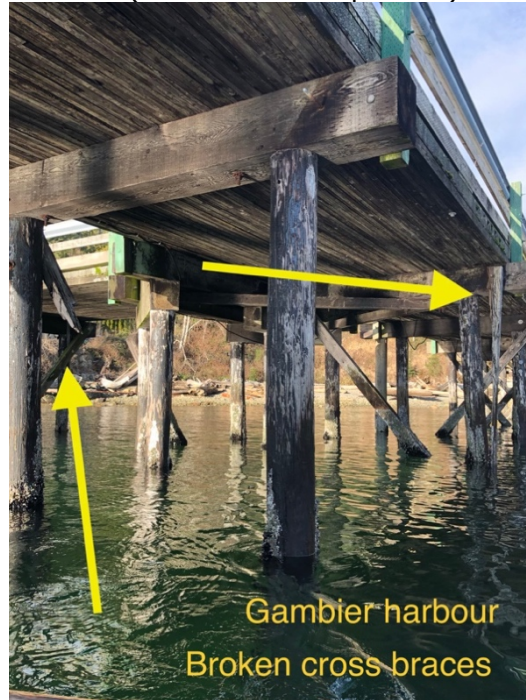
Bents 12&13 Broken Cross braces

- **Bent 11** (From Previous Inspection) Requires new Cross brace.
- **Bent 12** (From Previous Inspections) 2 New Cross Braces Required.

- **Bent 13** (From Previous Inspections) Cross brace Broken. Review by Herold Engineering recommended.
- **Bent 15** (From Previous Inspections) Bent 15 has a cross brace with a bolt that needs replacing by 24" x $\frac{3}{4}$ "
- **Bent 19** Lateral brace bolts have failed/are about to fail. See white spray-painted white spots in following images.

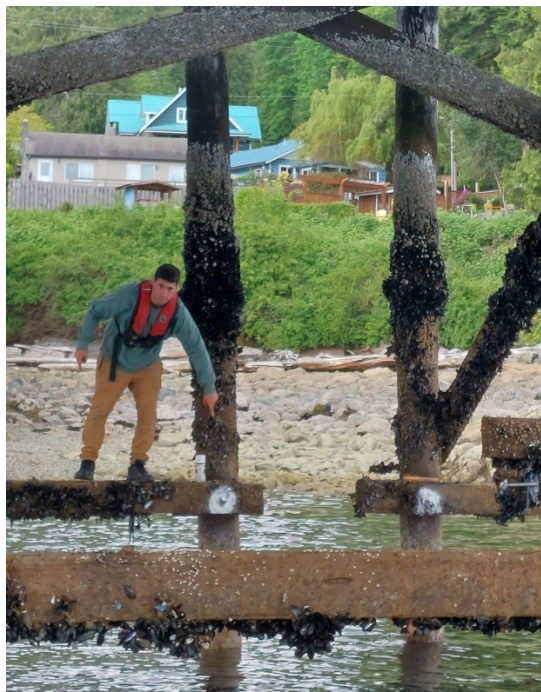
- **Bent 21** Damage to Cap On South East Side

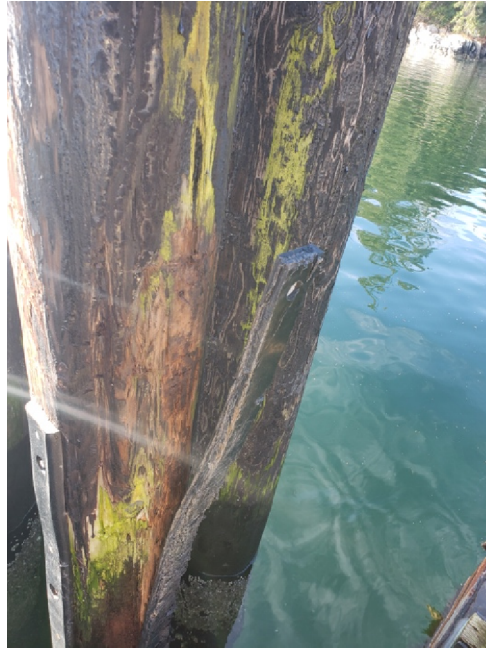
- Wear strip on pile requires ½" x 4" Lag Bolt (deferred).
 - Divers required to add 10' sections of wear strips on piles on south side of float below water line

Gambier Harbour. Float Pile wear strip.
