5. Garden Bay Lake

Garden Bay Lake Assessment Notes

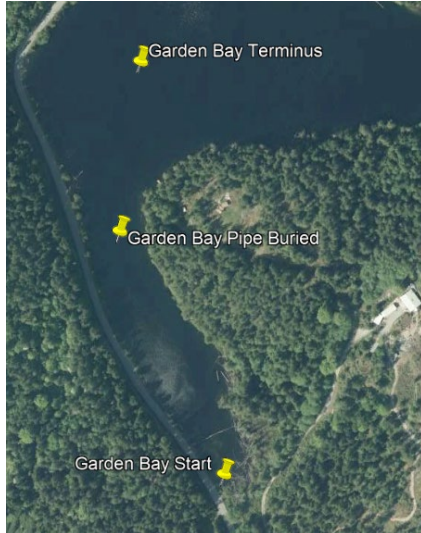
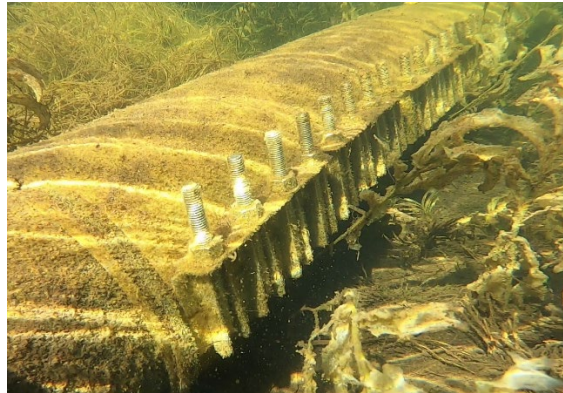
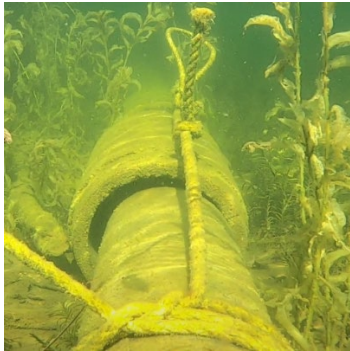
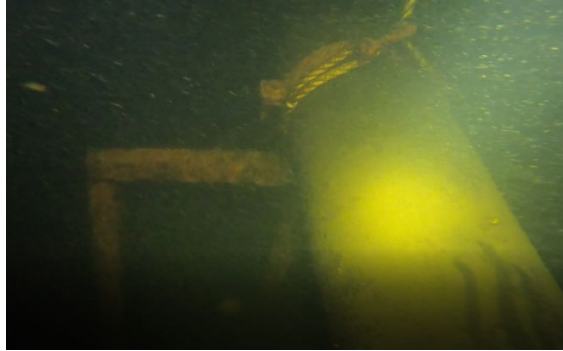
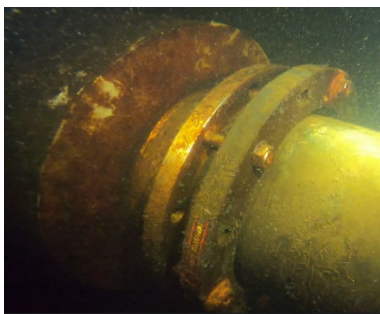
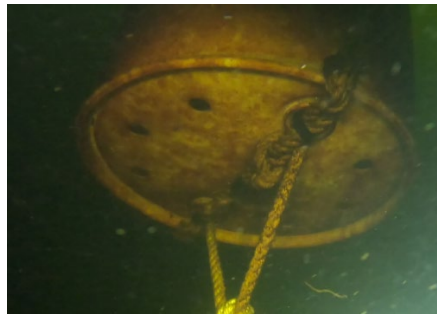
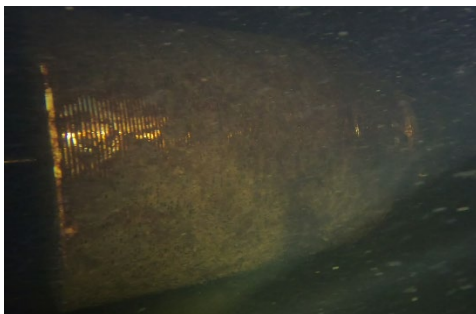
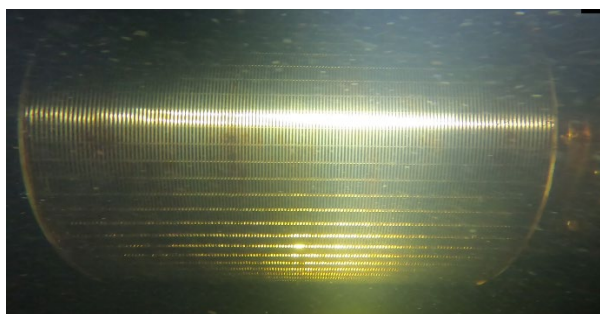
Intake screen stainless steel structure 2 feet / 0.6 metres in length and diameter of 24-inches

Stainless steel diffuser consists with slits 1-inch by 1/8-inch

Intake screen supported by steel A-frame structure & floating barrel

16 Bolt flange only supporting 8 bolts which connects screen to main pipe

Overall, the intake pipe and screen are visibly in good condition with no signs of leaks or damage. There is no indication that the 8-bolts, versus 16-bolts in the flange is of a concern, as the bolts are secure and in good condition. The screen did have a heavy amount of algae/sediment coverage when inspected which was all removed by divers
