Maintenance Report

SUNSHINE COAST REGIONAL DISTRICT

2023 - Electrical Maintenance and Testing

Location: Chapman Water Treatment Plant
5624 Reservoir Road, Sechelt, BC

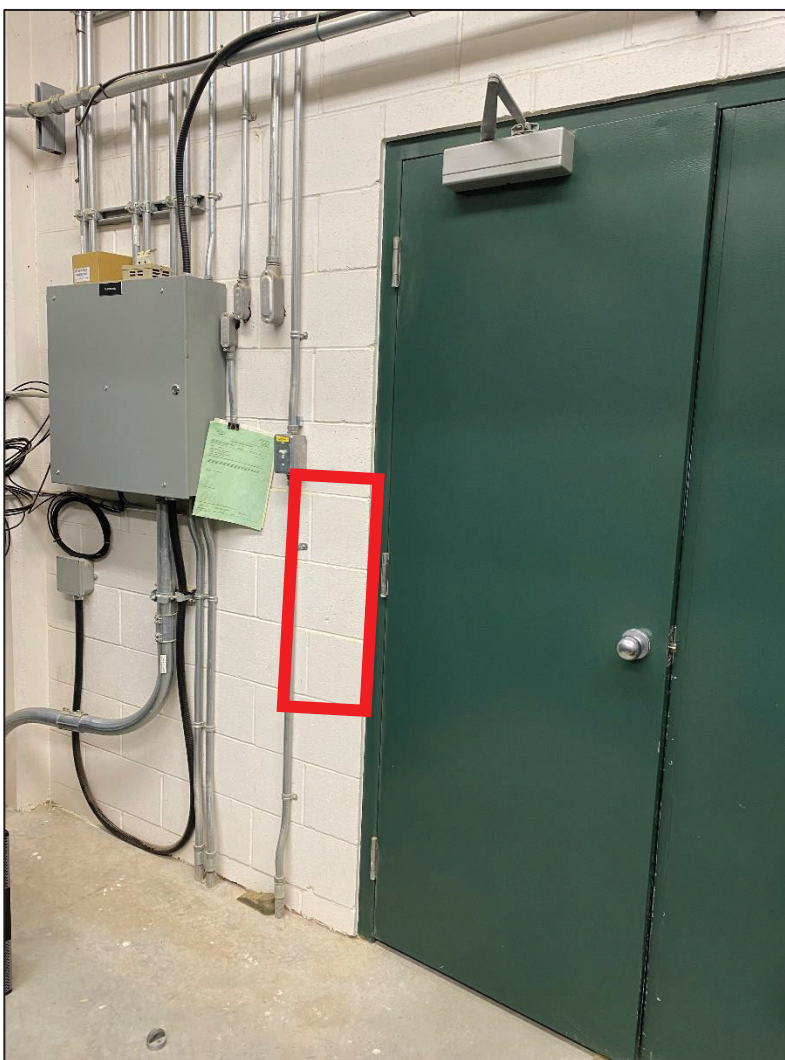
It was noted that there was no fire extinguisher present in main electrical room where MCC-A is located.

Figure 1: Suggested Location of Fire Extinguisher Install

NOTE 2: There is no fire extinguisher installed in the electrical room. Recommend installing one.

It is recommended that a properly rated fire extinguisher be permanently located in this area. It should be noted that an appropriate extinguishing agent be used for the application. Please consult your local fire inspector.

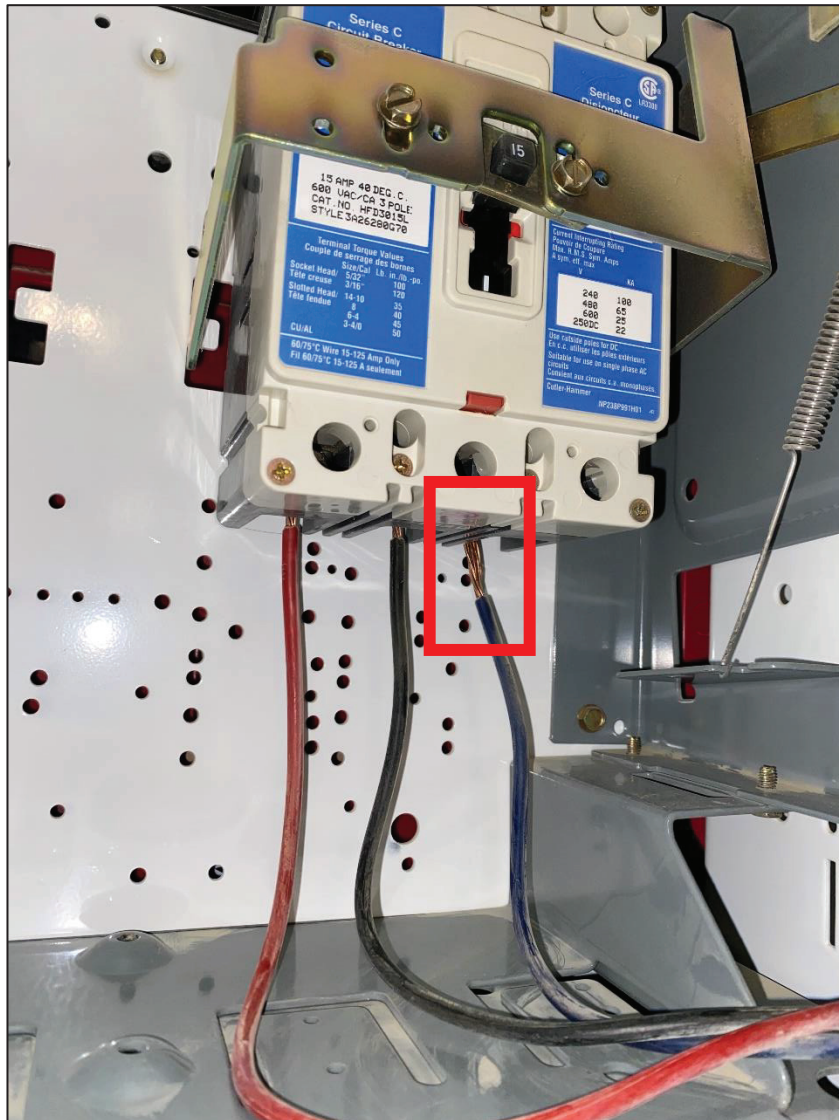
During the course of our maintenance work, we noted several instances of loose wiring. We found one of the three phase conductors not properly terminated to the molded case circuit breaker inside the following MCC buckets:

- Cell 7E (Rooftop Unit RTU-1)
- Cell 9B (Make Up Air Unit MAU-2)
- Cell 9C (Air Compressor)

Figure 2: Loose C-phase Conductor Found Inside Cell 7E (Rooftop Unit RTU-1)

NOTE 4: In this cell we found one of the three phase conductors not properly terminated to the breaker. We terminated this conductor. No further action required.

We terminated all the loose wiring that we found during the maintenance outage. No further action is required.

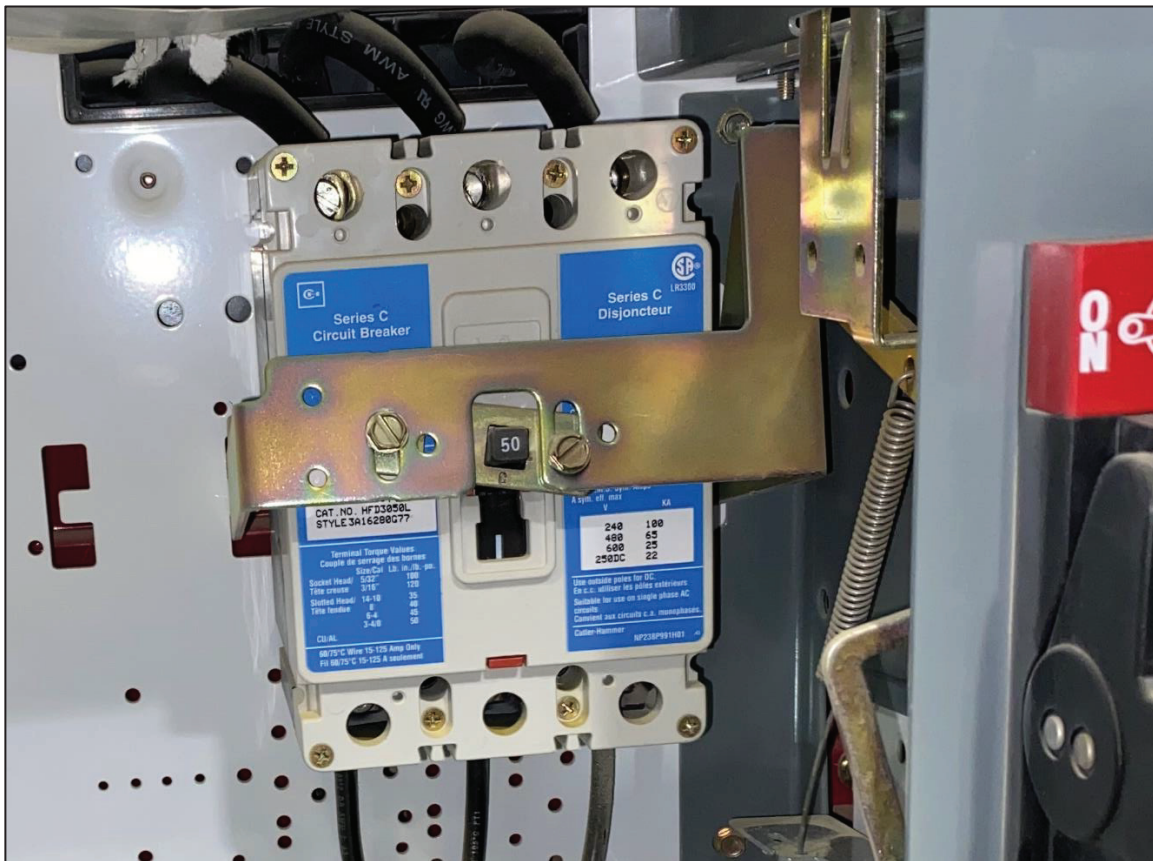
The 50A breaker for "MP-3-1-01 Maturation Pump #1" (Cell 5B) was giving us very bad contact resistance results on C-phase. Upon operating this breaker several times in an attempt to improve these results, the breaker completely failed on C-phase and no longer had continuity. There was no replacement breaker present on site, so this pump was taken out of service temporarily until a replacement breaker is sourced.

- Brand: Eaton Cutler-Hammer
- Type: Series C Molded Case Circuit Breaker
- Category Number: HFD3050L
- Style Number: 3A16280G77

Figure 3: Failed Maturation Pump #1 Breaker

NOTE 7: The 50A breaker for "Maturation Pump #1" was giving us very bad contact resistance results on C-phase. Upon operating this breaker several times in an attempt to improve these results, the breaker completely failed on C-phase and no longer has continuity. There was no replacement breaker present on site, so this pump was taken out of service temporarily until a replacement breaker is sourced. We also recommend replacing the 50A "Maturation Pump #2" breaker as it is also returning bad contact resistance results.

We recommend replacing this breaker and ordering additional breakers of several current ratings to keep as spares on site in case another breaker would fail in the future. **We also recommend replacing the 50A breaker for "MP-3-1-02 Maturation Pump #2" as this breaker was also returning bad contact resistance results.** We did not attempt to improve the results on this particular breaker to avoid a possible breaker failure like what happened to the Maturation Pump #1 breaker.
