April 27, 2017

XCG File No. 4-2111-05-02

Re: Post-Closure Use Guidelines and Best Management Practices, Gibsons Landfill

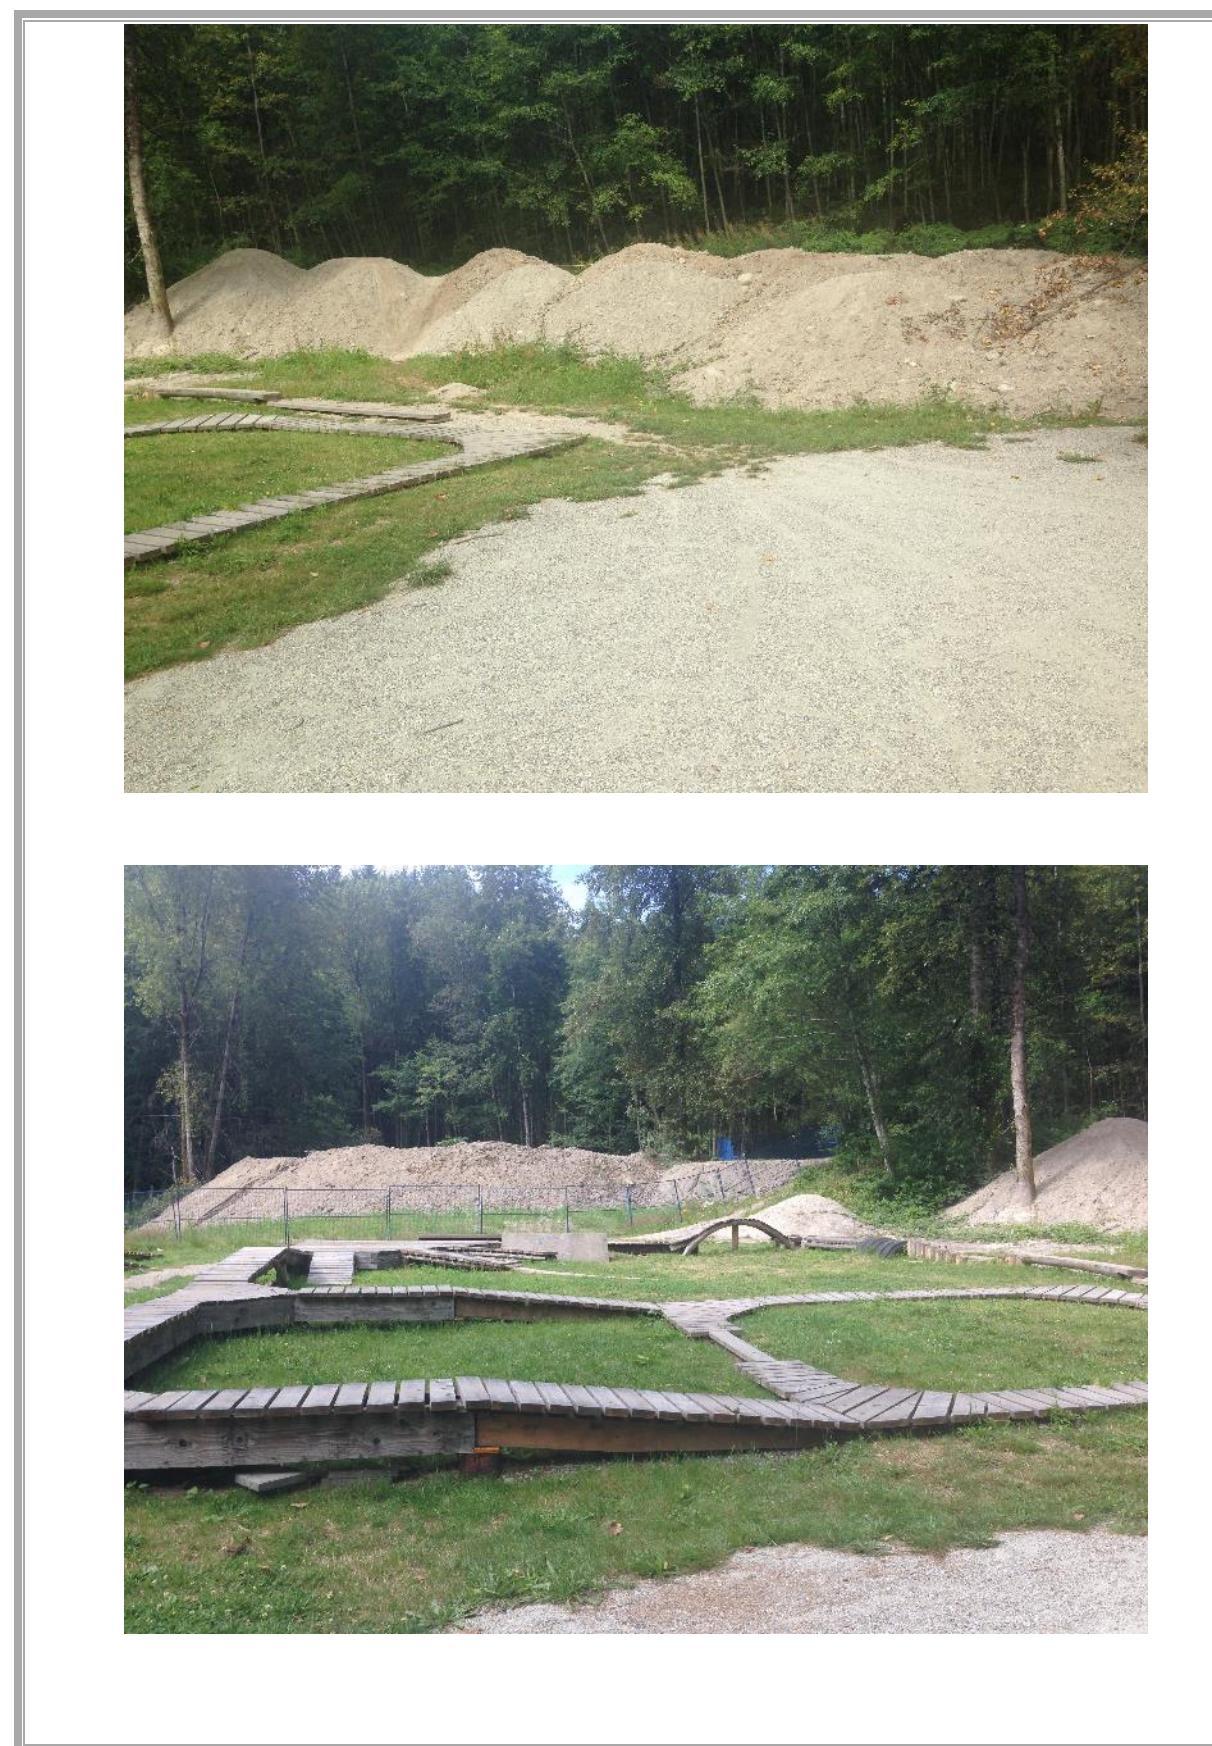
At the time of the Site visit, the skills area consisted of several elevated boardwalks and a small pump track. The elevated boardwalks were constructed of wood and tires with wood pile supports embedded into the existing landfill cover. The depth of the wood pile supports is unknown; however, it is assumed that the supports extend to a significant depth within the cover system and/or waste in order to adequately accommodate the boardwalk structure and bikers making use of the park. The small pump track consisted of several soil berms with most of the track established above the existing landfill cover. Short portions of the pump track appear to cut into the existing landfill cover.

Fill material stockpiles were observed to the southwest and northwest of the skills area, with a few smaller stockpiles located to the northeast. A temporary security fence was located to the southwest of the skills area, preventing public access to the fill material stockpiles located to the southwest. The fill material stockpiles to the northwest and northeast are fully accessible. It is understood that the fill material stockpiles located to the northeast were brought in to cover waste material which had recently been exposed when existing blackberry bushes were removed.

Paper machine dryer felt was observed along the southeast side of the pump track extending to the northeast. It is understood that the Parks Department has been using the dryer felt as a barrier between the existing landfill cover and the fill material that has been stockpiled.

Small quantities of waste material were observed in the vegetated areas surrounding the skills area. The exposed waste, which was limited to a few areas, consisted primarily of plastics and metals.

Based on the above guidelines and best management practices, and as per the requirements outlined in the Closure Plan, it is recommended that the skills area of Sprockids Park be relocated outside of the limit of waste, as there are features of the park (boardwalk supports and pump track) that have compromised the integrity of the final cover.

It is recommended that the final cover be rehabilitated to ensure that the landfill is adequately covered. Additional fill material should be added to areas where the existing cover has been disturbed and in areas with minimal coverage or where waste is exposed. Additional fill material should also be placed, as required, to ensure a minimum 4 percent grade is maintained for surface water drainage. The use of paper machine dryer felt as a barrier between the existing landfill cover and any new fill material is unnecessary. Any debris/waste that is currently exposed should be removed and all disturbed areas should be vegetated to prevent erosion.
