INFRASTRUCTURE SERVICES COMMITTEE

SUNSHINE COAST REGIONAL DISTRICT STAFF REPORT

SUBJECT: **CHAPMAN LAKE WATER SUPPLY EXPANSION PROJECT ENVIRONMENTAL ASSESSMENT REPORT**

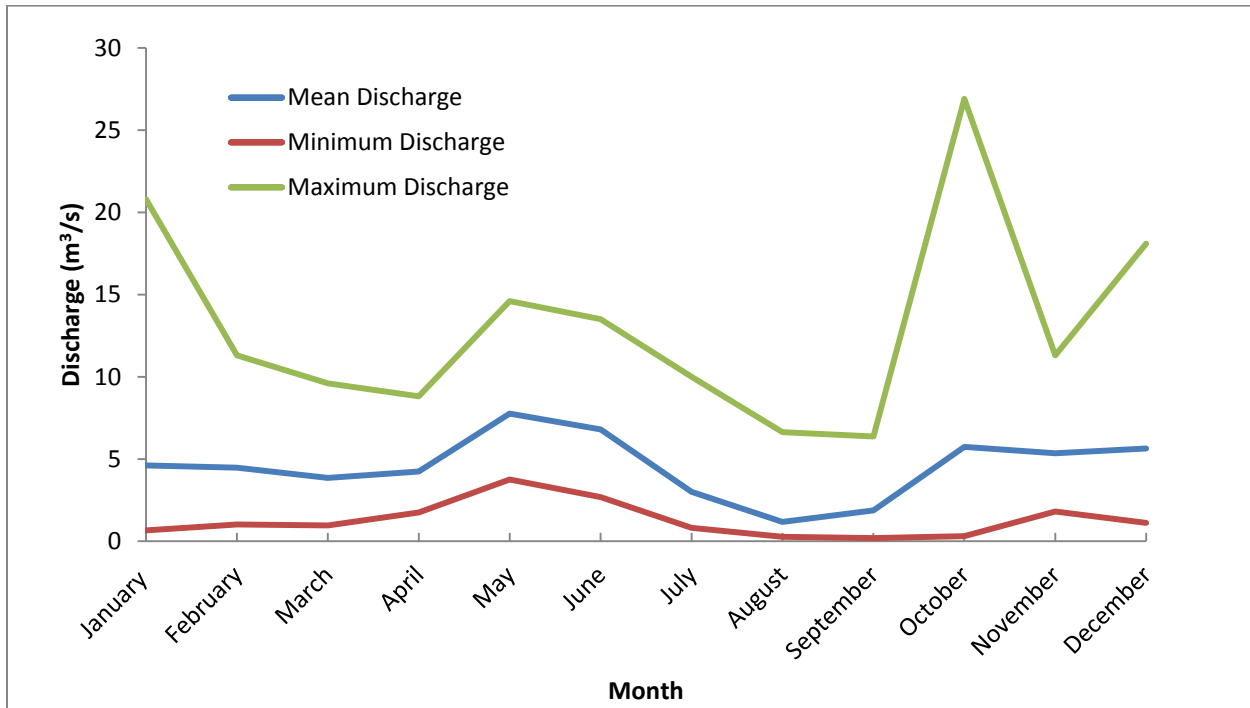
The following summarizes the results from Chapman and Reksten (1991) based on the gauging station located above the SCRD intake (Sta 08GA060). Mean annual discharge was 4.53 m³/s with the months of peak flow being May and June with an average flow of approximately 7 m³/s and the month of lowest average flow was August at 1.18 m³/s (Figure 4).

Figure 4: Chapman Creek Hydrograph (Station 08GA060)

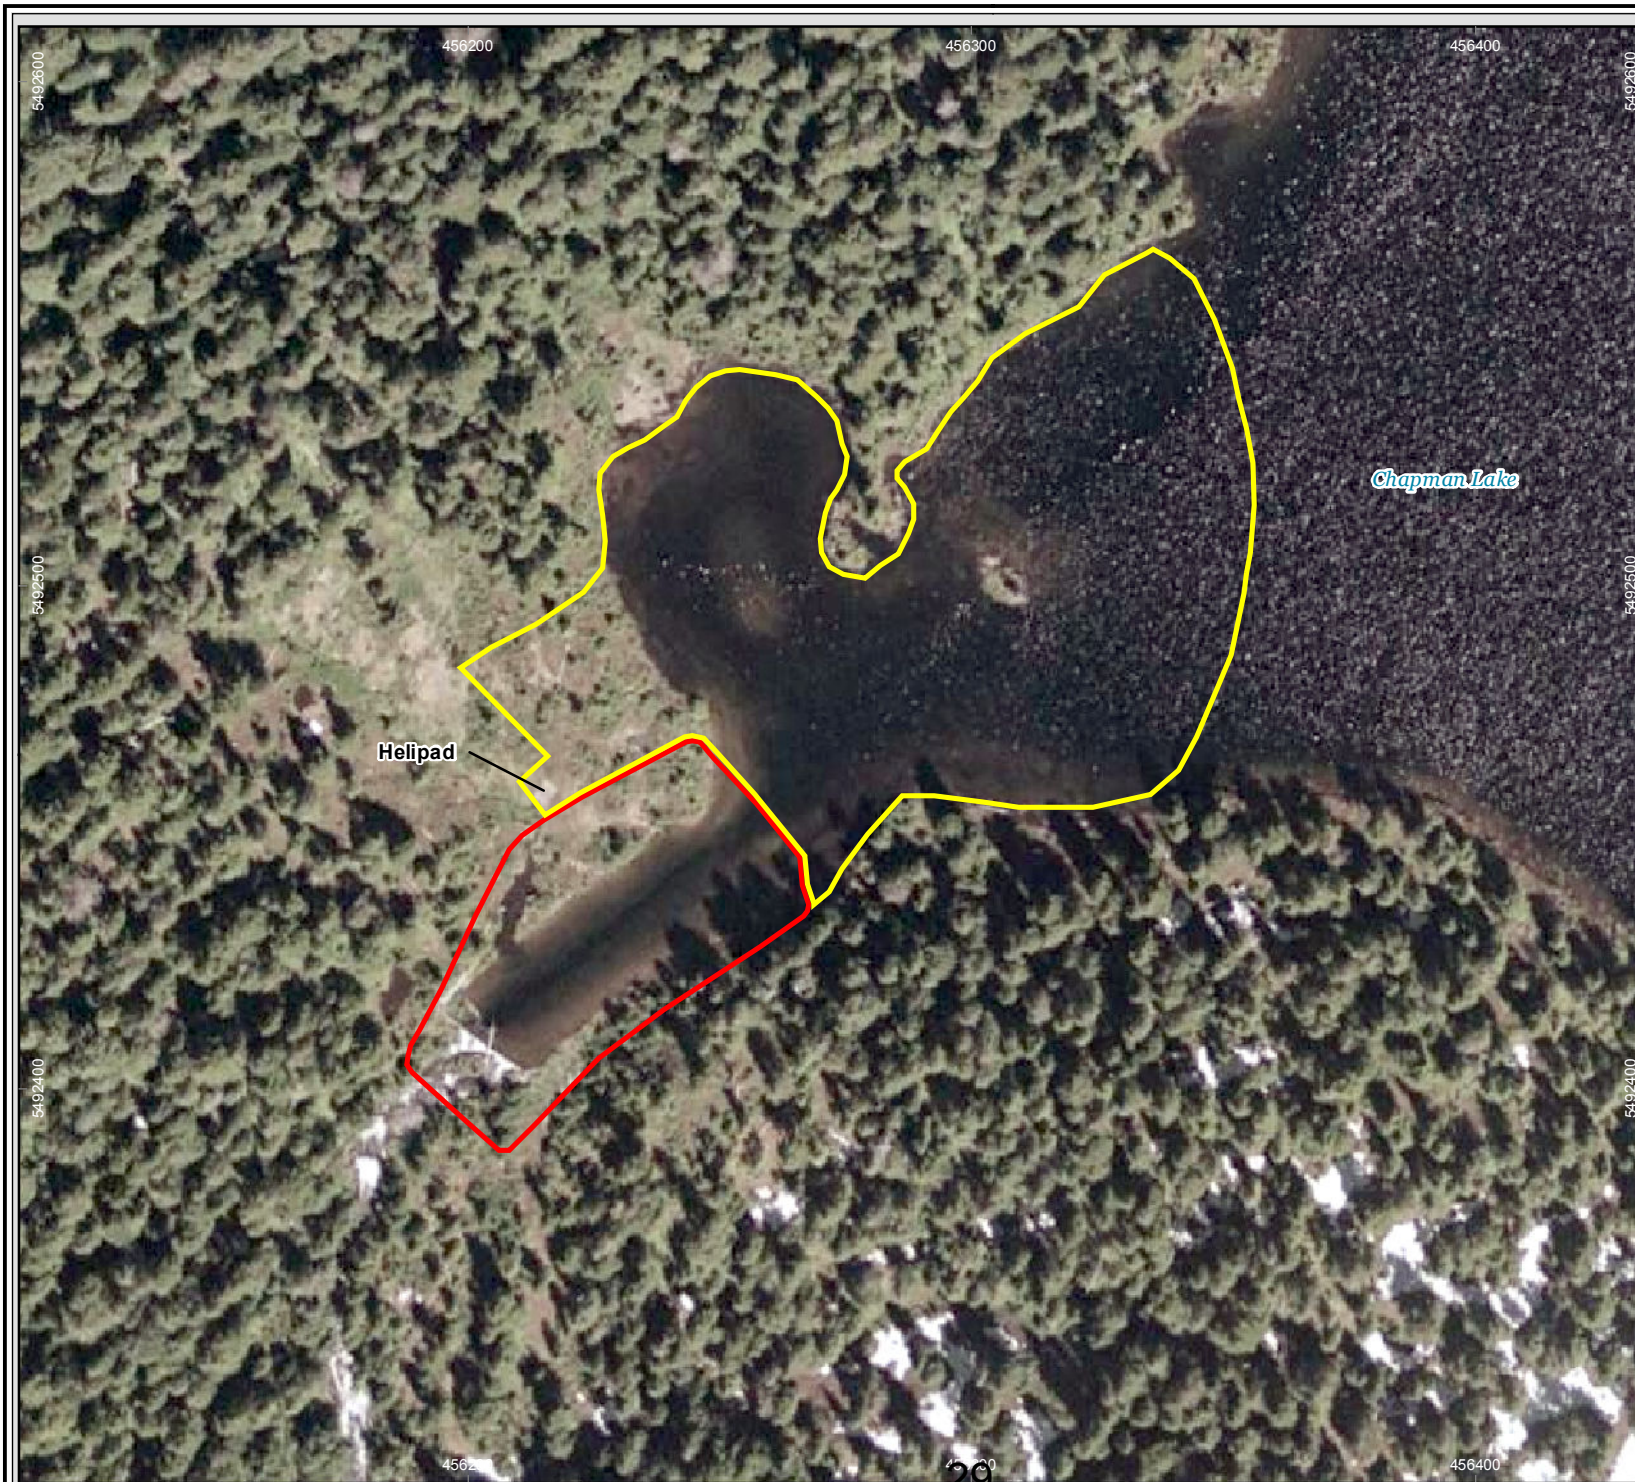
Figure 6 identifies the existing Park Use Permit area and the additional area that will be required to construct the new intake. The yellow area is the extra space needed for construction, laydown and worker camp that represents a land area of approximately 1,500 m² and an in-lake area of approximately 11,700 m² for a total of 13,200 m² that would be required for the pipe installation

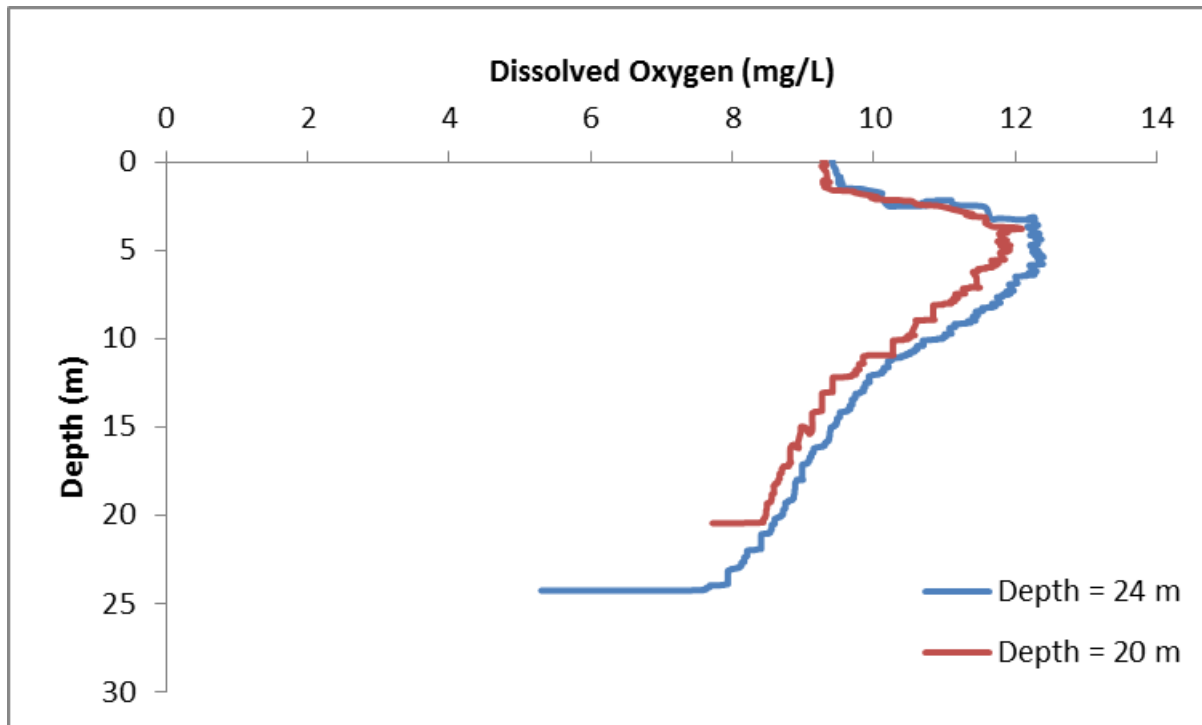
Figure 10: Dissolved Oxygen Depth Profile in Chapman Lake, 2016

dissolved oxygen profiles are depicted in Figure 7 and Figure 10 respectively. Temperatures ranged from 17.9°C at the surface to 3.9°C at depth with the thermocline occurring between the 4 m to 9 m depth. Similar results were obtained in 1999 (Whitehead) although a profile to the bottom was not performed in the original study. Temperature was consistent between the two locations measured in 2016. Dissolved oxygen levels peaked at approximately the 4 m to 6 m depth.

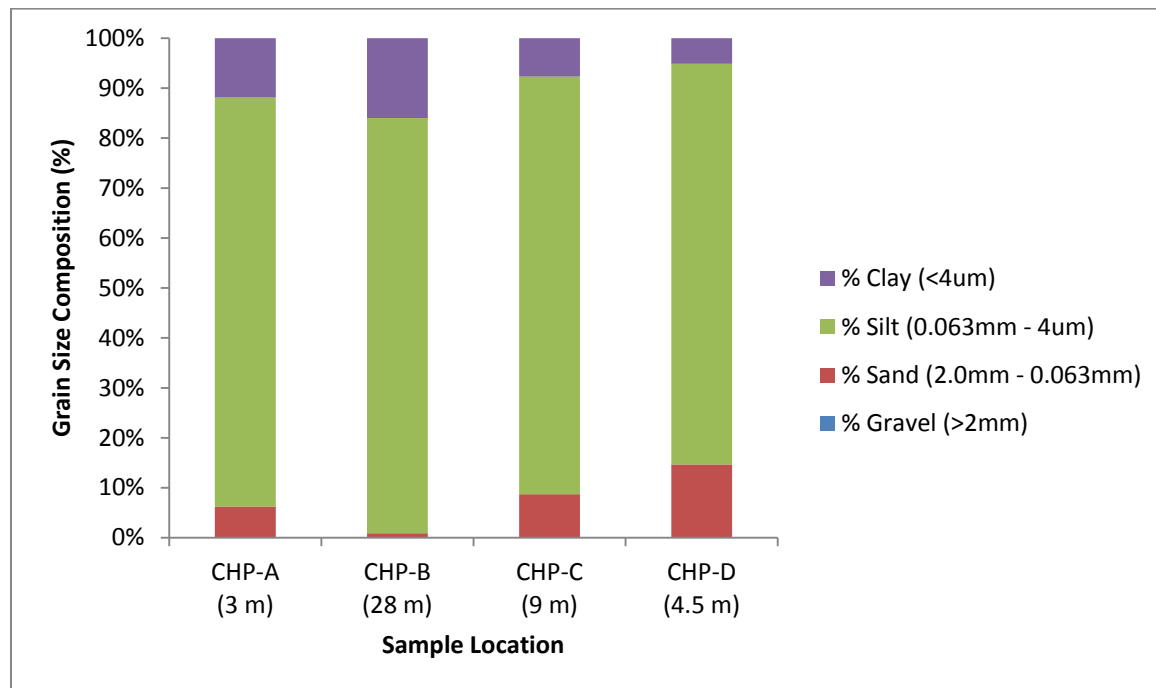
The results of the 2016 laboratory analysis confirms the previous findings in the 1998 study, that silt was the predominant lake material observed at depth. Figure 11 provides the percent composition grain size for each of the sample locations. The dominant grain size at each of the locations was silt.

Figure 11: Sediment Grain Size Analysis in Chapman Lake, 2016

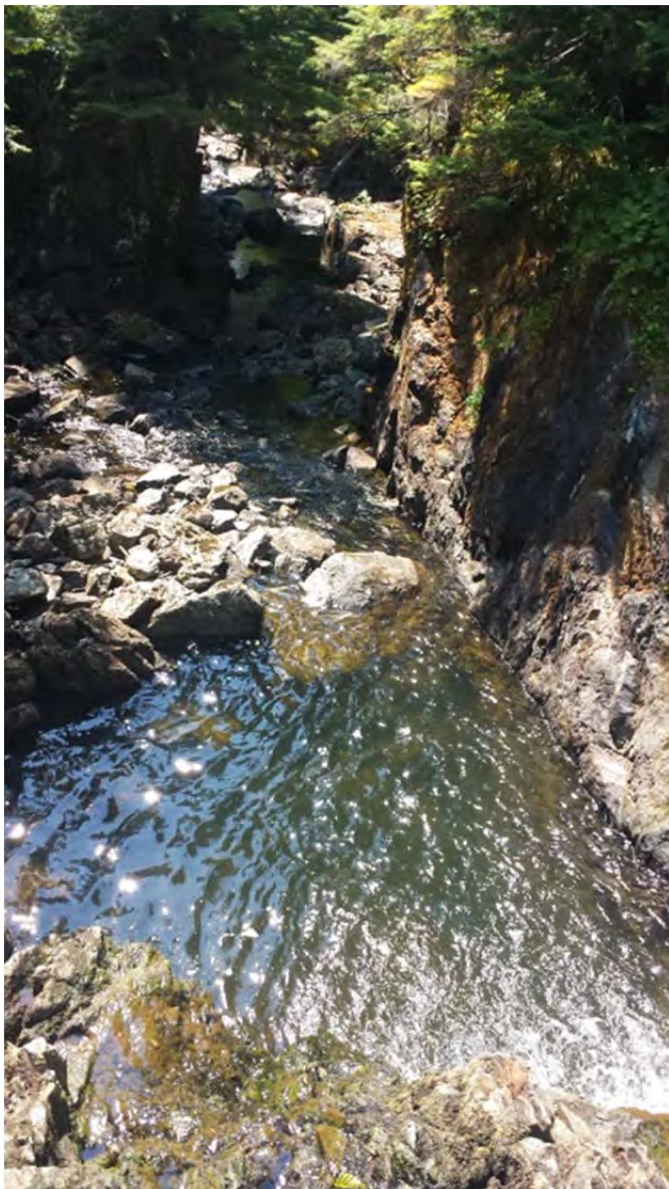
Photograph 5. ↑

Photograph 4. ↑
Chapman Lake dam from inside lake area looking downstream

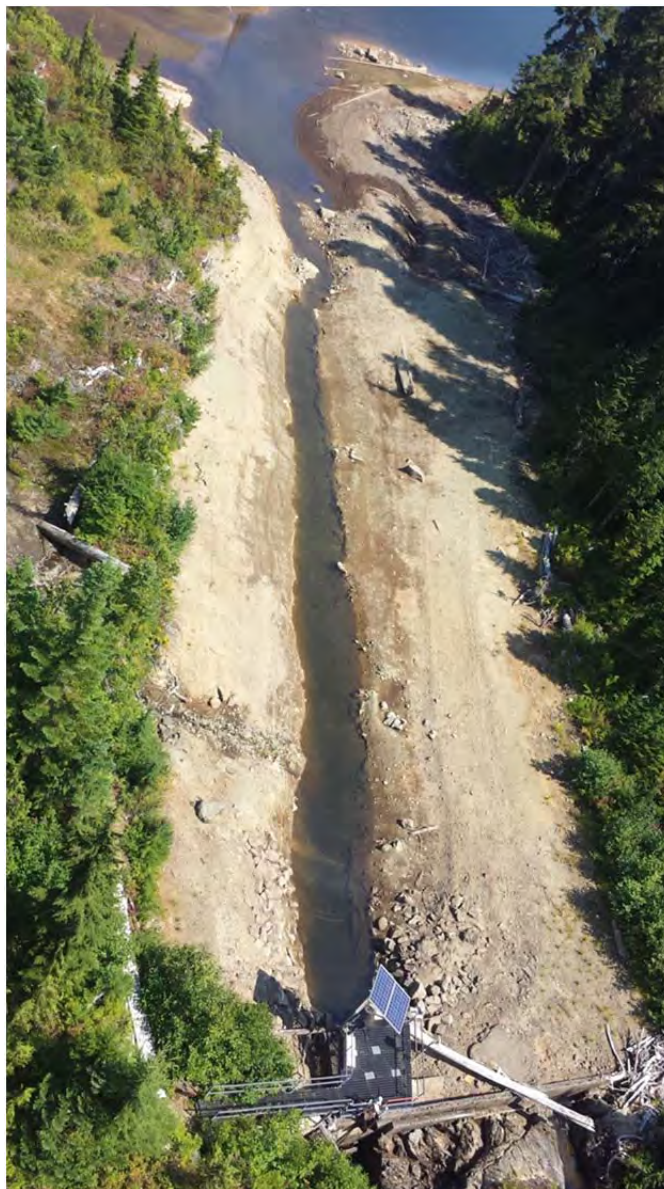
Photograph 6. ↑

Chapman Lake outlet top of waterfall looking downstream

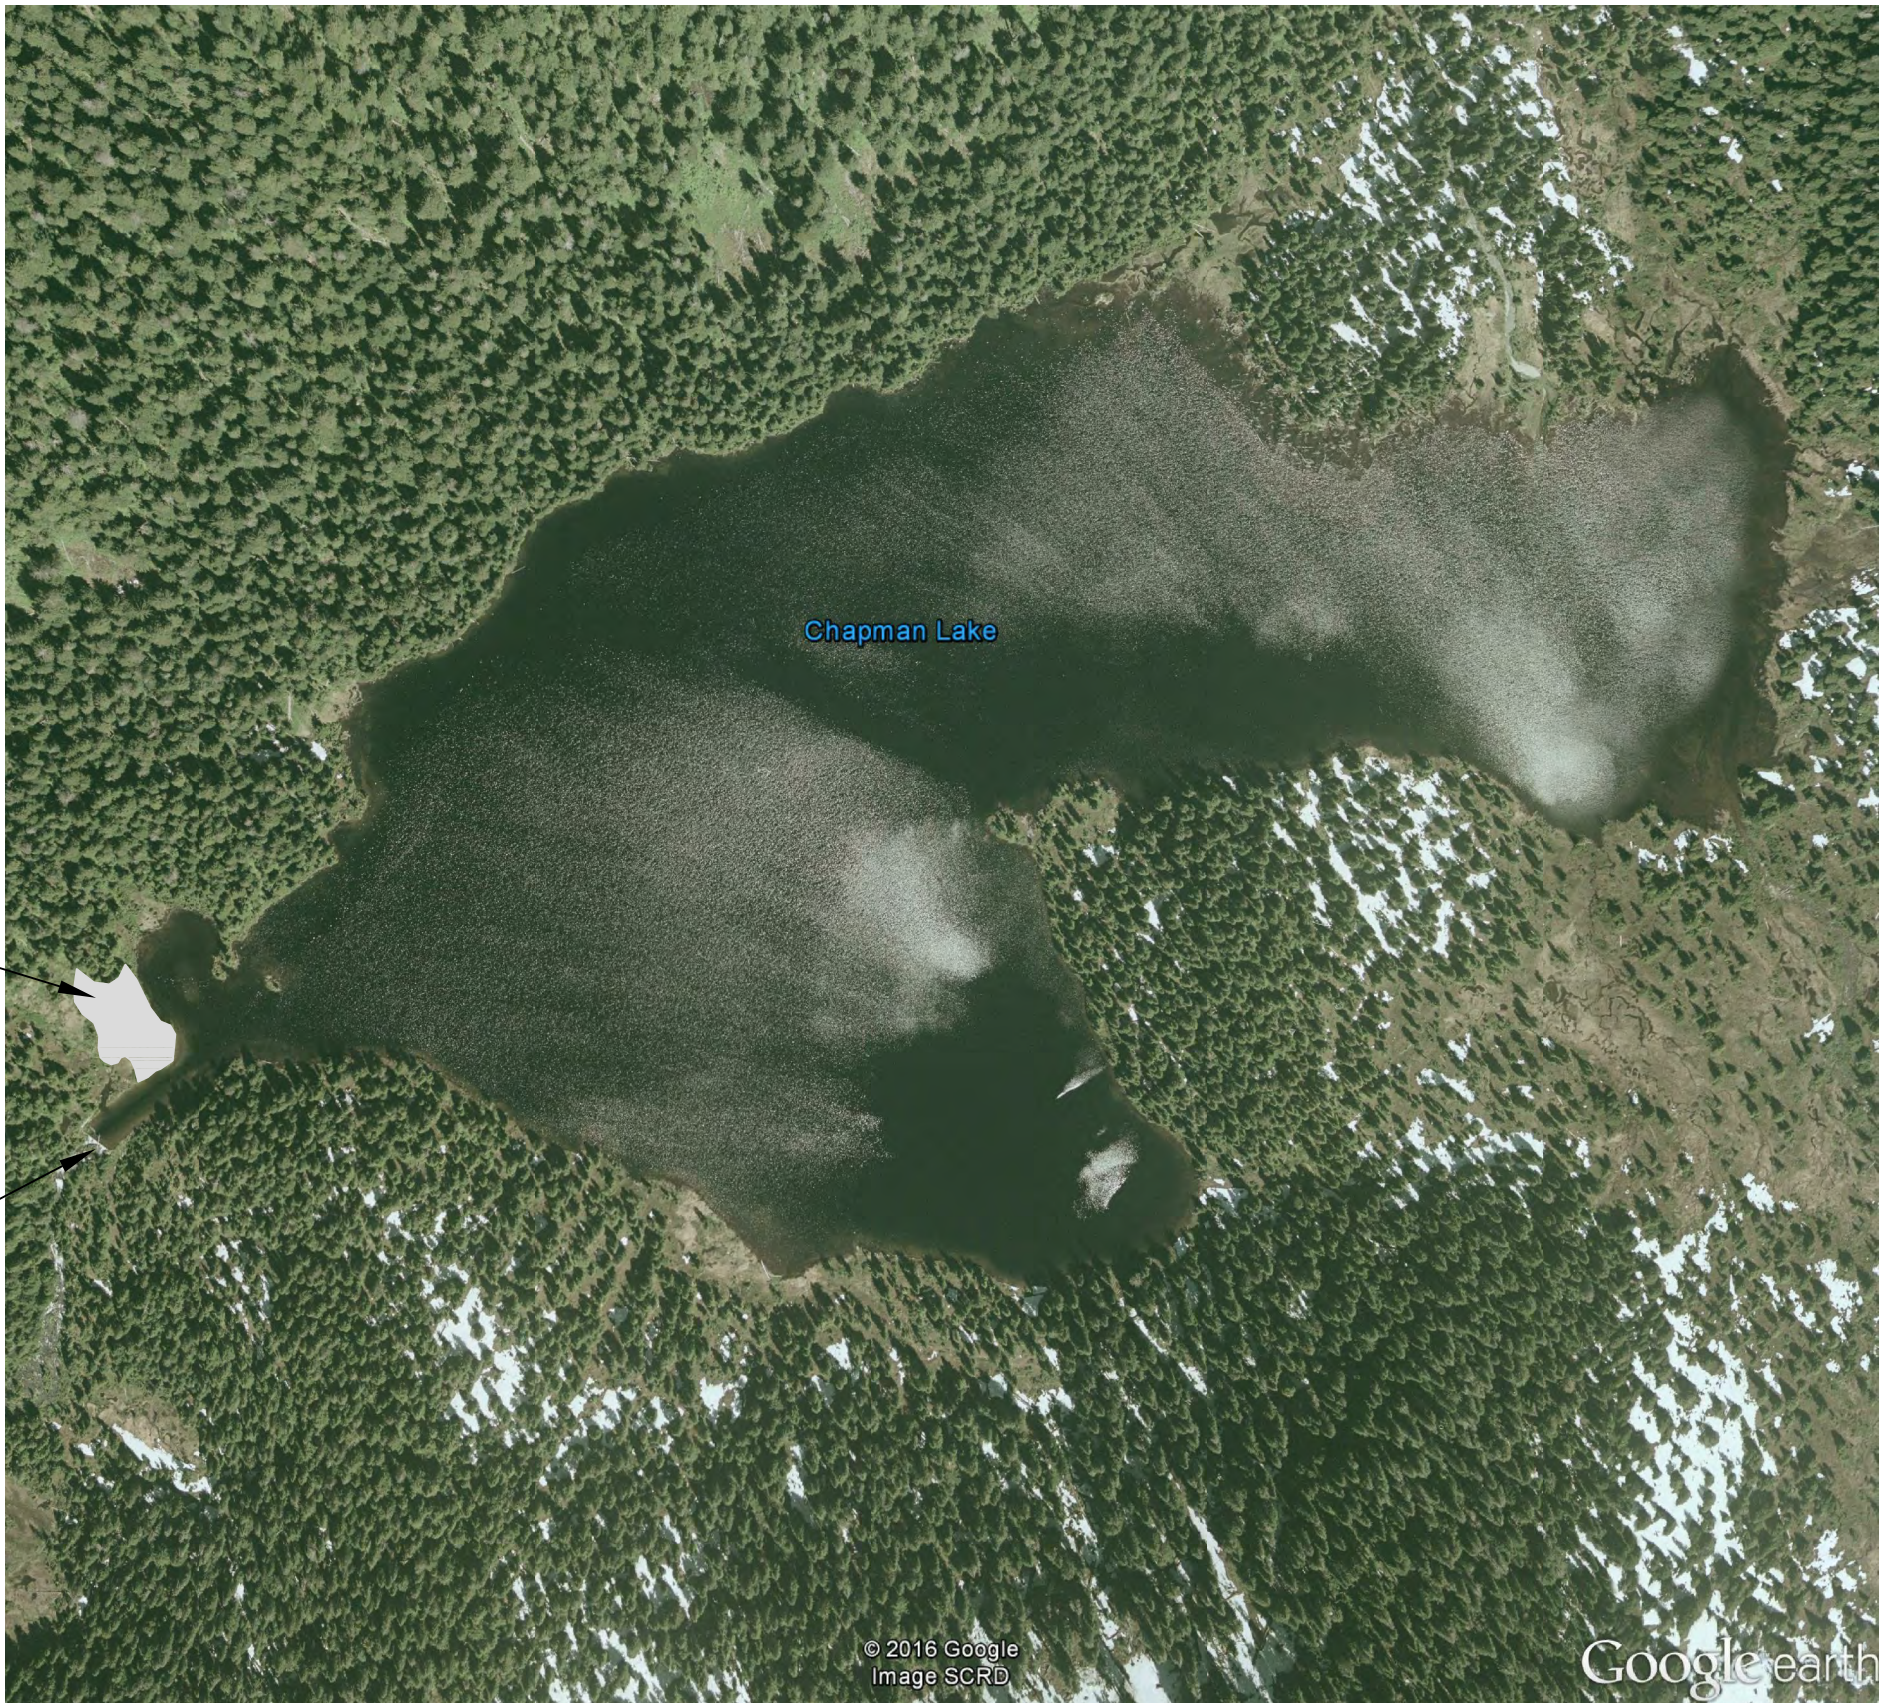
EXISTING
DAM TO BE
MODIFIED

CHAPMAN LAKE SITE (NTS)

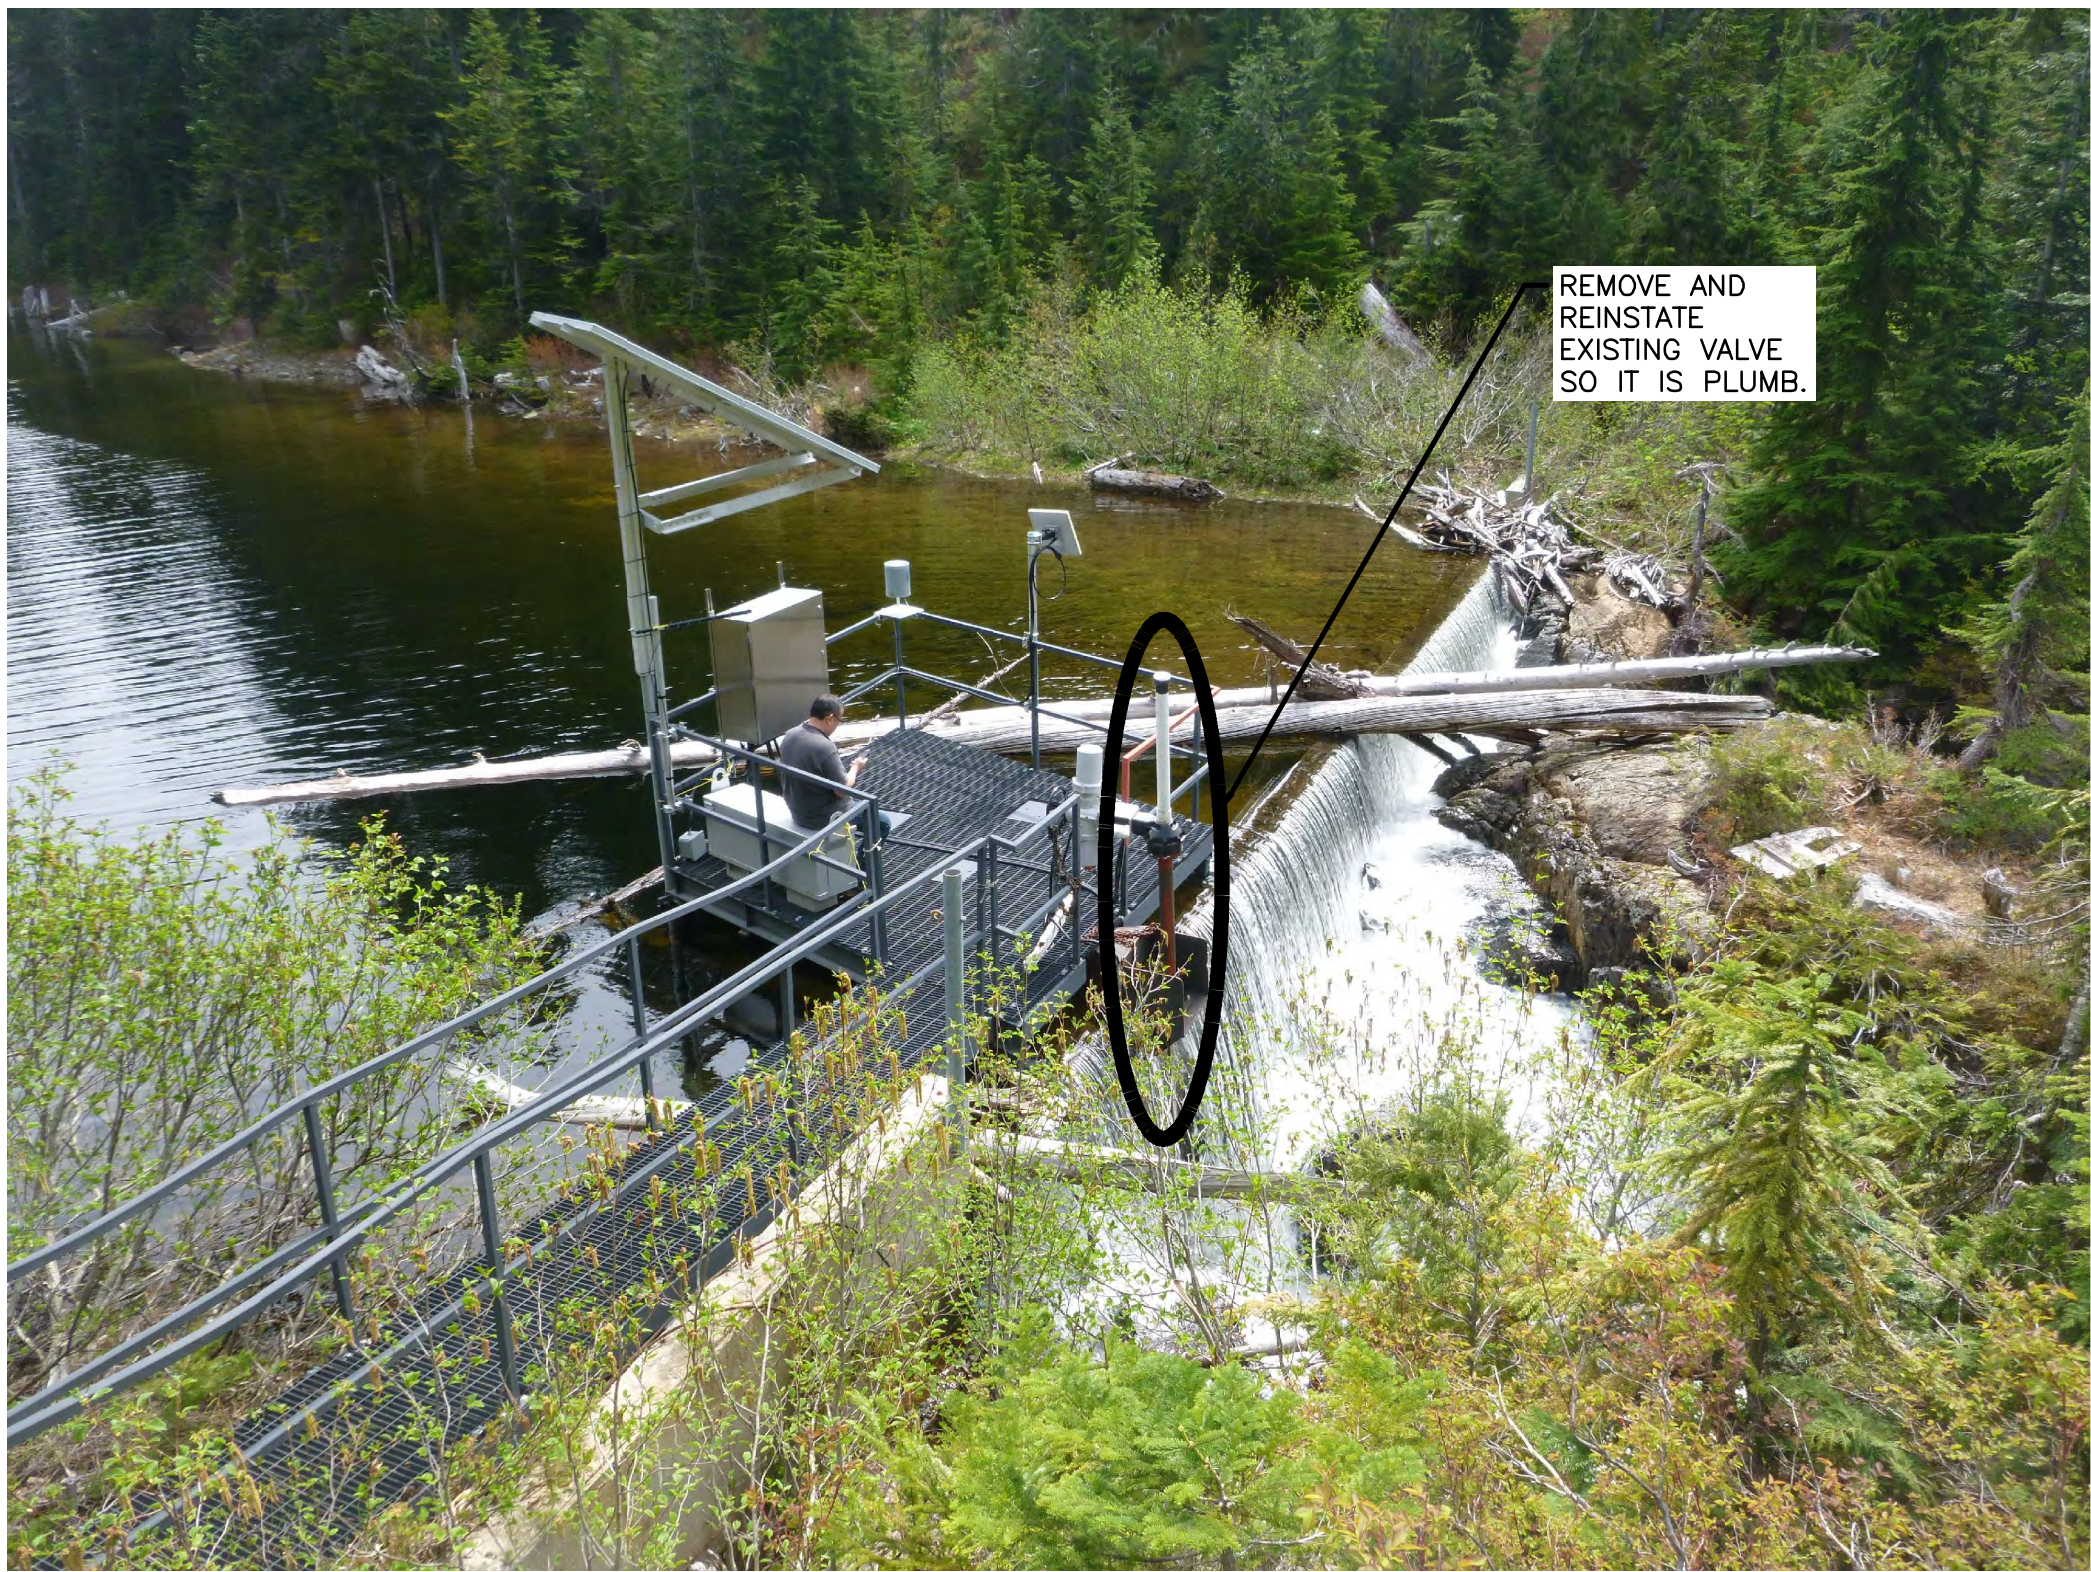
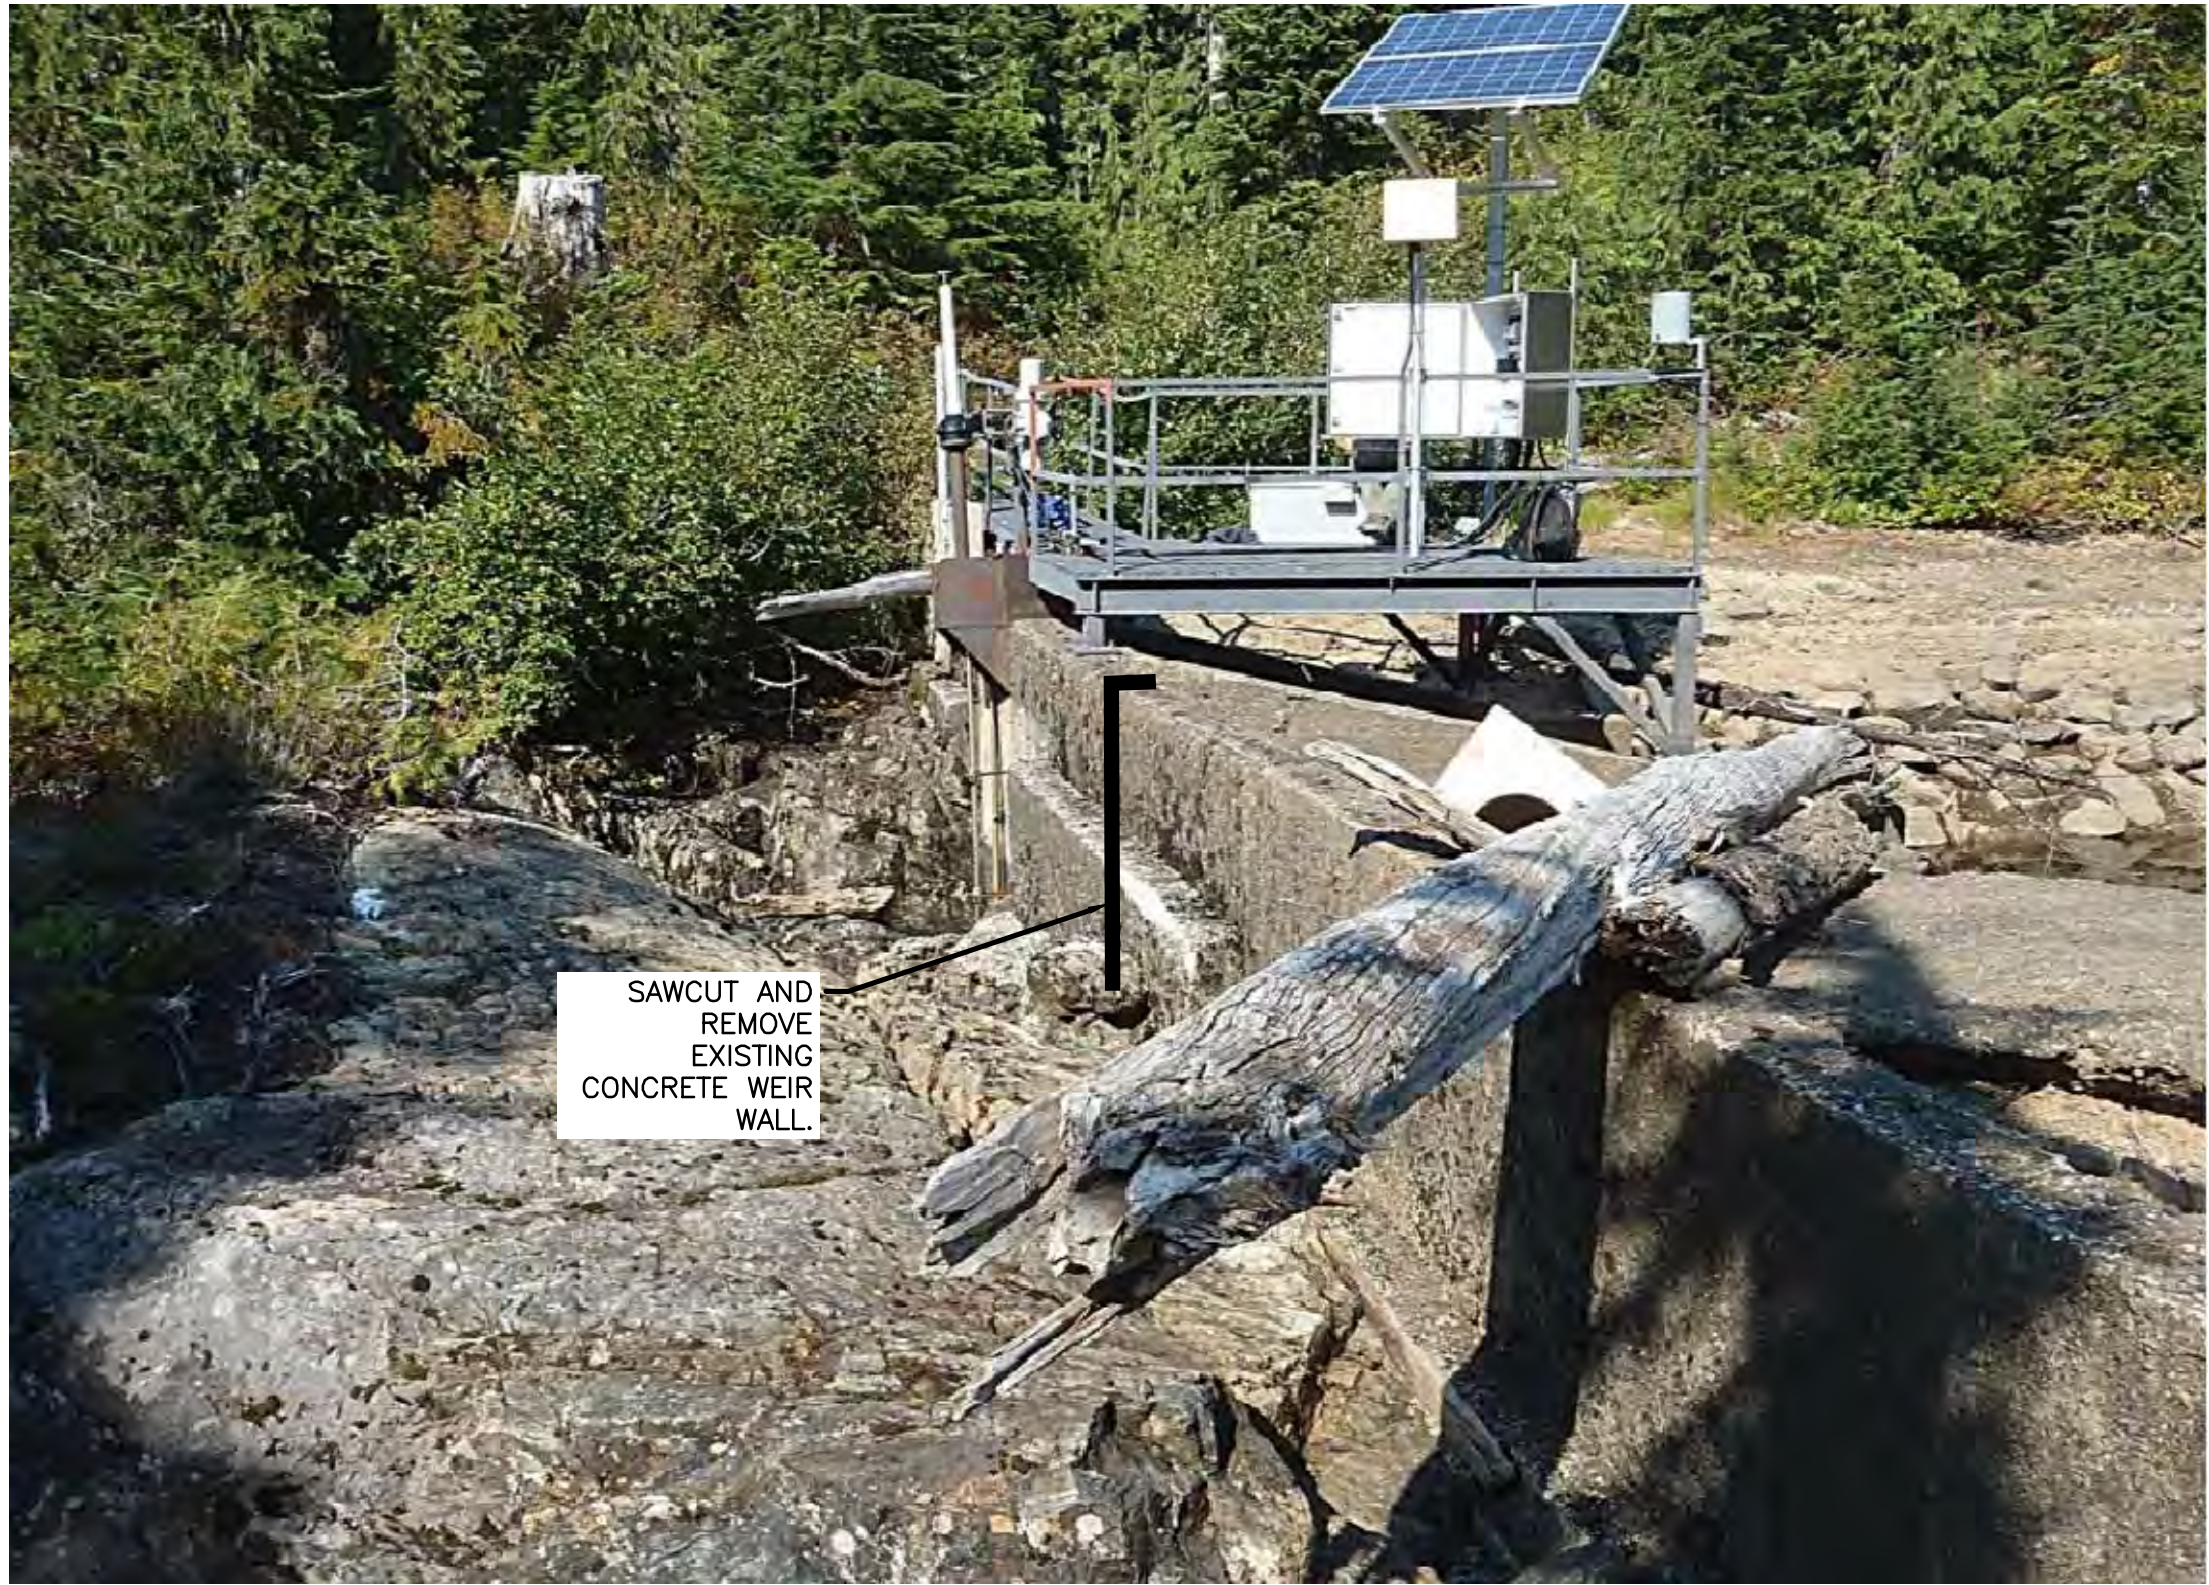
- | EXISTING FACE OF DAM
1:50

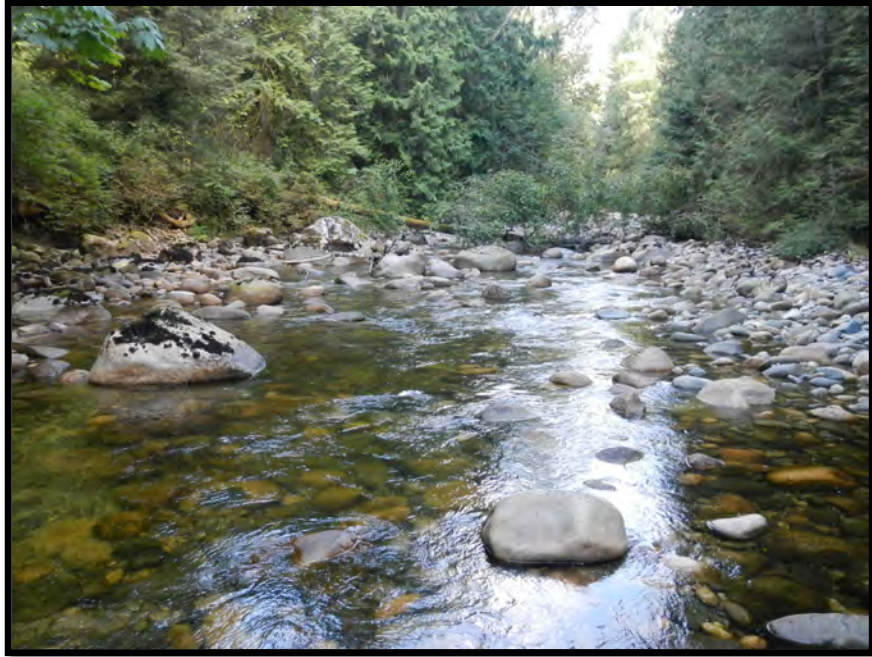
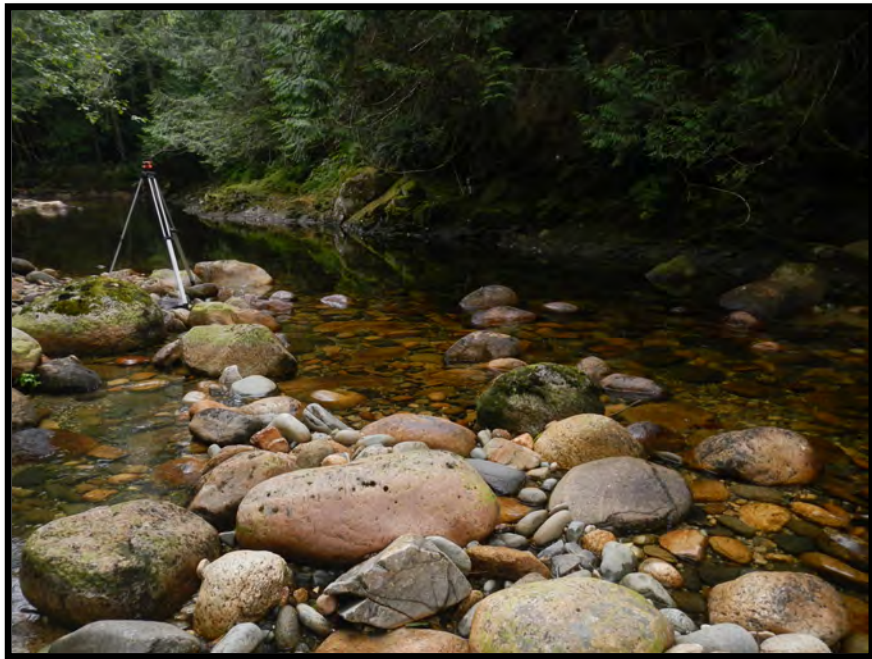
Figure 2: Example of observed available rearing habitat found in Reach 2 and 3 of the Chapman Creek mainstem. The photos were taken August 10 at an estimated flow of 0.20 -0.22 cms.

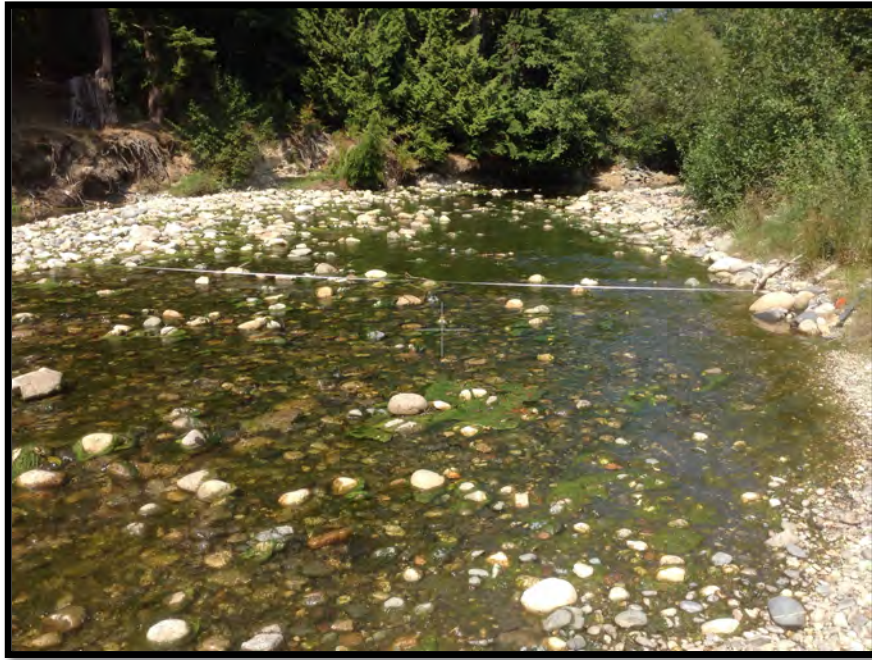
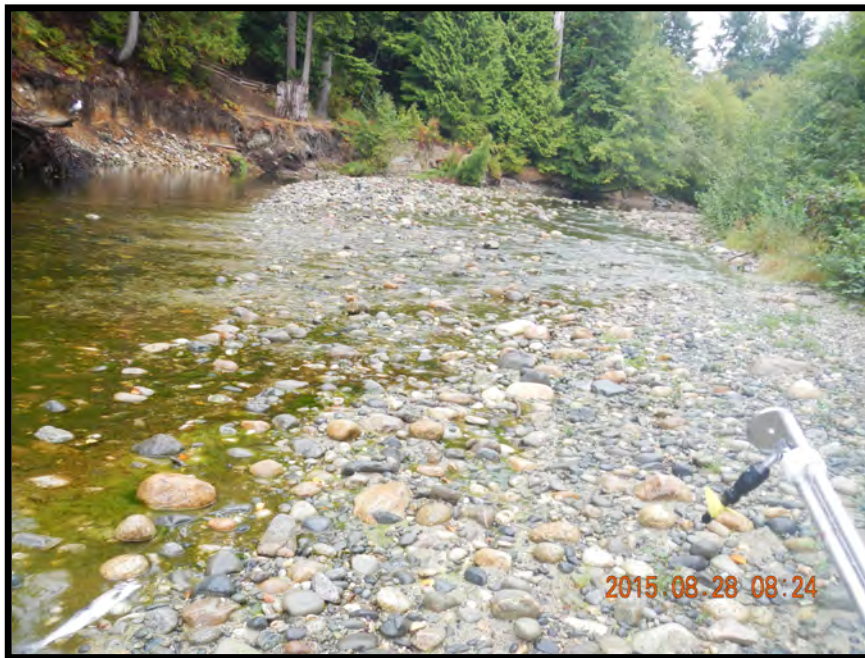
Figure 6: Photos of the first riffle above the high tide mark on lower Chapman Creek. This area is characterized by extensive bedload build-up and in some years presents a migration barrier at low flows. The pool immediately downstream provides the first significant adult holding location.
