Sunshine Coast Regional District

Well Protection Plan

July 2017

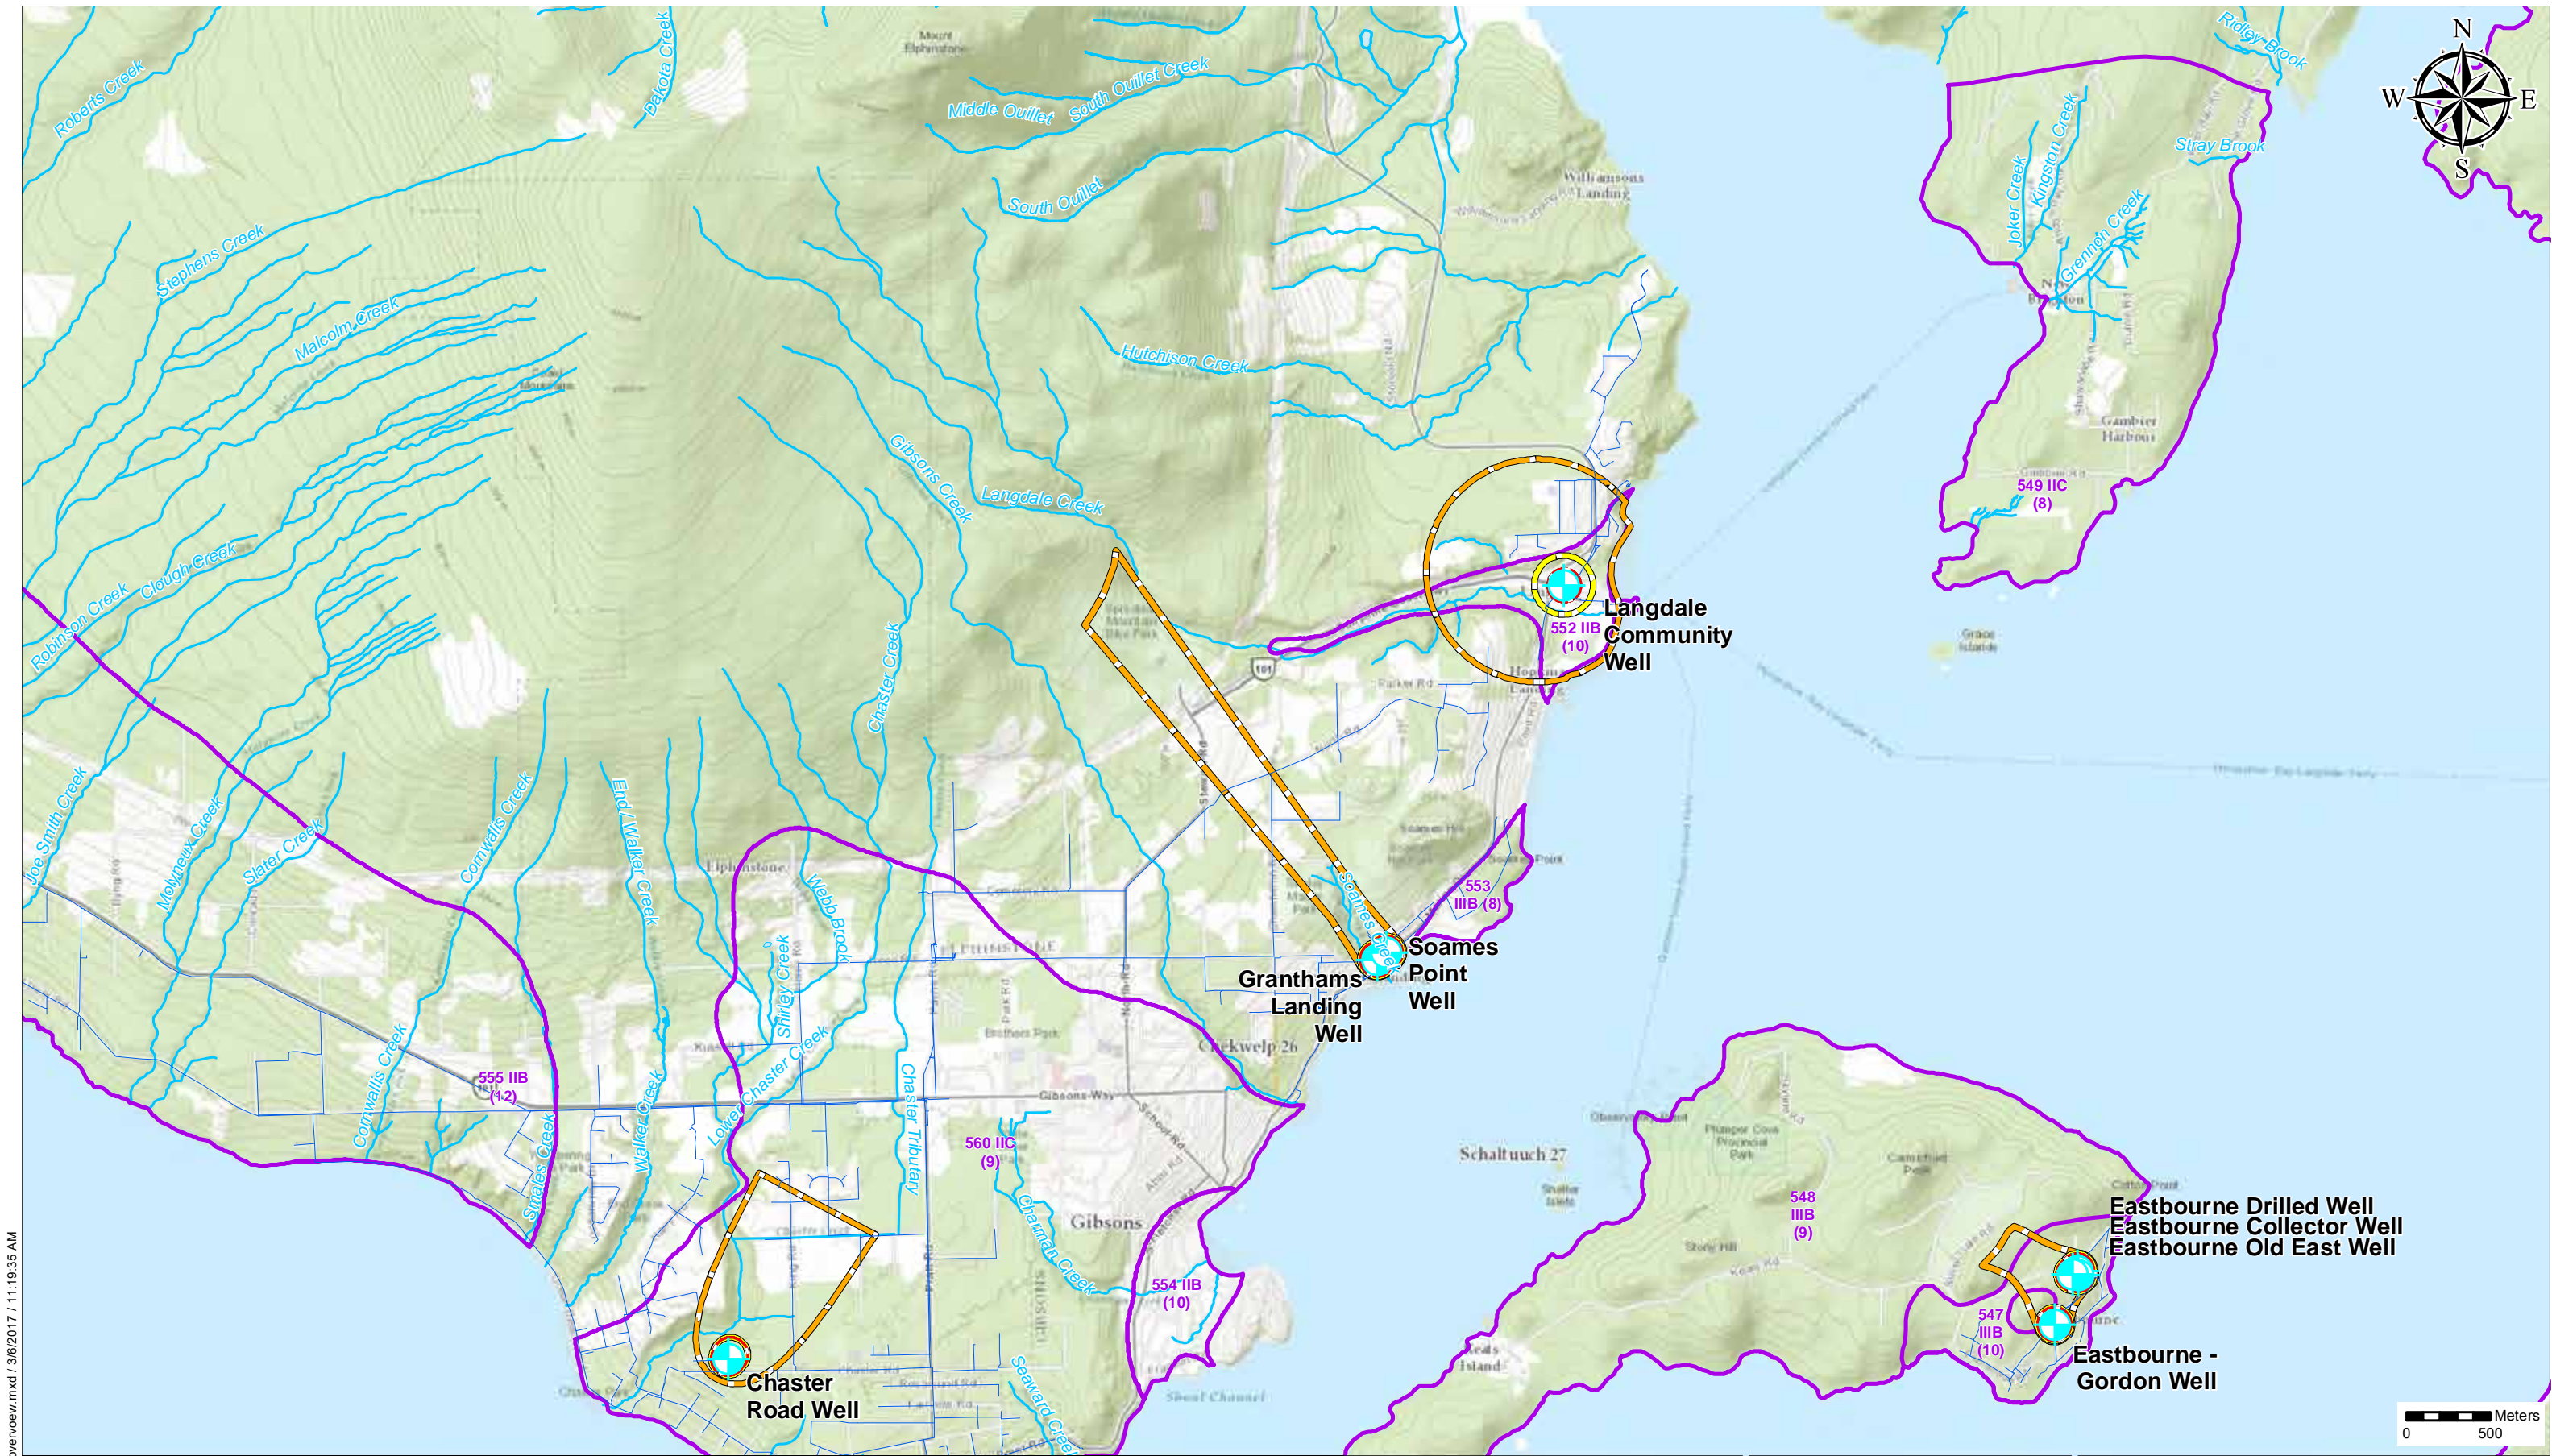
- Aquifer Protection Area**
- A - 100m Well Protection Zone
 - B - 200 Day Time of Travel
 - C - 10 Year Time of Travel
- Aquifer protection areas are based on the maximum (sustainable) well pumping rate, not the actual well pumping rate
