2035012 Final Report for
**Sunshine Coast
Regional District**

**Feasibility Studies - Replacement/Upgrade
of Three Wastewater Systems**

Onsite Wastewater Treatment and Dispersal System Assessment – Greaves Wastewater Treatment Facility

PROJECT No: 2021.02

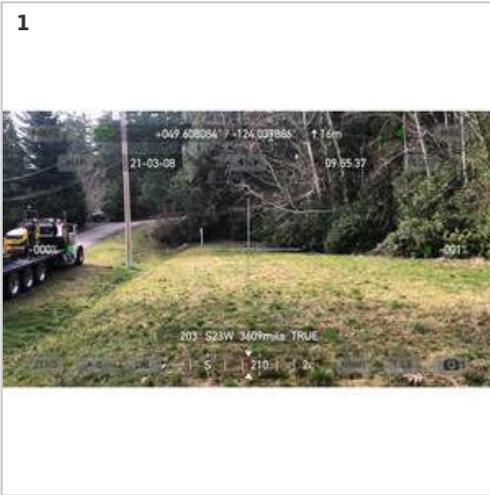
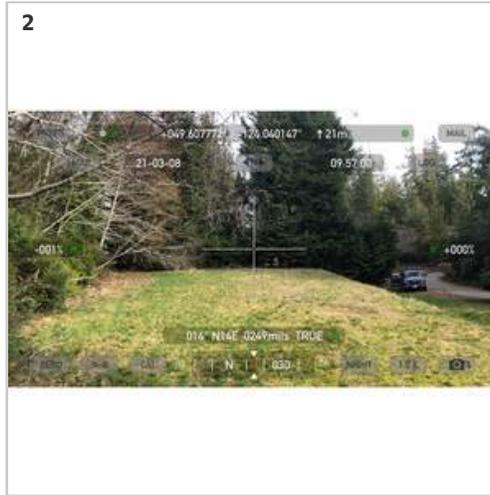
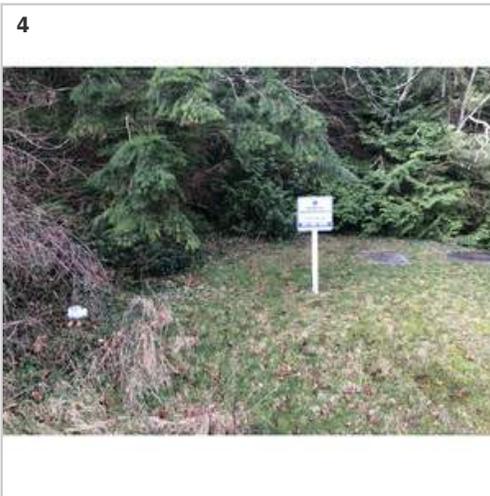
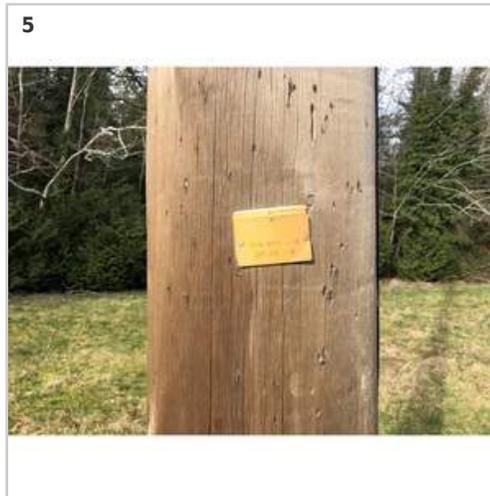
#16 - GENERAL SITE OBSERVATIONS

- Vegetation encroachment, primarily Western Red Cedar and Alder trees, is significant. All trees within 3m-5m of the dispersal area should be felled and the stumps removed. Ongoing vegetation management is recommended.

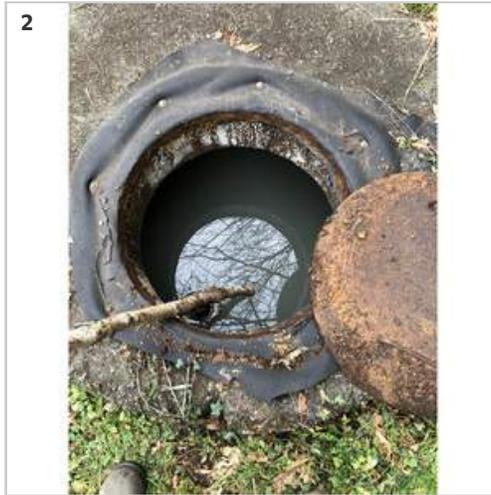
#17 - SIPHON CHAMBER

- The syphon chamber has a performance malfunction and is currently operating via the overflow. The syphon mechanism should be replaced. A replacement floating outlet configuration may offer reduced maintenance and additional usable life for the existing dispersal field.

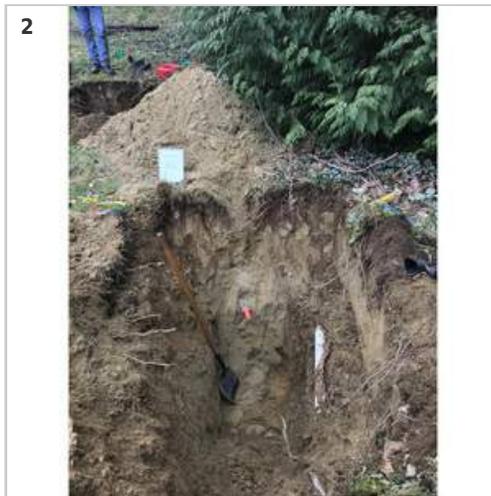
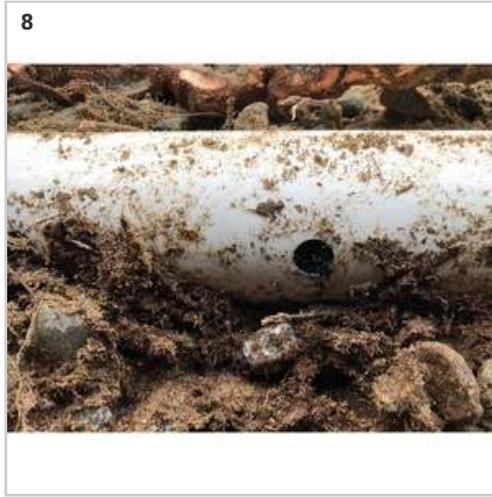
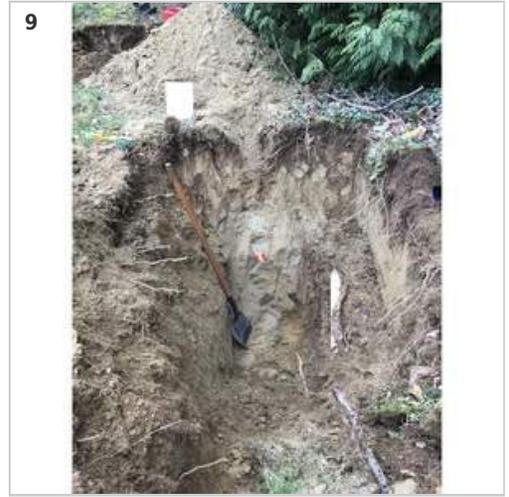
#22 - TEST PIT 1 AND LATERAL EXPOSURE

- Test pits and soil assessments indicated approximately 130 cm of unsaturated and permeable soil, with favourable loamy sand of single grain / loose consistency, with no indication of a seasonal high-water table.

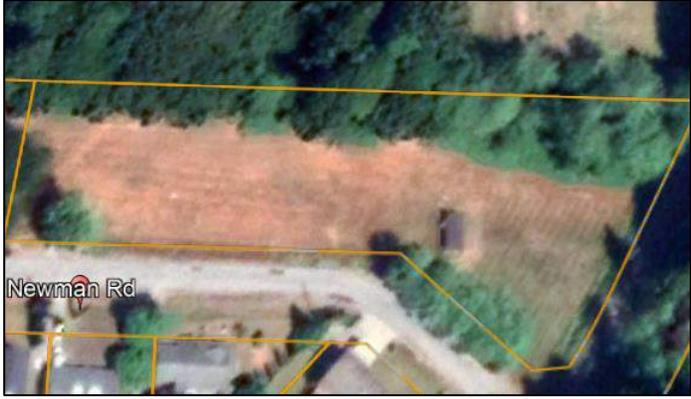
Infiltrative Layer	<p>The infiltrative layer was constructed with a blinding layer of approximately 10 cm of coarse sand. The infiltrative layer and biomat condition were inspected via excavation of several locations within the dispersal area.</p> <ul style="list-style-type: none"> The blinding layer was found to be in good condition with no indications of clogging 	<p>The condition of the infiltrative layer indicates that there may be significant usable life remaining within the drainfield.</p>
Vegetation	<p>The current dispersal area is grassy/herbaceous and is surrounded in the North by primarily Alder trees and blackberry shrubs. Satellite imagery indicates that the vegetation has encroached approximately 6m-10m in from the parcel boundary at North.</p>

<p>Aggressive tree and shrub species should be cleared at least 5m from the dispersal area. A vegetation management plan should be enacted.</p>
