West Bay, Gambier Island Ports Condition Assessment

PORTS CONDITION ASSESSMENT

WEST BAY, GAMBIER ISLAND

Herold Project No.: 4551-012

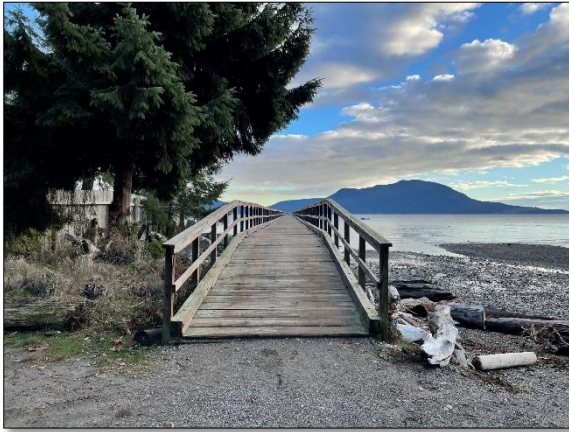
Photograph 1: West Bay, note: general arrangement from shore looking south

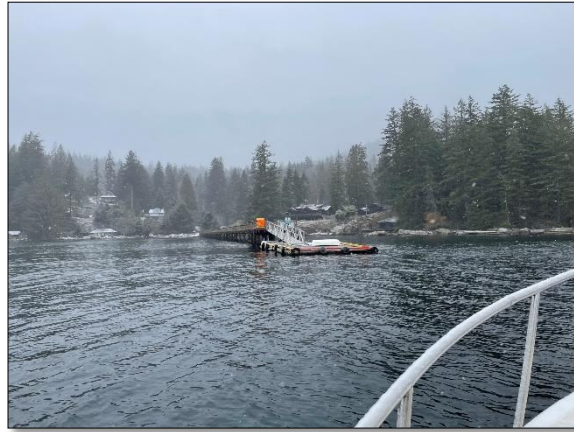
Photograph 2: West Bay, note: general arrangement from seaward end looking north

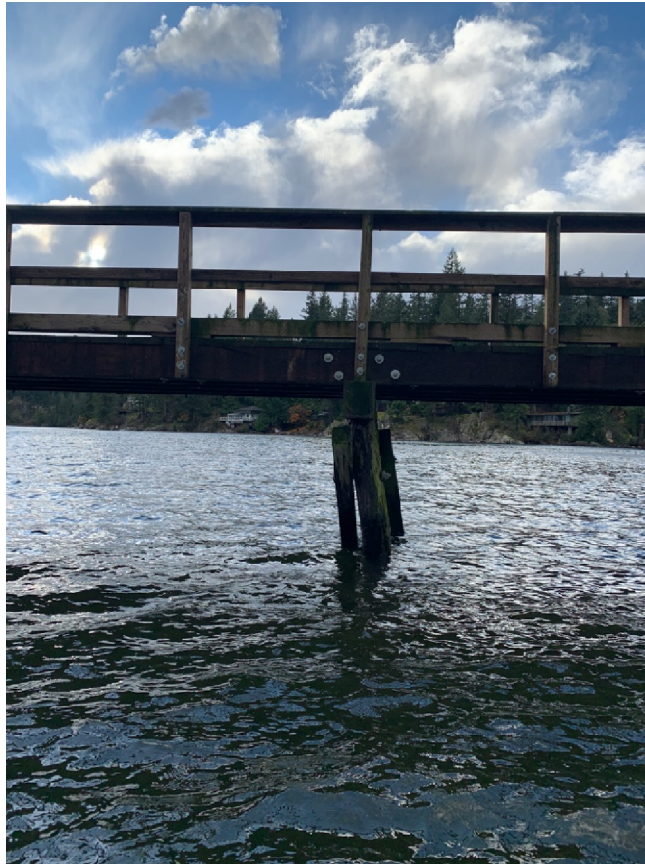
- **Bent 16** Pile 16A slanted 10 deg
 - (From previous inspection April 2019) Bent 20 has a noticeable lean, 10* South, 10* West. Recommend monitoring during future inspections. Continue to monitor.

- **Bent 22** Pile 22A has no washer on cross brace bolt. (Replace bolt, washer nut)
- **Bent 29** 29B cross brace not tight to pile. Recommend tightening (deferred)
- **Other Notes:** Pile Caps becoming Covered in Algae, encouraging rot. Pressure washing recommended in Calm weather, mid tide.

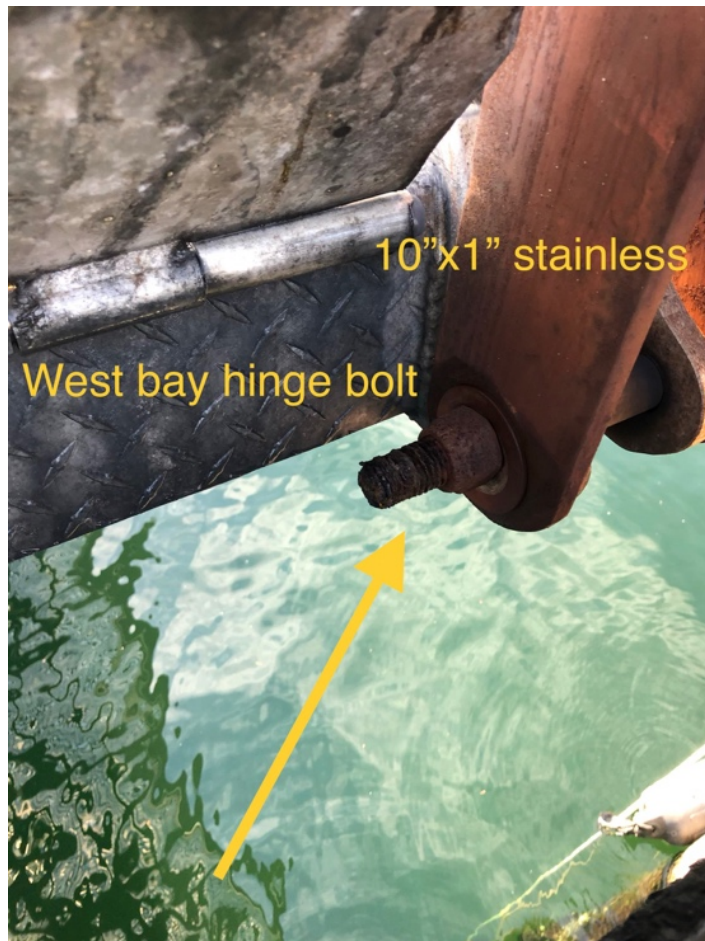
- From Previous Inspection, January 2021) Bolts at hinge rusting. Replacement recommended. Until replacement can be coordinated grease should be added, so slow rusting/wear. (No grease nipple)

- (From Previous Inspection May 2021) Having observed the gangways at Plumper Cove and at The BC Ferries dock, all of the SCRD gangways could be improved by having more horizontal guards
- Engineer to inspect hinge.

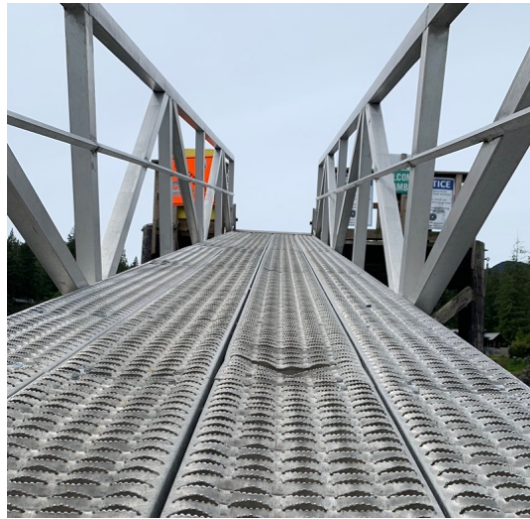
- (From previous inspection April 2019) Checkered steel transition plate wearing on corners due to side to side movement causing contact against the hinge flange. Not currently a safety concern, however it should be monitored at future inspections for sharp edges.
- Damage to gangway deck, tripping hazard stitches required if someone falls. 4'x12' section could be replaced

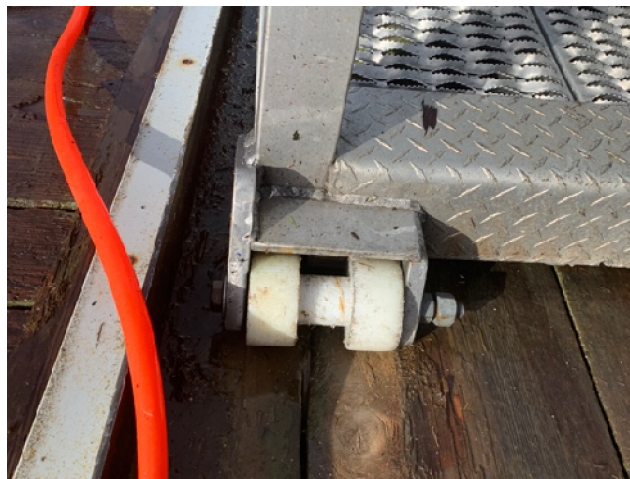
- (From Previous Inspection May 2021) 2x12's under gangway damaged, continue to monitor at future inspections
- Wheels appear to be worn and should be monitored for replacement.

- Gangway guides were loosening and had new fasteners installed during round 8

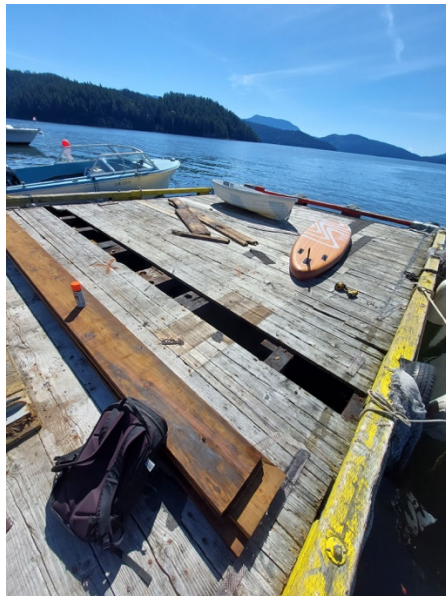
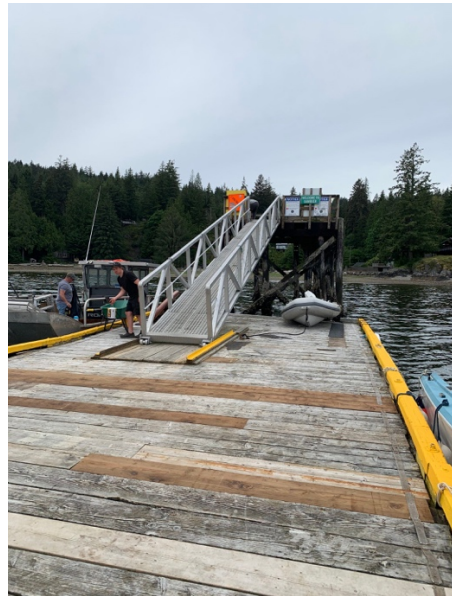
- Several Deck boards were replaced during Round 8

- More deck boards showing signs of rot, expect to replace more within a year

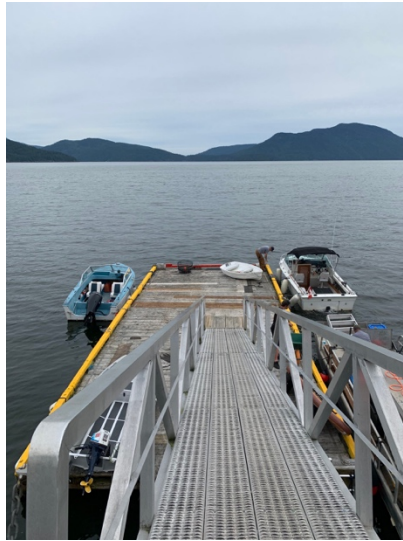
- (From Previous Inspection January 2021) 12' 4x6 bull rail worn, will need replacing soon.
 - Deferred, still strong.
- Several lag bolts were added to bullrails during round 8.

- Bullrails painted during this inspection round per contract

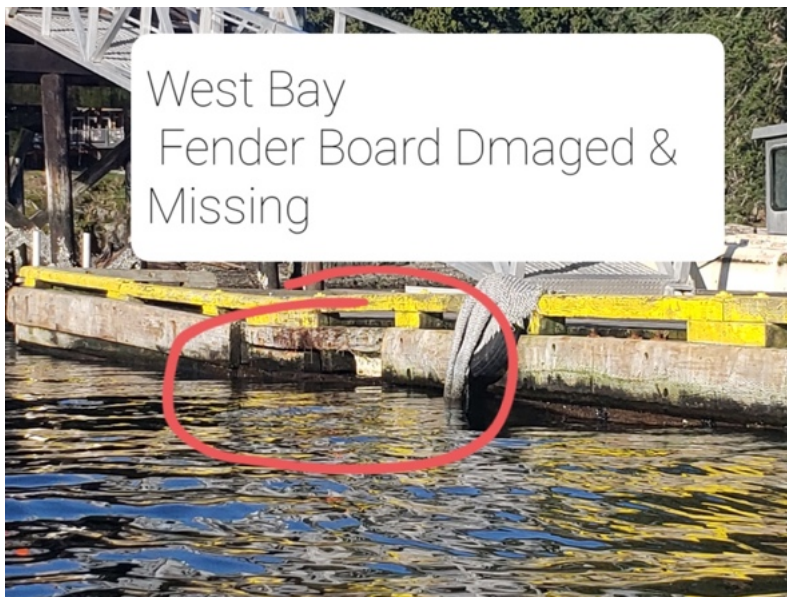
- (From previous inspection April 2019) Fender/Rub boards loose or missing around most of the float
 - (From previous inspection September 2019) Recommend float repairs including flange repairs and fender board replacement as noted by Pelagic Technologies on their dive inspection report (Report dated August 14, 2019)
 - (From Previous Inspections) 40' of fender/rub board missing, monitor at future inspections

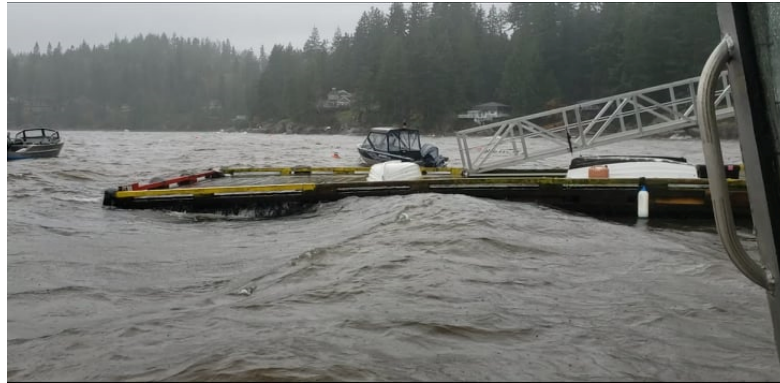
- (From previous inspection April 2019) Float structure appears to be compromised. Noticeable movement in the splice location of the outside flange on west side of float. There is also a "sag" in this location, and a hinge point located where the flange splices. Fender boards are also missing in this location. Herald Engineering should review and advise.
 - (From previous inspection September 2019) Dive inspection completed August 14, 2019. SCRD/Herald Engineering to confirm if repairs to be undertaken during 2020.
