Gambier Harbour, Gambier Island Ports Condition Assessment

PORTS CONDITION ASSESSMENT

GAMBIER HARBOUR, GAMBIER ISLAND

Herold Project No.: 4551-012

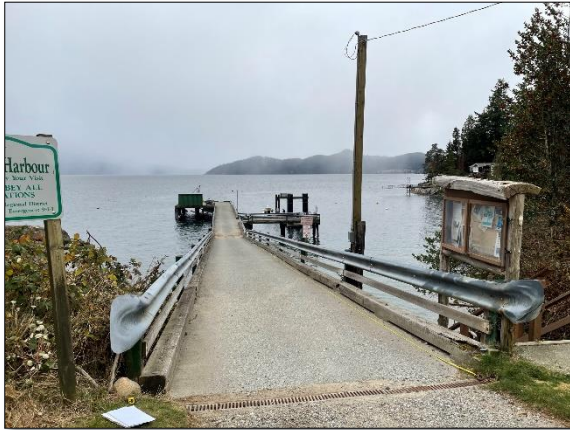
Photograph 1: Gambier Harbour, note: general arrangement from shore looking south

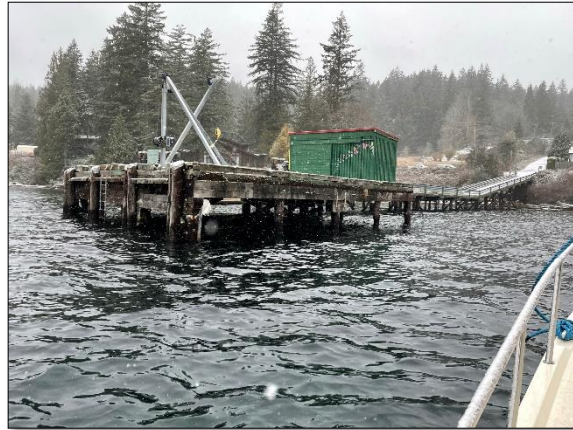
Photograph 2: Gambier Harbour, note: general arrangement from seaward end looking northwest

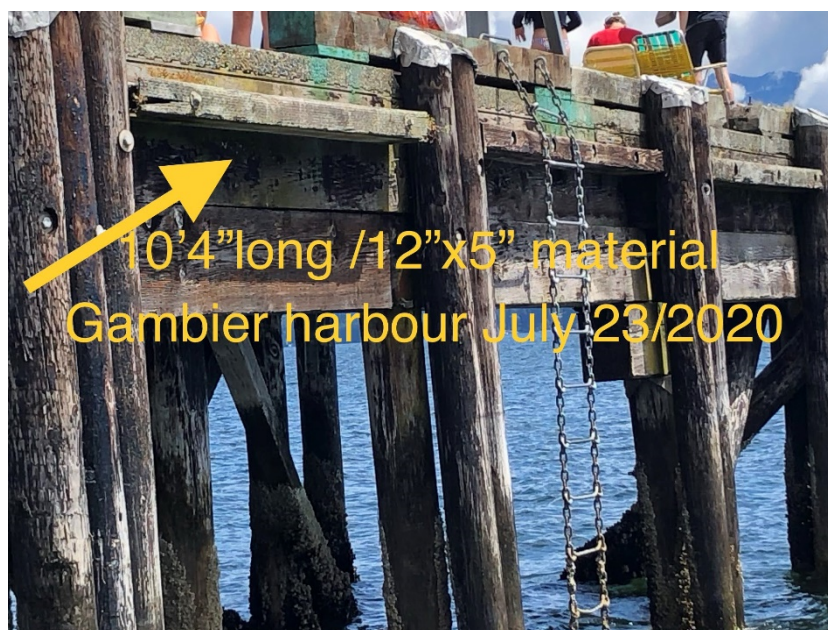
- (From Previous Inspection May 2021) East curb rail (shown above, left arrow) is no longer secured on the south side. Safety concern. Updated photo on the right. Replacement recommended.
- (As mentioned in January 2021 Report) Damage noted on horizontal member between fender piles on the end of the wharf head. Recommend considering replacement as part of future capital upgrades. **Continue to monitor**

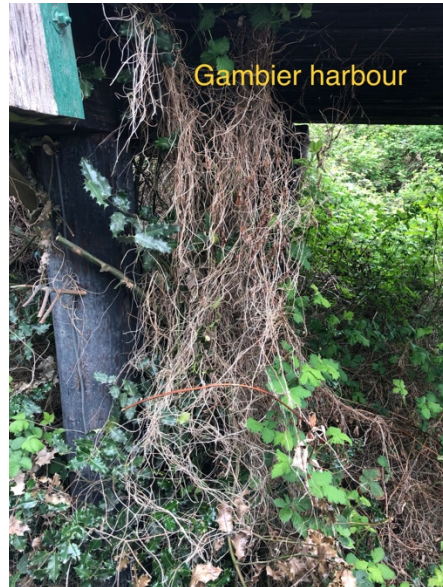
- **(From Previous Inspection November 2021) Bent 1** covered in vegetation. Recommended to remove for longevity and to allow a more accurate inspection.

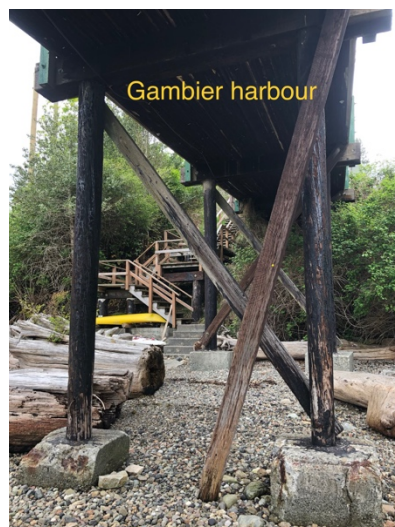
- **Bent 2** Pile 2C Slanted. Monitor closely, could be getting worse due to the creek.
- **Bent 3**
 - (From Previous Inspection November 2021) Footing 3C and 3D Cracked. Loose cross brace. Cross brace and bolt have failed at Pile D

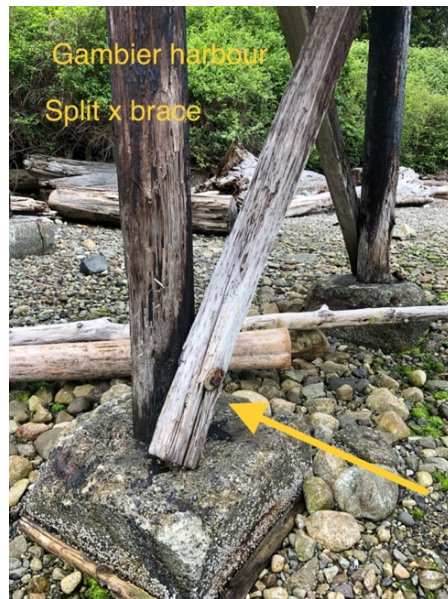
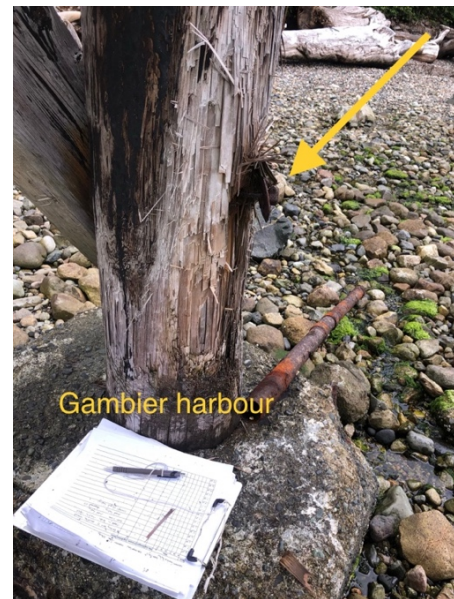
- **Bent 4** (From previous inspection April 2019) Damage observed on pile on Row C' Bent 4. 254mm of pile thickness remaining, engineer review recommended to determine if replacement is required. Bolt connecting the bottom of the cross brace needs to be replaced at a minimum, see photo for reference. Chipped footings also

- (Previous recommendation from April 2019) Herold Engineering to review and make recommendation. * further decay visible during May inspection.

to be reviewed by Herold Engineering. 20" x 1 1/2" threaded rod needed to replace bolt.

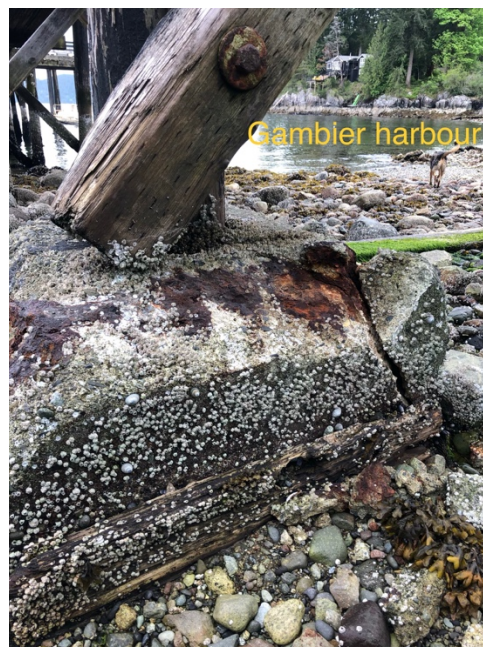
- **Bent 5** (From previous inspection September 2019) Wear and deterioration on concrete pile footings noted on pile bent 5. Herold Engineering to review and make recommendation. * Deterioration continuing. Rusted Bolts require replacing.

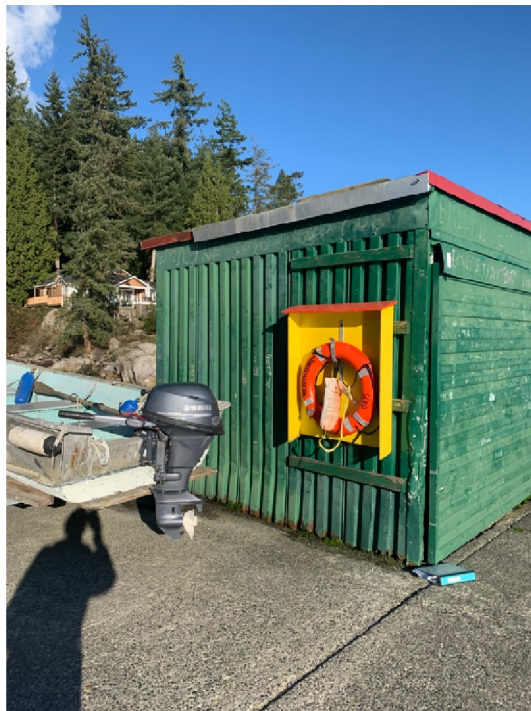
- (From previous inspection April 2019) Metal wall cladding showing significant rust, recommend monitoring on future inspections
 - Shed needs to be upgraded.
 - Steady increase in rust since last inspections – continue to monitor until renovation/replacement.

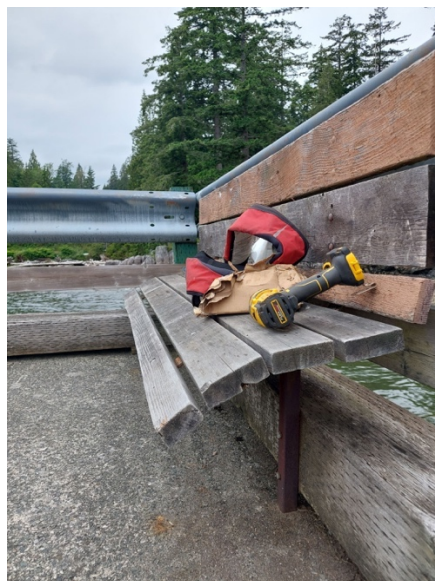
- (From Previous inspection January 2021) Signage locations and sizes observed per Autumn's request. All signage is due for replacement
- Bench on wharfhead requires repairing or replacing. Confirm if in scope for SCRD

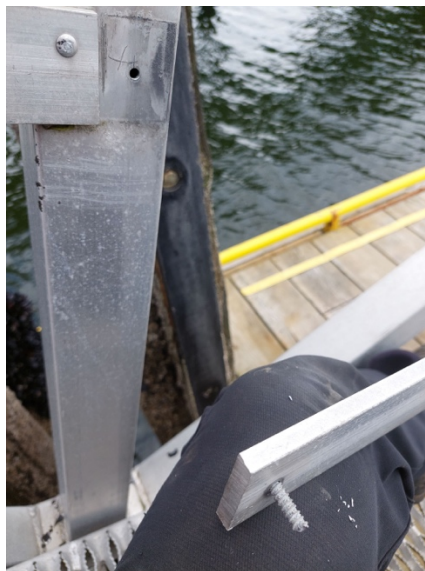
- As mentioned in the Halkett Bay May 2021 report, most of the SCRD gangways have large enough opening in which a child could fall through. At Plumper Cove and at BC ferries they have far more horizontal members that reduce this risk. Consider welding extra strips on either side.
- A detached horizontal member on gangway was reattached during round 8.

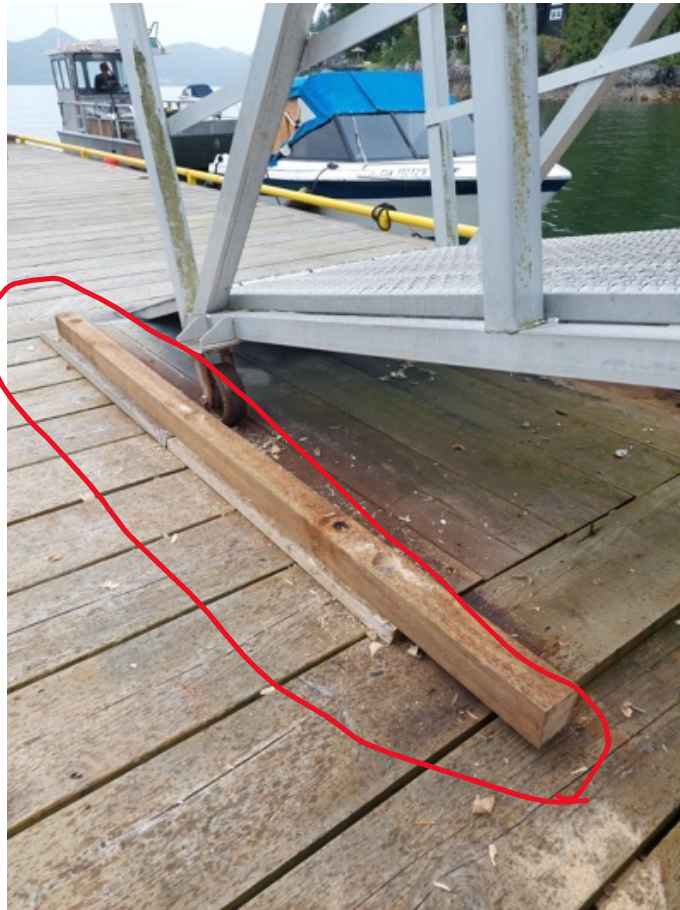
- Gangway guide was extended to match other side, as it was not functioning during sub 1' tides. Monitor at future inspections

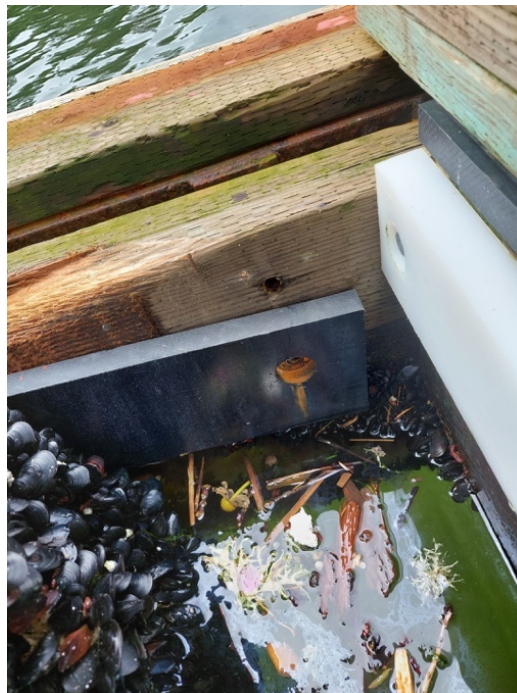
Gambier Harbour. Float Pile wear strip.

- Pile well wear strips on 2 southern pile wells were repaired during this visit.

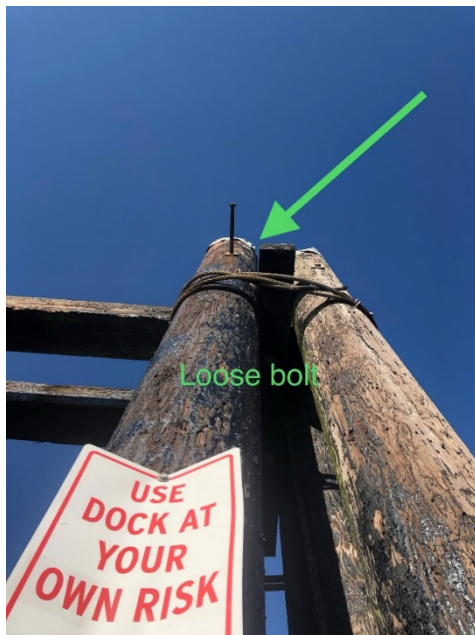
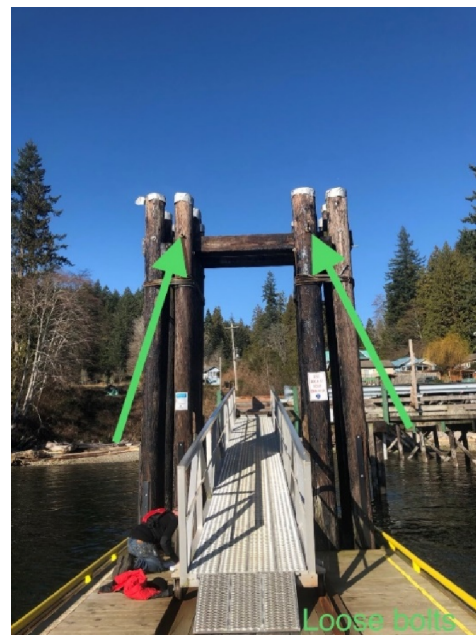
- (Previous recommendation from February 2020) Loose bolts noted at the top of dolphin pile connection to cross beams.
 - High tide, calm weather and longer ladder required. Tighten or replace bolts at next maintenance visit. *Tides and weather again not favorable during May visit.
 - Unable to access safely to complete due to height, not a risk of failure. Recommend we take off the list.

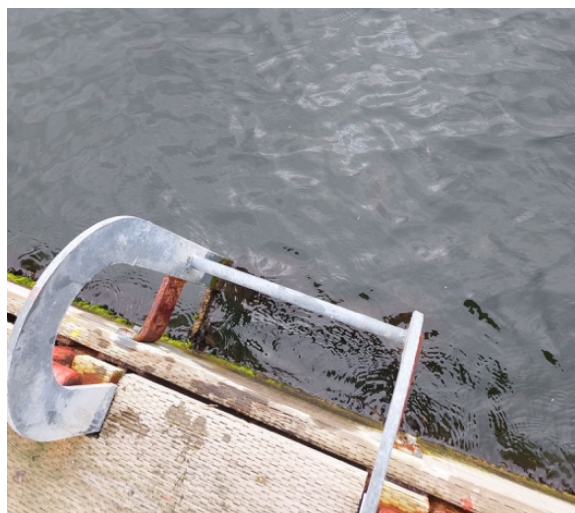
- Ladders were cleaned during this inspection visit (as per contract)
- Note rusting of new ladder. Aluminum Ladders are superior.
